EFFECTS ON A VEHICLE IMPACTING A
CONCRETE SAFETY SHAPE BARRIER AT
A LOW SPEED AND A LARGE ANGLE

The following conclusions are based on the results of an 1860 lb vehicle/27.4 mph/52° impact test, Test 431, into a safety shape concrete barrier.

3.2 Test Results, Test 431 (1860 lbs/27.4 mph/52°)

FIGURE 4 - Data Summary Sheet - Test 431

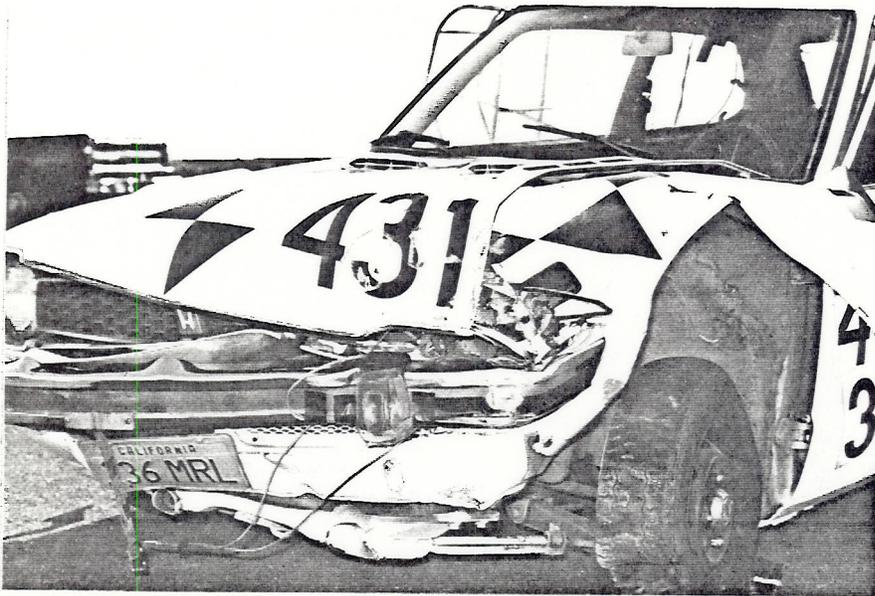
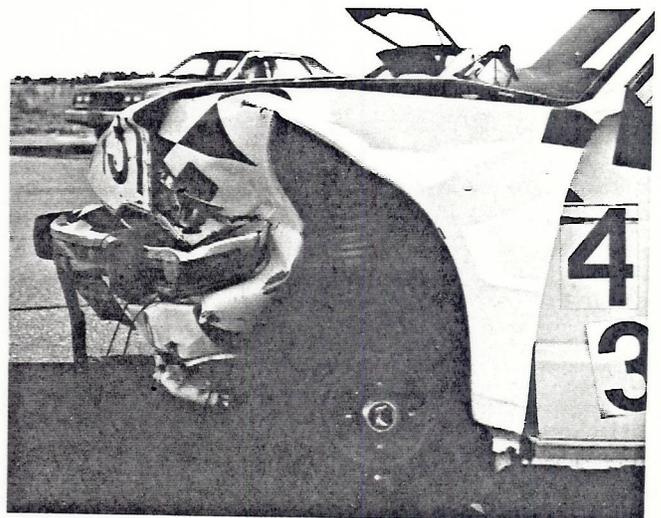
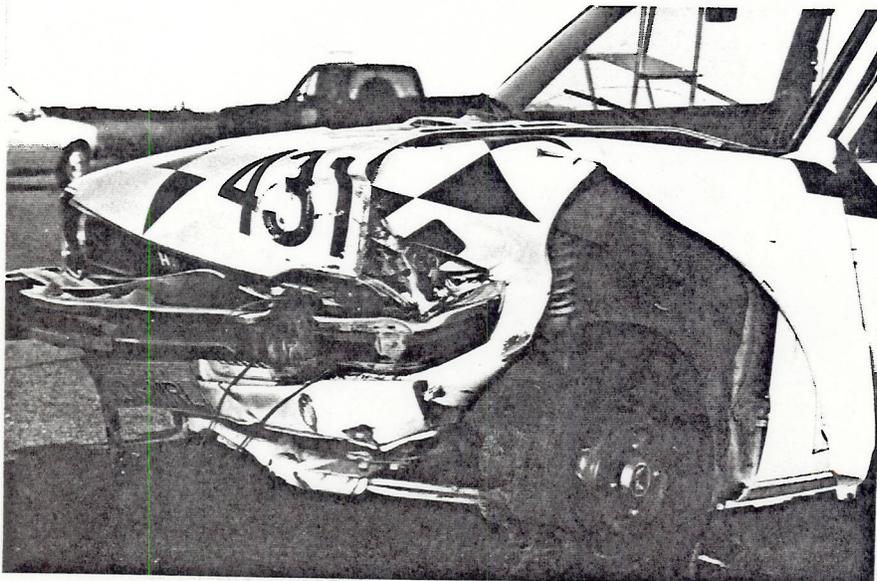
FIGURE 5 - Vehicle Damage

Damage to the vehicle was relatively severe. Immediately after impact the left front quarter panel was crushed and buckled above the tire. The front bumper was crushed toward the right side of the vehicle. The

left side of the hood was crushed back and the hood opened. The left front headlight was crushed, and the front frame members under the engine were bent. The left front tire was flat, and the rim was scraped and bent, Figure 5. The left inside door panel was dented and bent forward (out) from impact by the dummy, Figure 6. The left door post from the upper front corner to 6 inches down its length, was struck by the dummy head, and bent 1/2-inch forward. During the redirection of the car, the left side was scraped. Paint from the side of the vehicle was transferred to the upper half of the barrier on an area about 20" long and 10 inches high. There was no intrusion of barrier or vehicle components into the passenger compartment. The steering wheel was bent about 6 inches toward the windshield from the impact of the dummy.

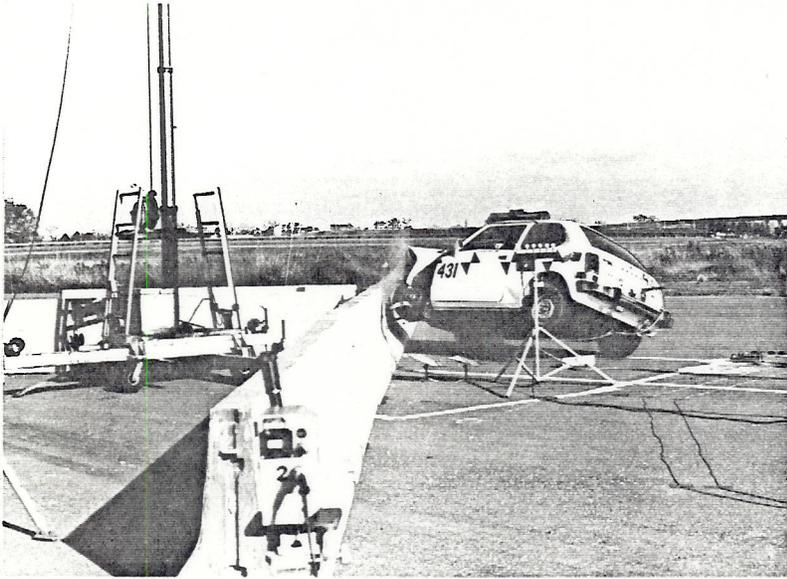
Vehicle Climbing
Barrier and Rolling
During Impact

During impact, and immediately after, the vehicle rode up the face of the barrier and across the face while rolling steadily clockwise to its right side. There was no intrusion of the passenger compartment when the car rolled over. If the camera rack had not been mounted outside the passenger door, the car would have continued to roll with the possibility of greater vehicle damage and more severe injuries to passengers.

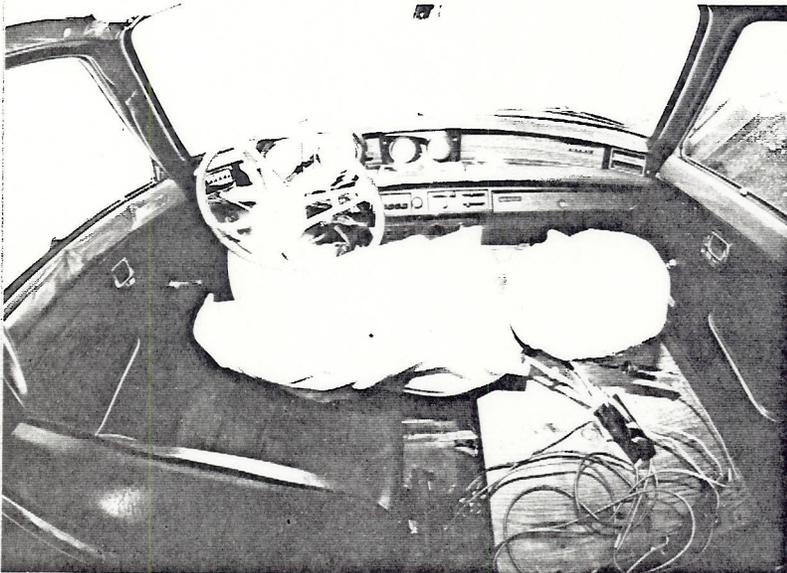
Dents in Door
and Doorpost Due
to Dummy Impact

During impact, the unrestrained 5th percentile female dummy, which was in the driver's seat, was thrown forcefully ahead into the steering wheel bending it and pushing it forward six inches from its original plane. The steering column was forced down. The dummy continued to move toward the left front corner of the car, and hit the left front door post, bending it. Then it was thrown to the right toward the passenger seat as the car rolled over to the right. After impact the dummy was laying across the front passenger seat with its legs wedged under the steering wheel, Figure 6.

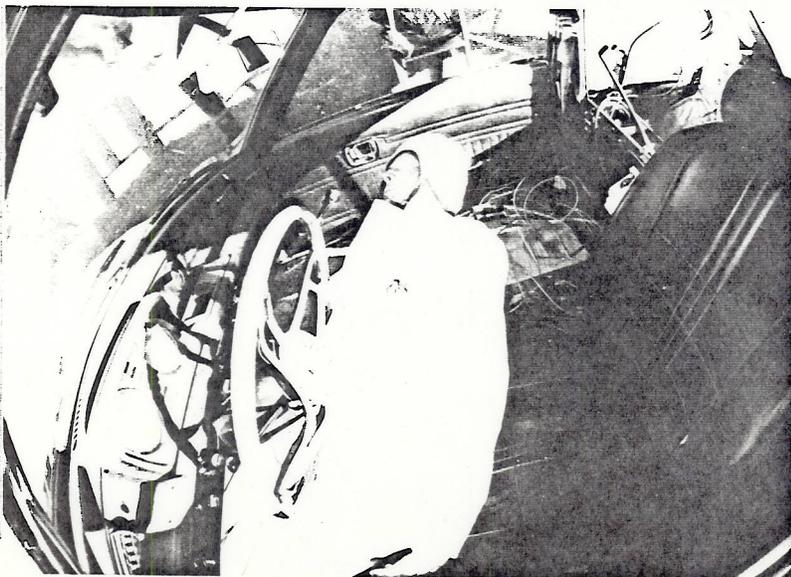
Final Position of Dummy
After Impact.

Dummy measurements are optional according to NCHRP Report 230. The Head Injury Criterion (HIC) was calculated to be 317 for test 431. This value is much less than the upper limit of 1000 which marks the threshold of serious injury or death due to head trauma. The maximum 3 ms dummy chest resultant acceleration was 50.8 g's, less than the 60 g limit. The test movie shows the dummy was thrown forcefully ahead into the steering wheel, bending and pushing it forward. The movie shows the dummy then hitting and denting the left front door post. It eventually fell to the right toward the passenger seat. If shoulder and lap belts had been worn correctly, there would have been virtually no chance of dummy impact with the interior of the passenger compartment.

This dummy behavior was not surprising under these tests conditions. It clearly illustrates the value of seat restraints which reduce or eliminate most injuries during an impact.

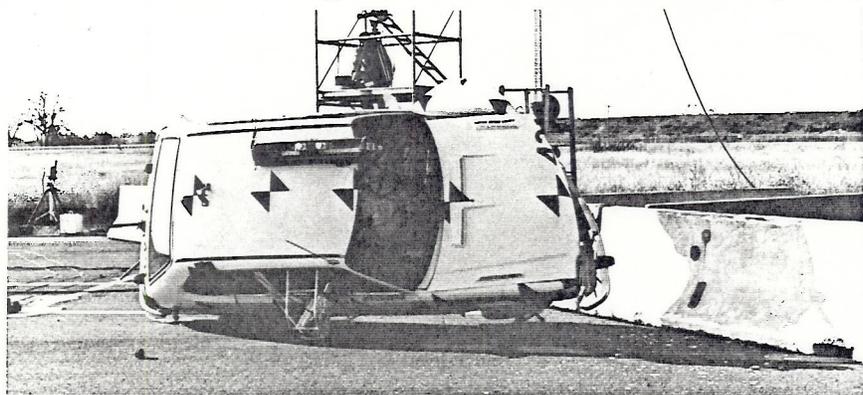
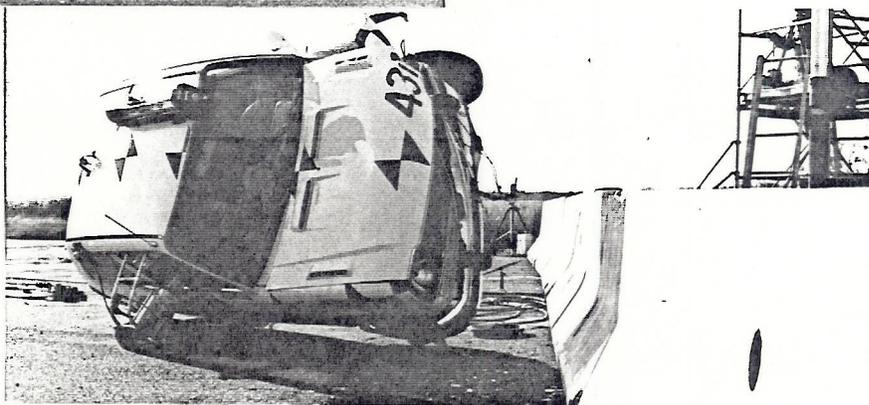
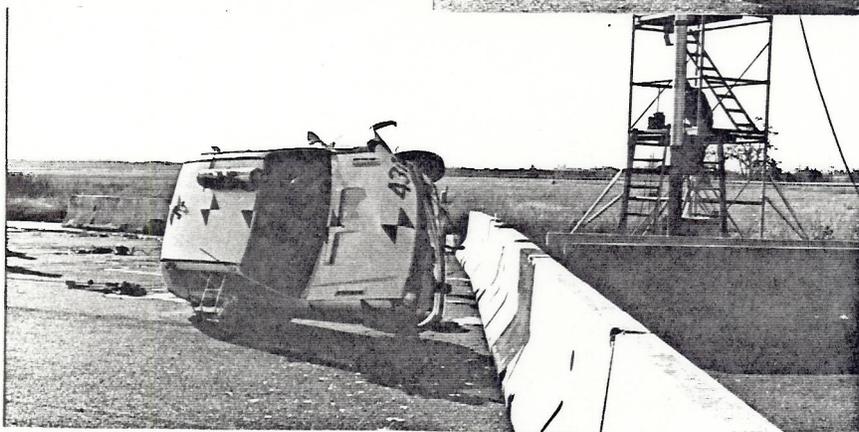
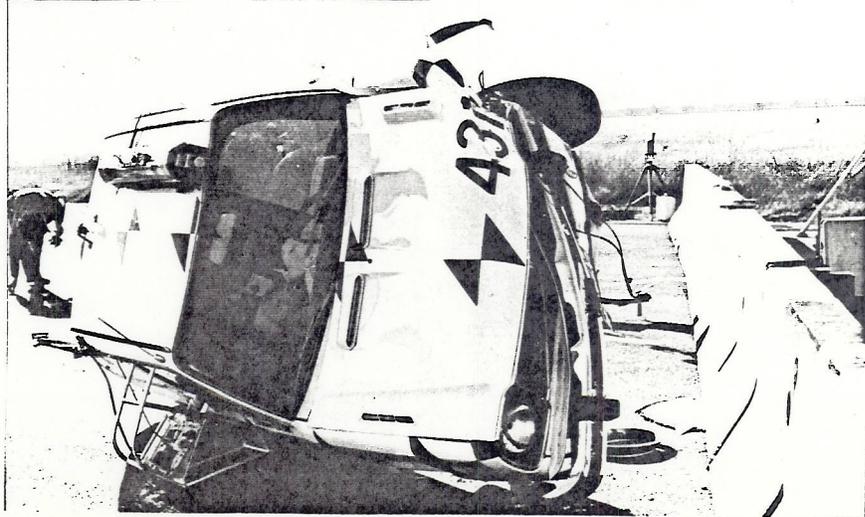
Figure 8 - Final Position of Vehicle After Impact

The vehicle remained on its right side at an angle of 69 degrees with respect to the center line of the barrier. The horn became stuck when the dummy struck the steering wheel and the dashboard.

In test 431, the final resting position of the test vehicle after impact is shown on the Data Summary Sheet, Figure 4, in the Test Results section of this report and in Figures 6, 7 and 8. The test vehicle rode up the face of the barrier and across the face while rolling steadily clockwise to its right side where it rested, lying on the camera rack hanging on the right window. The vehicle remained on its right side at an angle of 69° with respect to the center line of the barrier. Rollovers do not meet the safety evaluation criteria for highway safety devices according to NCHRP Report 230. Hence, it is clear that this impact was extra hazardous due to the rollover.

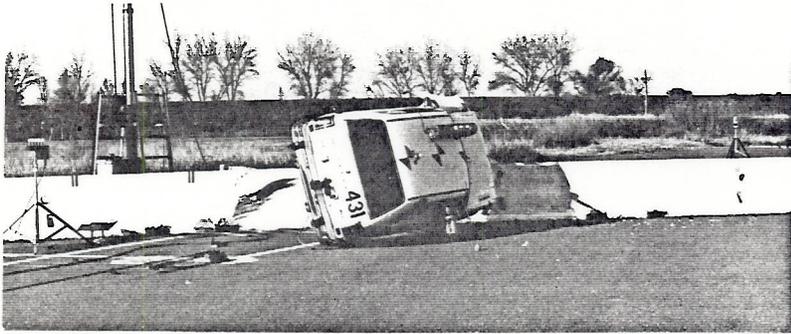
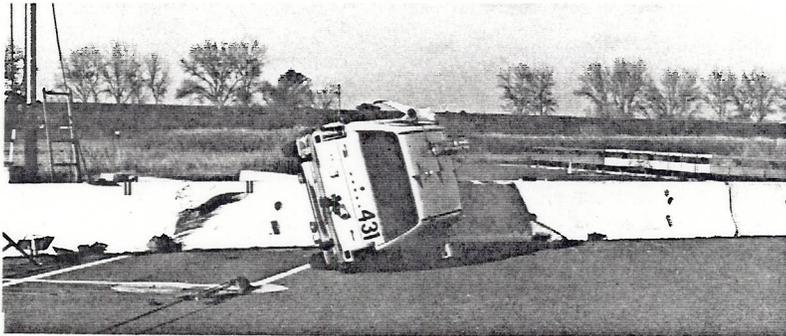
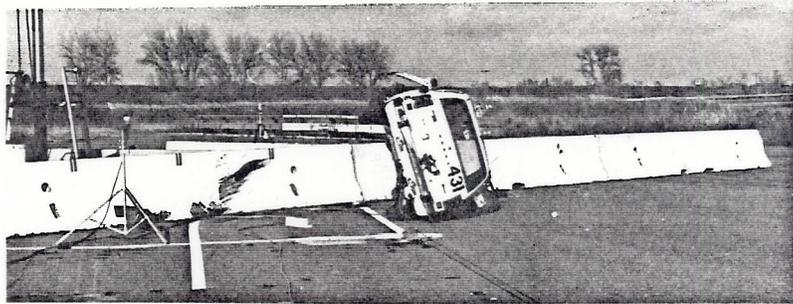
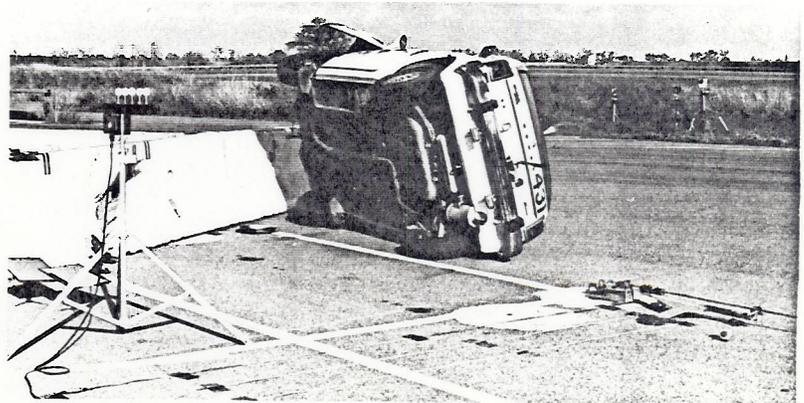
Figure 9 - Car Tire Marks on the Barrier

There was no evidence of any structural failure of the barrier. No visible cracks were detected. The only damage imparted to the barrier was a few scrapes and tire marks, Figure 9.

Criteria A and D - passed. The test barrier did not fail structurally. There were no visible cracks in the barrier. Other than tire marks, minor sheet metal scrapes, all of which would require minor maintenance

repair, the test barrier suffered no damage. No barrier debris intruded into the passenger compartment of the vehicle during the test.
