Subject: **San Francisco Bay Area Toll Bridge Seismic Retrofit 2013 First Quarter Project Progress and Financial Update**

Briefing on E2 Anchor Bolts – May 7, 2013

THE SAN FRANCISCO-OAKLAND
BAY BRIDGE
SEISMIC SAFETY PROJECT

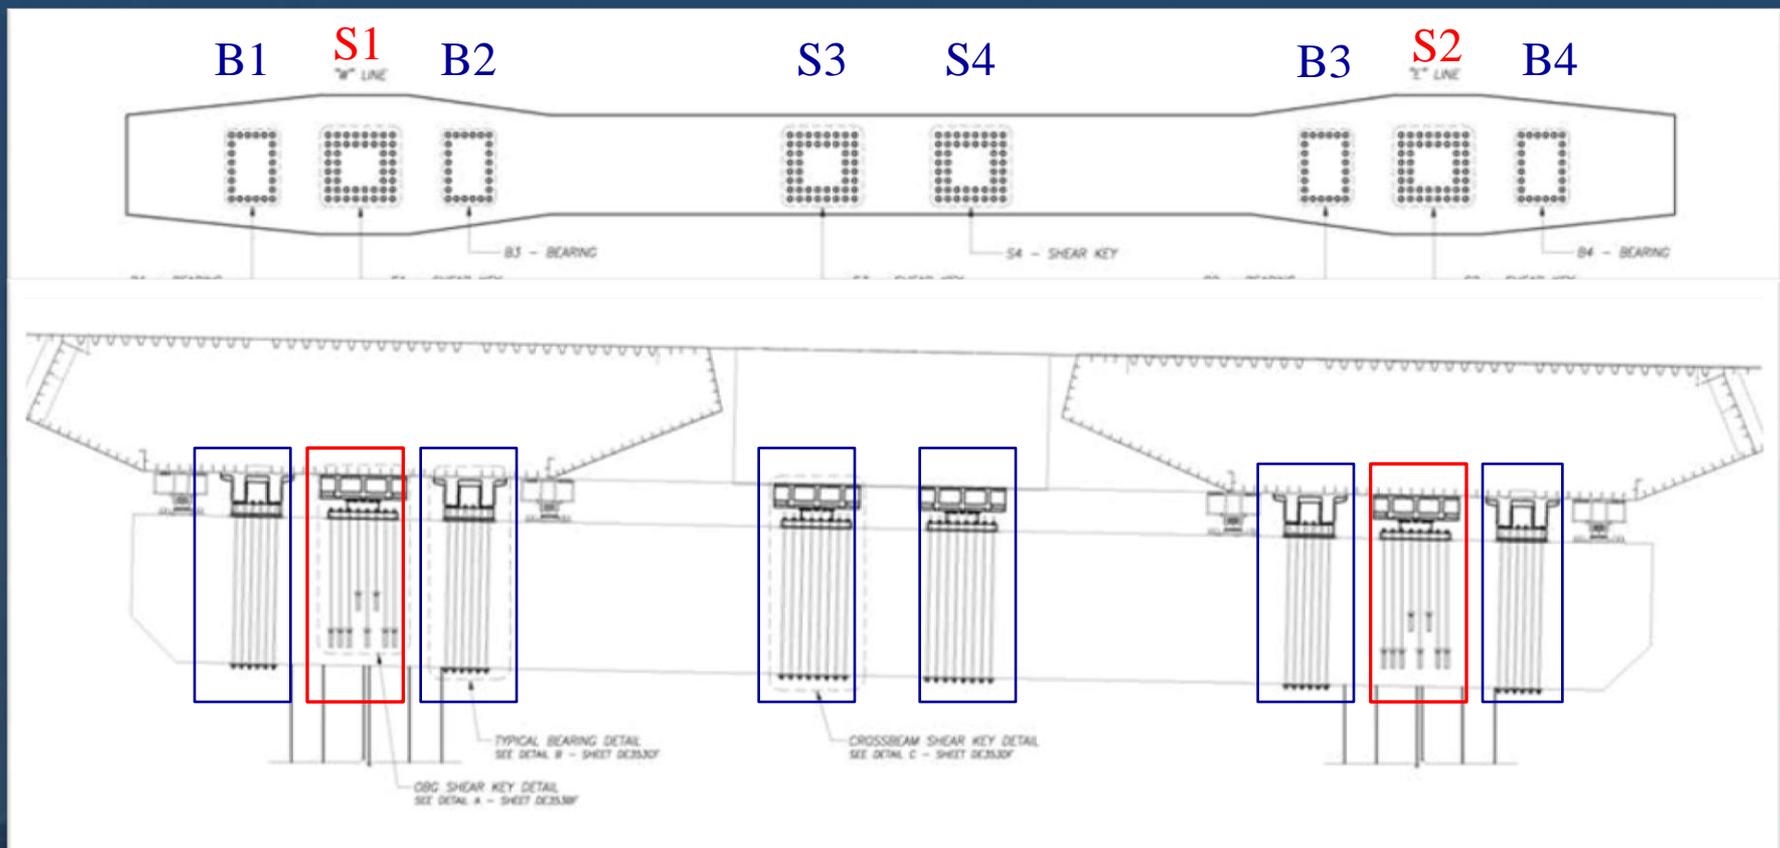
- Bearings and shear keys are secured to E2 by 3 inch diameter anchor bolts, ranging from 9 feet to 24 feet in length.
- 96 bolts manufactured in 2008 shown in red are embedded in the pier.
- 192 bolts manufactured in 2010 shown in blue are not embedded in pier.

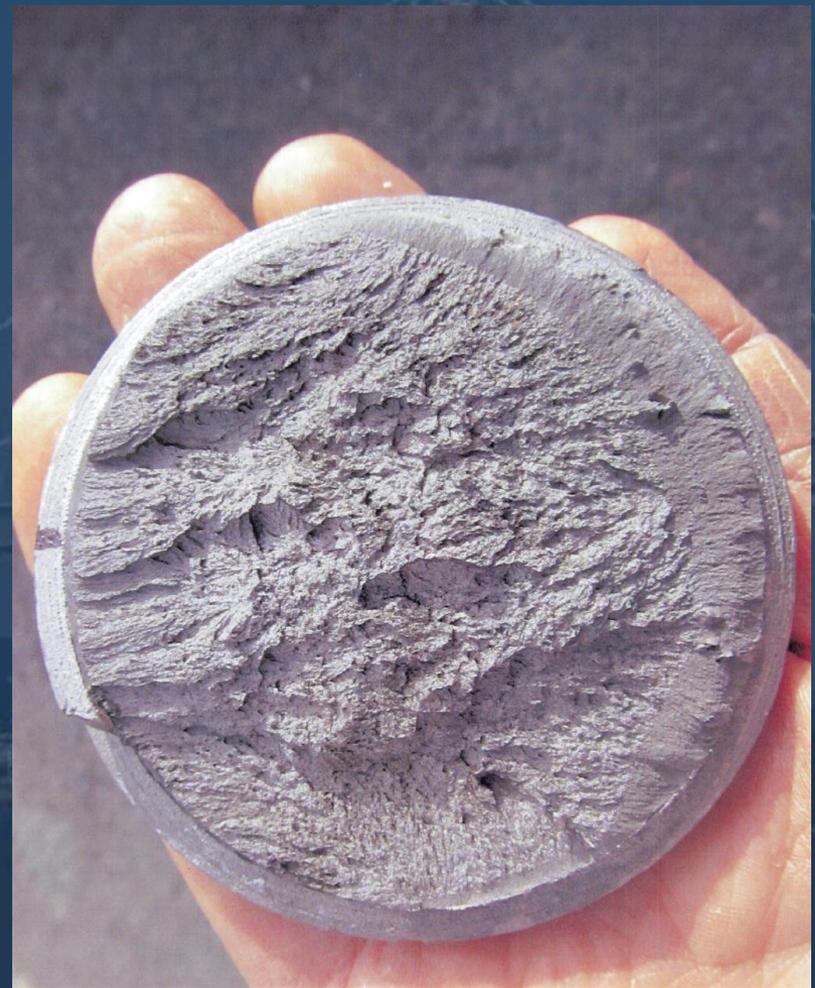
Failure of 2008 Bolts Due to Hydrogen Embrittlement

- Under detailed investigation, 2008 bolt failures are due to hydrogen embrittlement.
- Excess hydrogen in the 2008 bolts caused the threaded areas of bolts to become brittle and fracture under high tension.

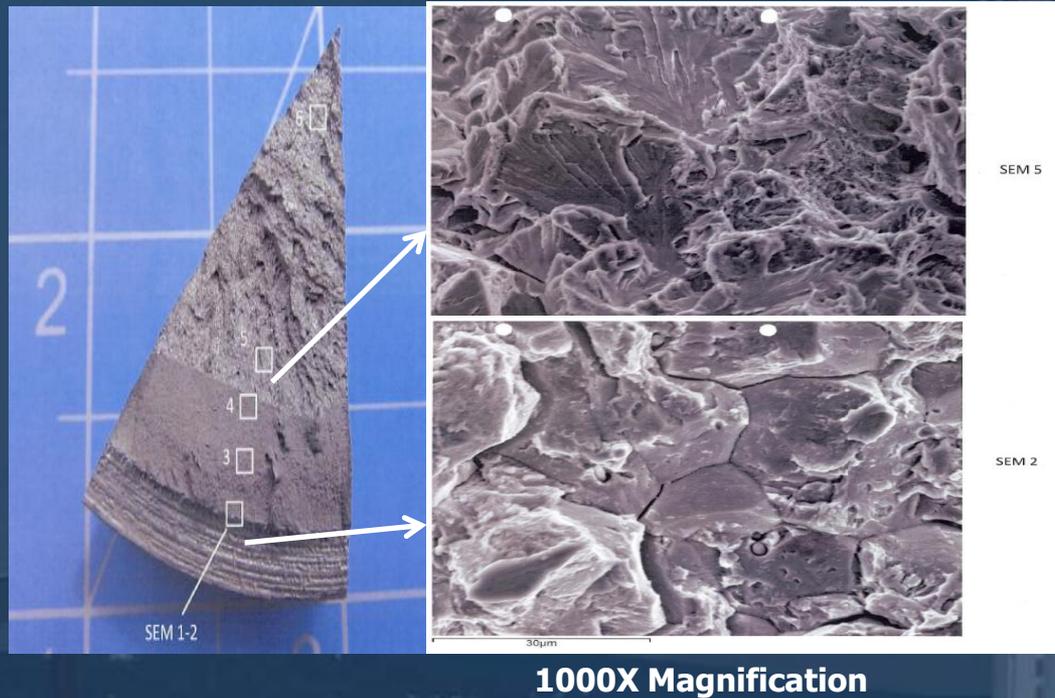
Hydrogen Embrittlement

- On-going metallurgical analysis indicates 2008 bolts were susceptible to hydrogen embrittlement due to “a lack of uniformity in the microstructure of the steel”
- Identified under electron microscope.

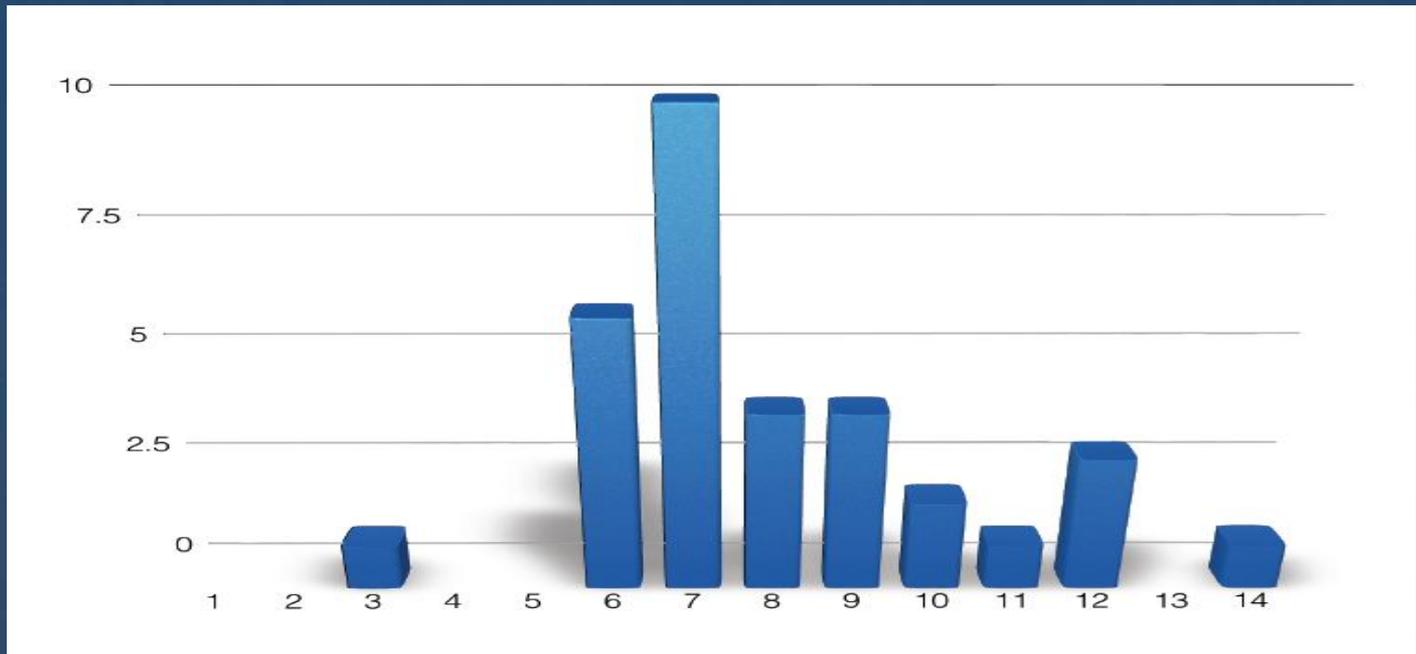
DAYS AFTER STRESSING (2008 BOLTS)

- Failure by hydrogen embrittlement is time dependent and should happen within weeks of tensioning.
- 2008 bolts failed days after tensioning. After 14 days, all 2008 bolts were de-tensioned.
- Industry standard testing protocols for A354 bolts are not time-dependent. Lesson learned: Additional material specifications and testing protocols could have reduced risk of hydrogen embrittlement.

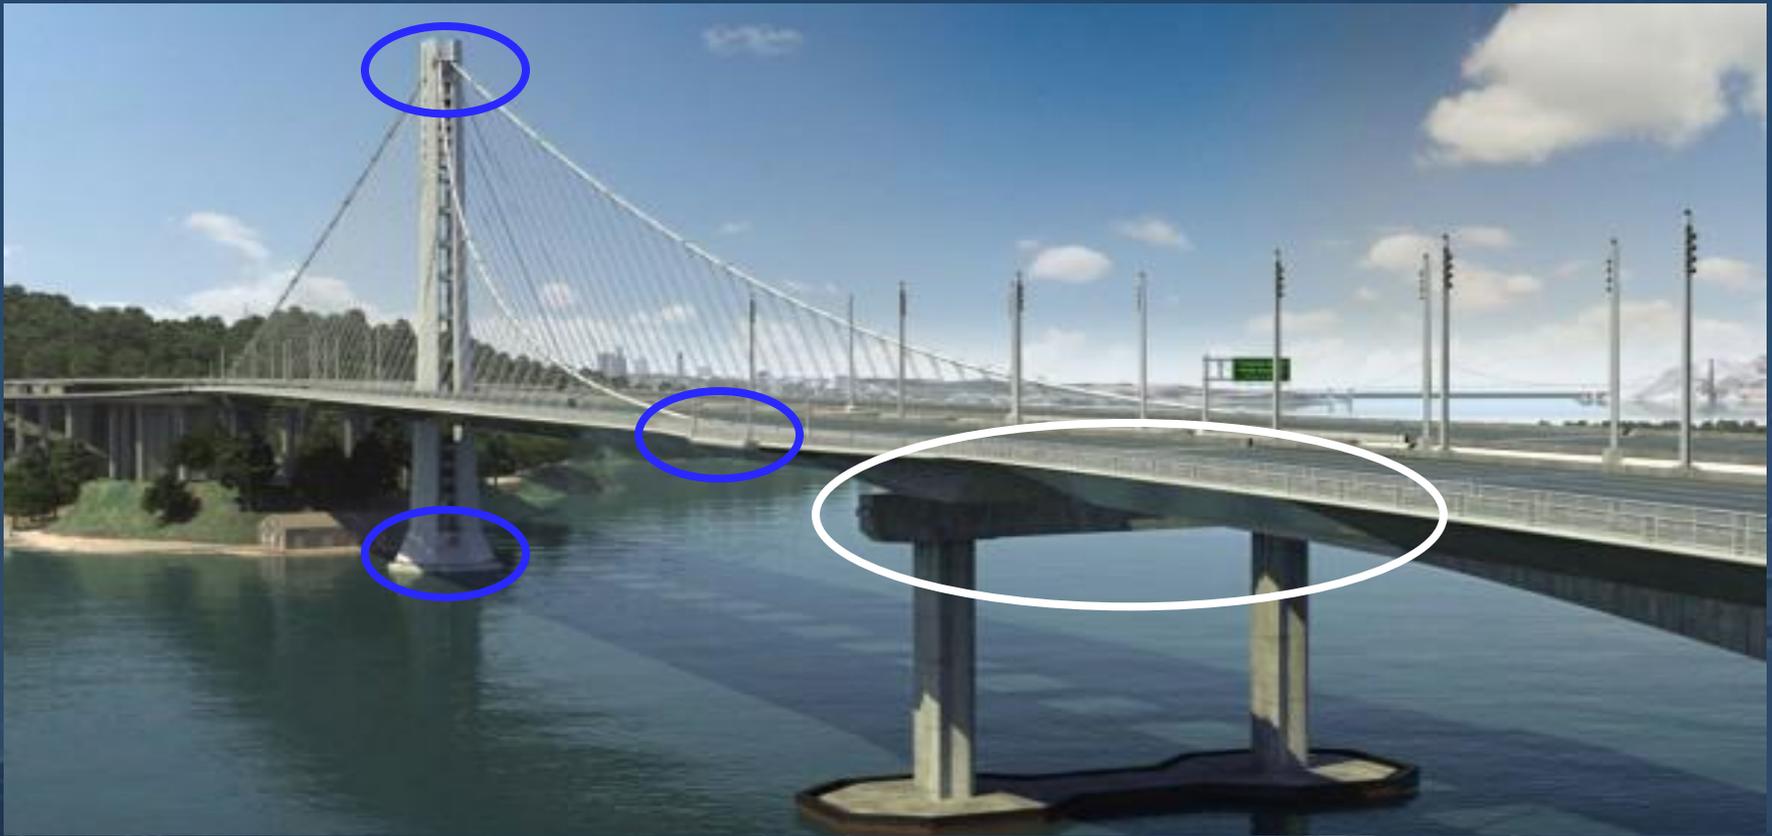
- **Visual inspections of similar anchor bolts revealed no abnormalities.**
- **Some E2 Bearing assembly bolts are not accessible to inspection.**
- **Most anchor bolts at other locations are under lower tension levels.**
- **Prioritized Desk Audit of QC/QA results underway.**
