Report on the A354 Grade BD High-Strength
Steel Rods on the New East Span of the
San Francisco-Oakland Bay Bridge
With Findings and Decisions

July 8, 2013

TOLL BRIDGE PROGRAM
OVERSIGHT COMMITTEE

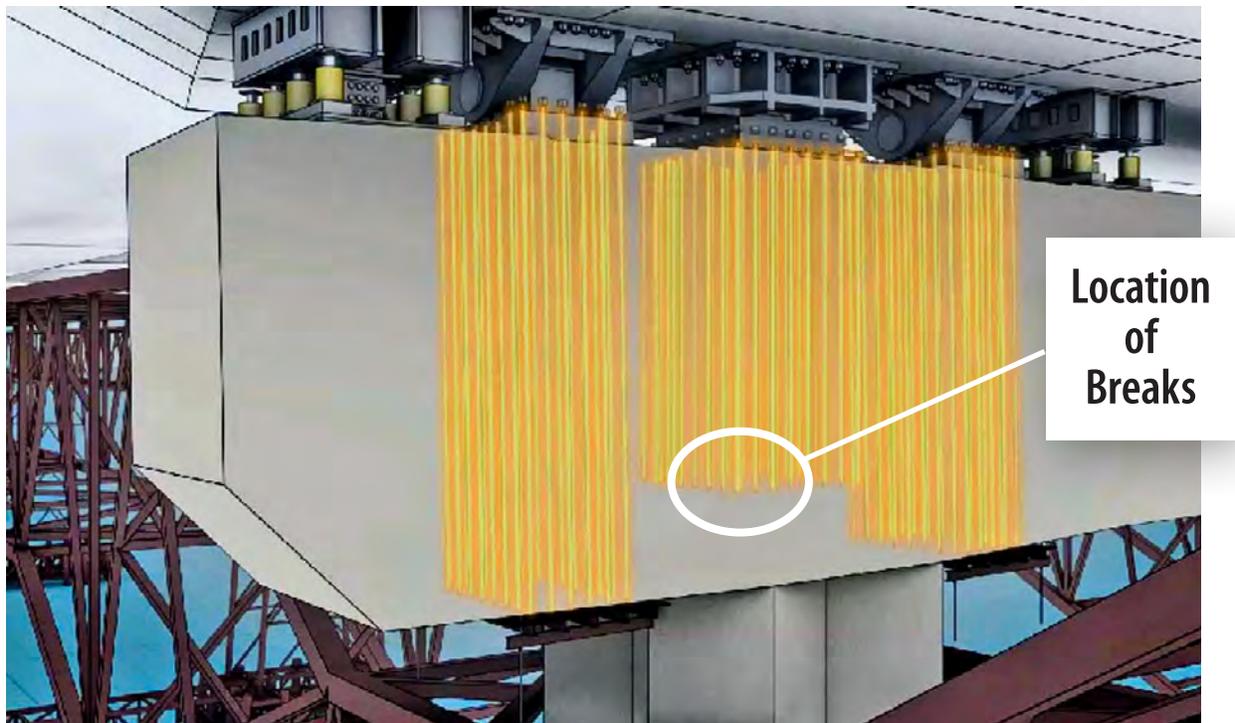
Figure 4 Location of Failed A354 Grade BD Anchor Rods

The E2 pier cap, including the embedded 2008 shear key anchor rods, was completed by early 2009. Due to the extended construction schedule, Pier E2 was completed three years before the roadway boxes were erected in place over the pier. This resulted in the anchor rods being exposed to the environment for an extended period of time before the next construction stage, which would tension and grout them in place. This open environment is shown in a Pier E2 construction progress photograph (Figure 5) taken soon after completion of the pier cap. There were no provisions made in the design by the T.Y. Lin International/Moffatt & Nichol Design Joint Venture or the installation procedures prescribed by American Bridge/Fluor Joint Venture to include water drainage or sufficient rain protection to prevent the ingress and accumulation of rainwater or other moisture in the anchor rod housings during this extended period.

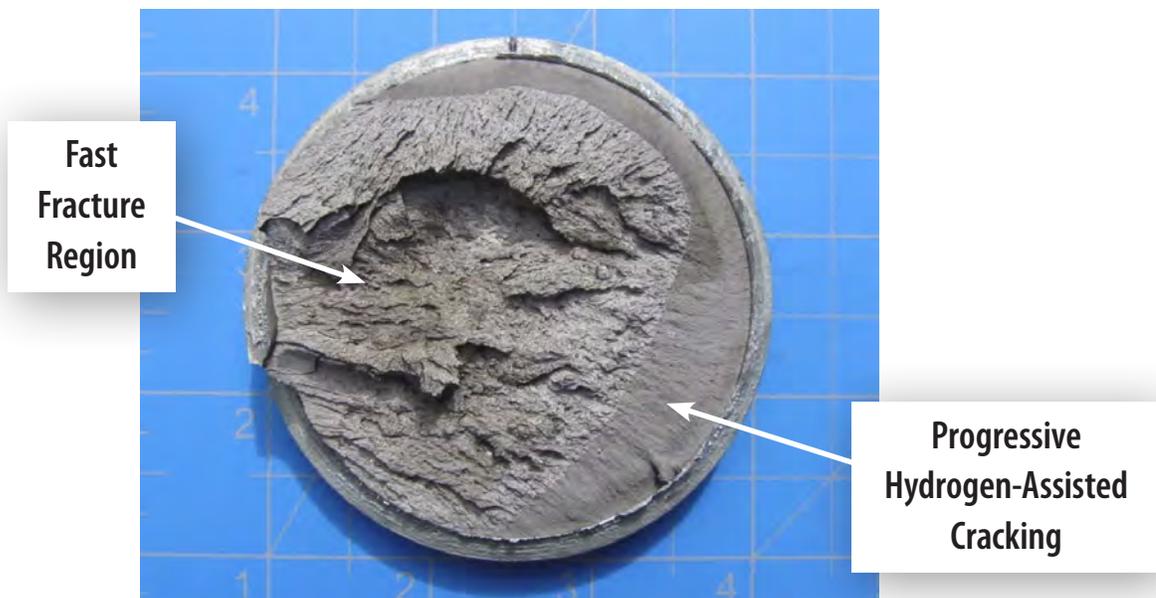
Figure 8 Fracture Surface of Rod S1-G1 After Cleaning

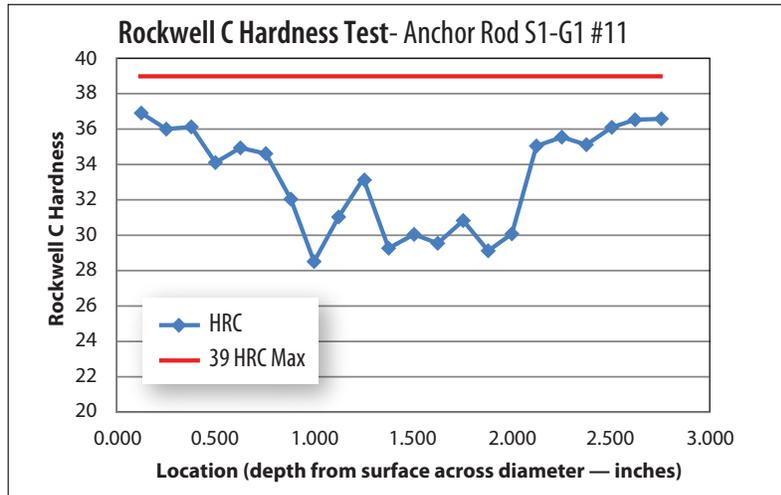
4 Hardness testing: The Rockwell C hardness test is a technique that assesses a material's tensile strength, wear resistance and ductility. Samples were machined at Christensen Materials Labs and tests were performed in Hayward, California by Anamet Inc., where Rockwell C hardness measurements were made across the diameter and at mid-radius locations of both rods. Figures 11 and 12 illustrate the results of the Rockwell hardness tests conducted on Rod S1-G1 and Rod S2-A6, respectively. The results of the Rockwell hardness test show variation in hardness, with the outer diameter approaching 39 HRC (high hardness is generally considered greater than 35 HRC). The center hardness drops to as low as 25 HRC, indicating the material was not uniformly through-hardened. The metallurgical report states that completely uniform through-hardening is difficult to achieve in large diameter rods such as these; however, the large disparity in hardness from center to edge indicates that the steel may not have had optimal through-thickness hardenability or was improperly heat-treated. ASTM A354 for grade BD specifies a maximum rod hardness of 39 HRC, as shown by the solid red line in Figures 11 (Rod S1-G1) and 12 (Rod S2-A6).

Figure 11 Rockwell Hardness Test Results — Rod S1-G1

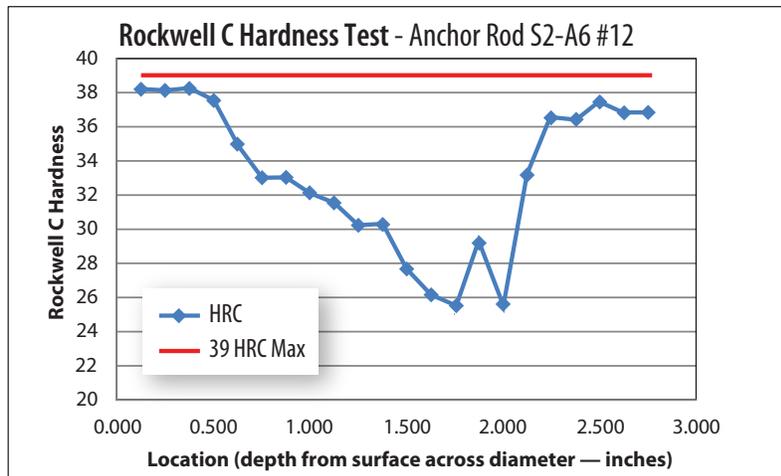
Figure 12 Rockwell Hardness Test Results — Rod S2-A6

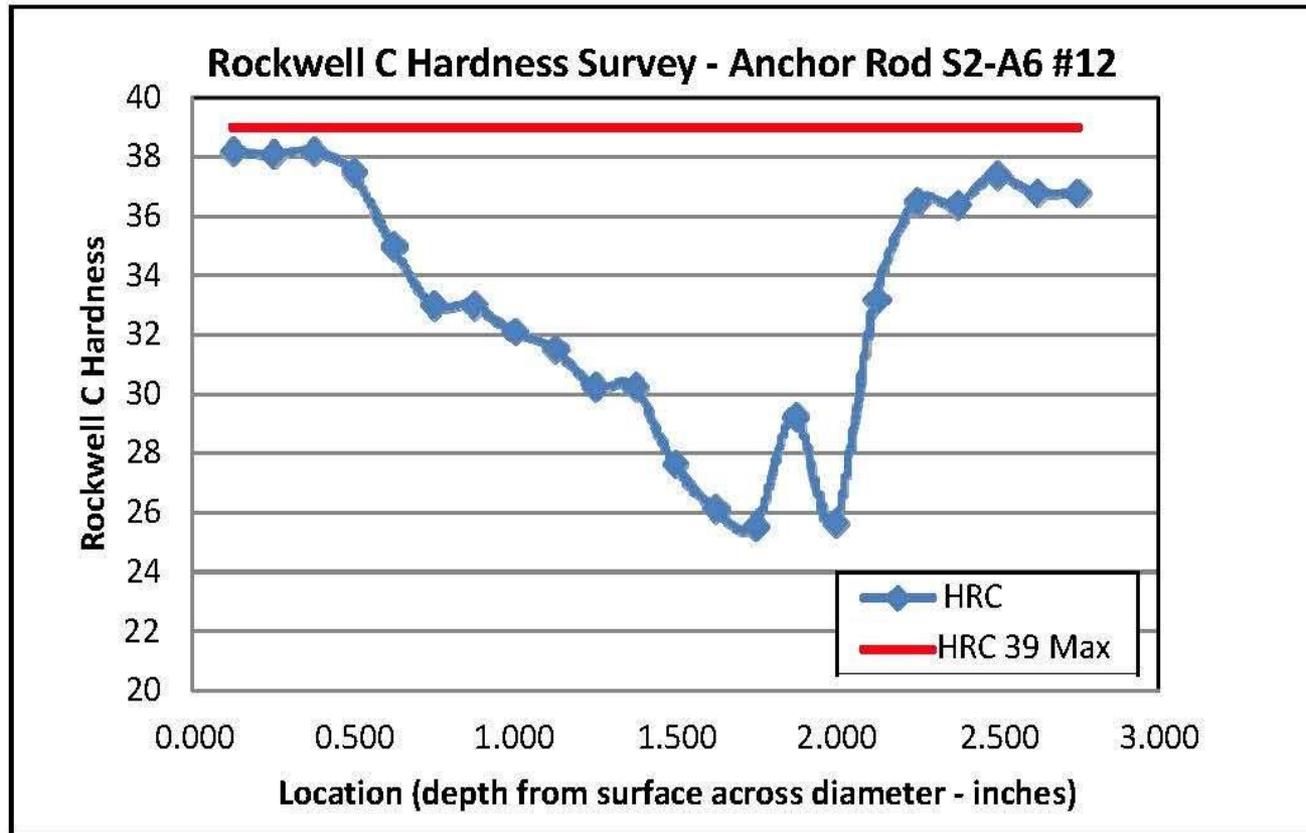
2008 Rods Failed Due to Hydrogen Embrittlement

- Rods exhibited a material susceptibility to hydrogen embrittlement with a heterogenous structure and high surface hardness.
