A Report of an Investigation to Determine Causes for Displacement and Faulting at the Joints in Portland Cement Concrete Pavements

May 1949

F.N. Hveem

State of California  
Division of Highways  
Materials and Research Department

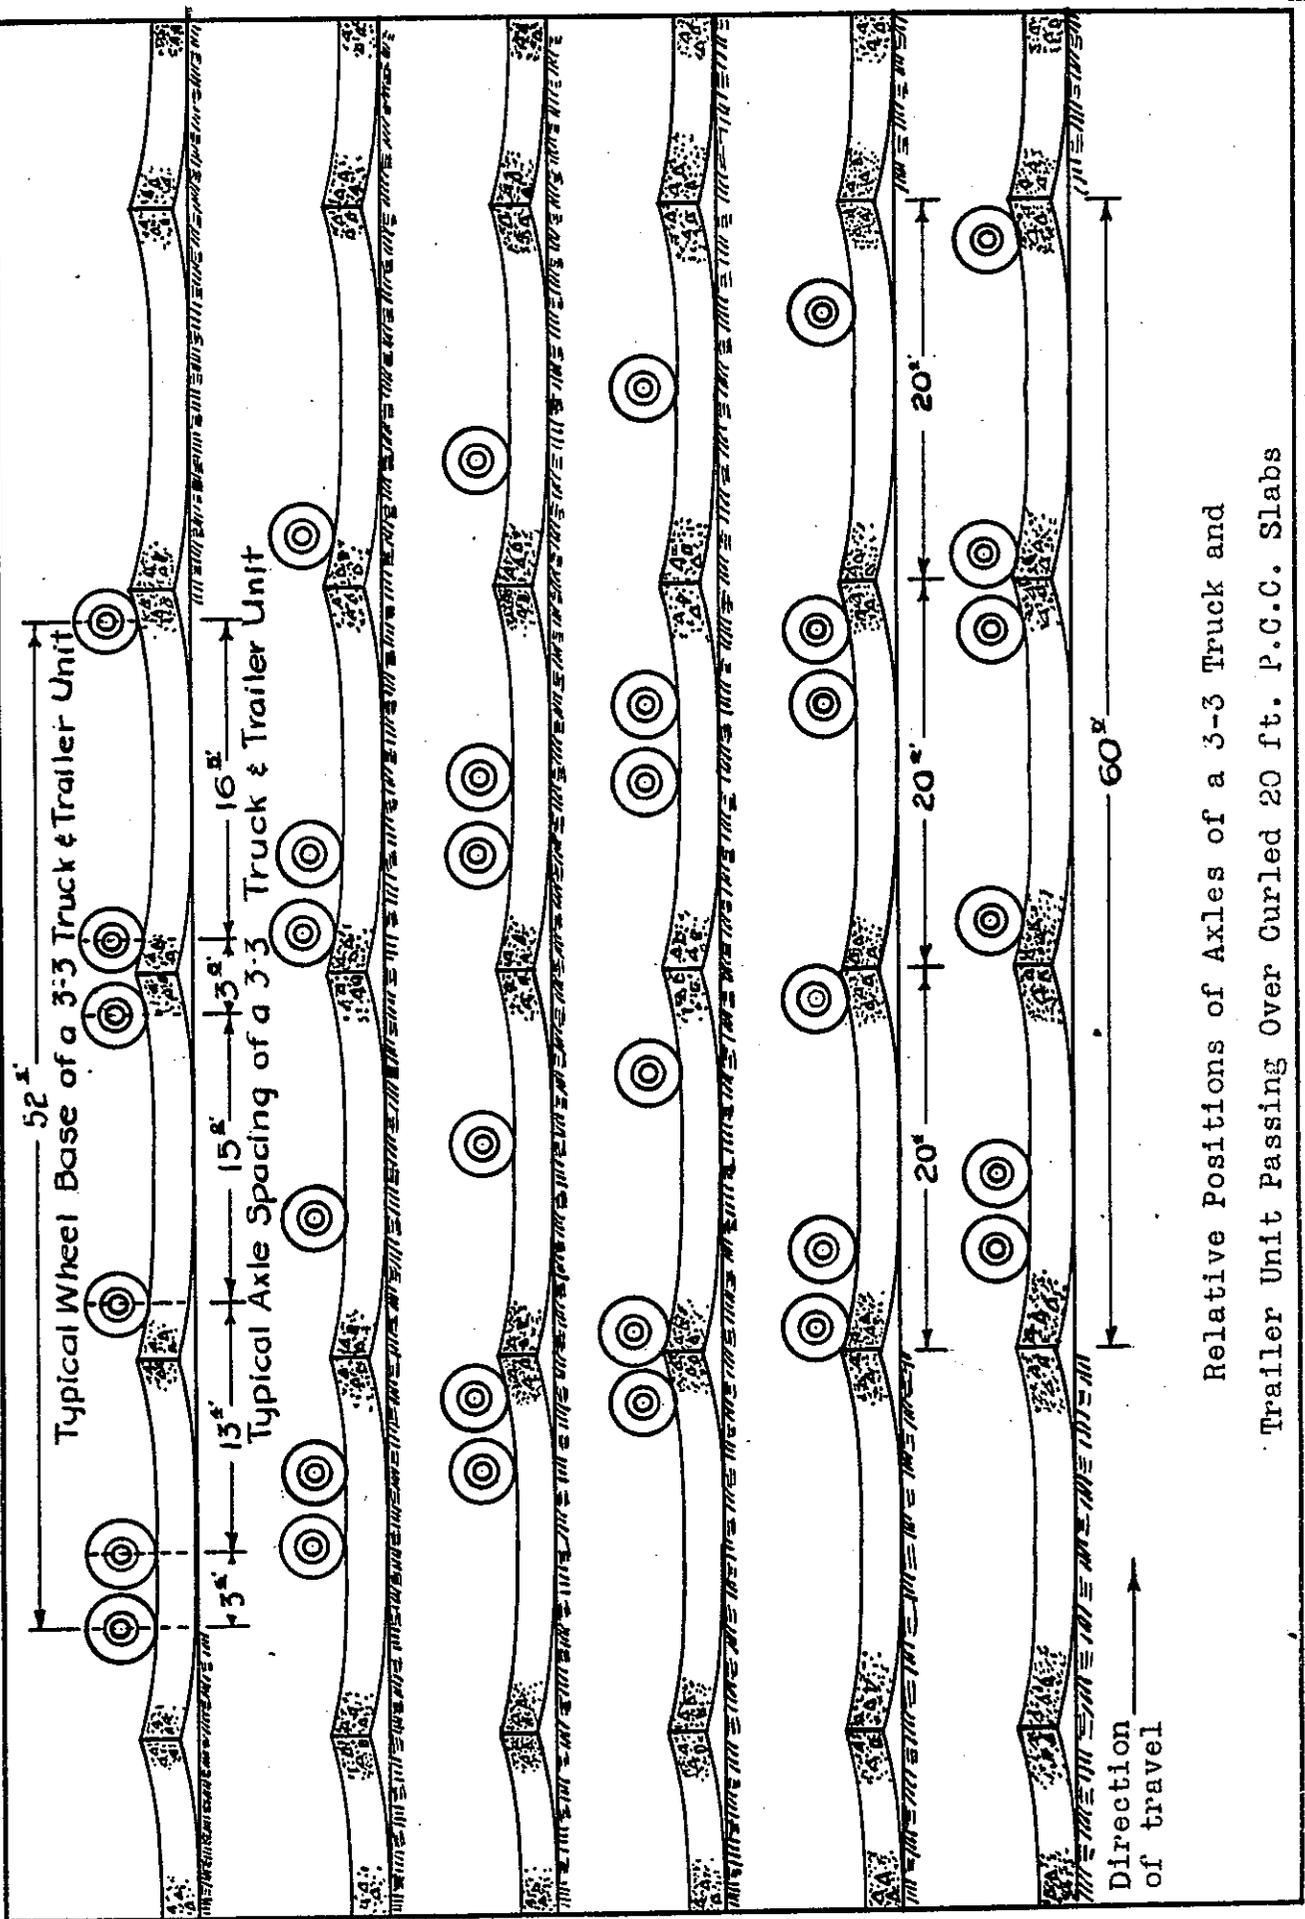
Relative Positions of Axles of a 3-3 Truck and Trailer Unit Passing Over Curled 20 ft. P.C.C. Slabs

The accompanying drawing (2) is a diagrammatic sketch showing the progress of a 3-3 truck and trailer unit across a series of curled P.C.C. pavement slabs, each 20 ft. in length. Axle spacings are to scale for one of the many combinations encountered on California highways.

The rapid progress of such a truck and trailer unit across each slab from left to right produces many very complicated stresses and reaction in the slab. This subject is considered in detail in the preceding text.

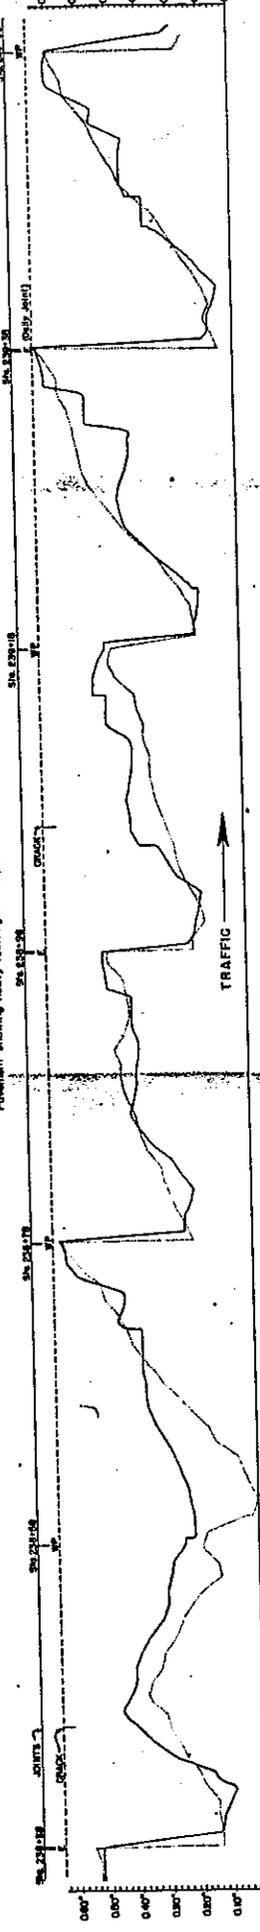
XIII - Ora-60-C - Job Letter (N) - South of Laguna Beach, West Lane. Readings taken 30" west of longitudinal joint between center and west lanes. Pavement showing heavy faulting or "striping".

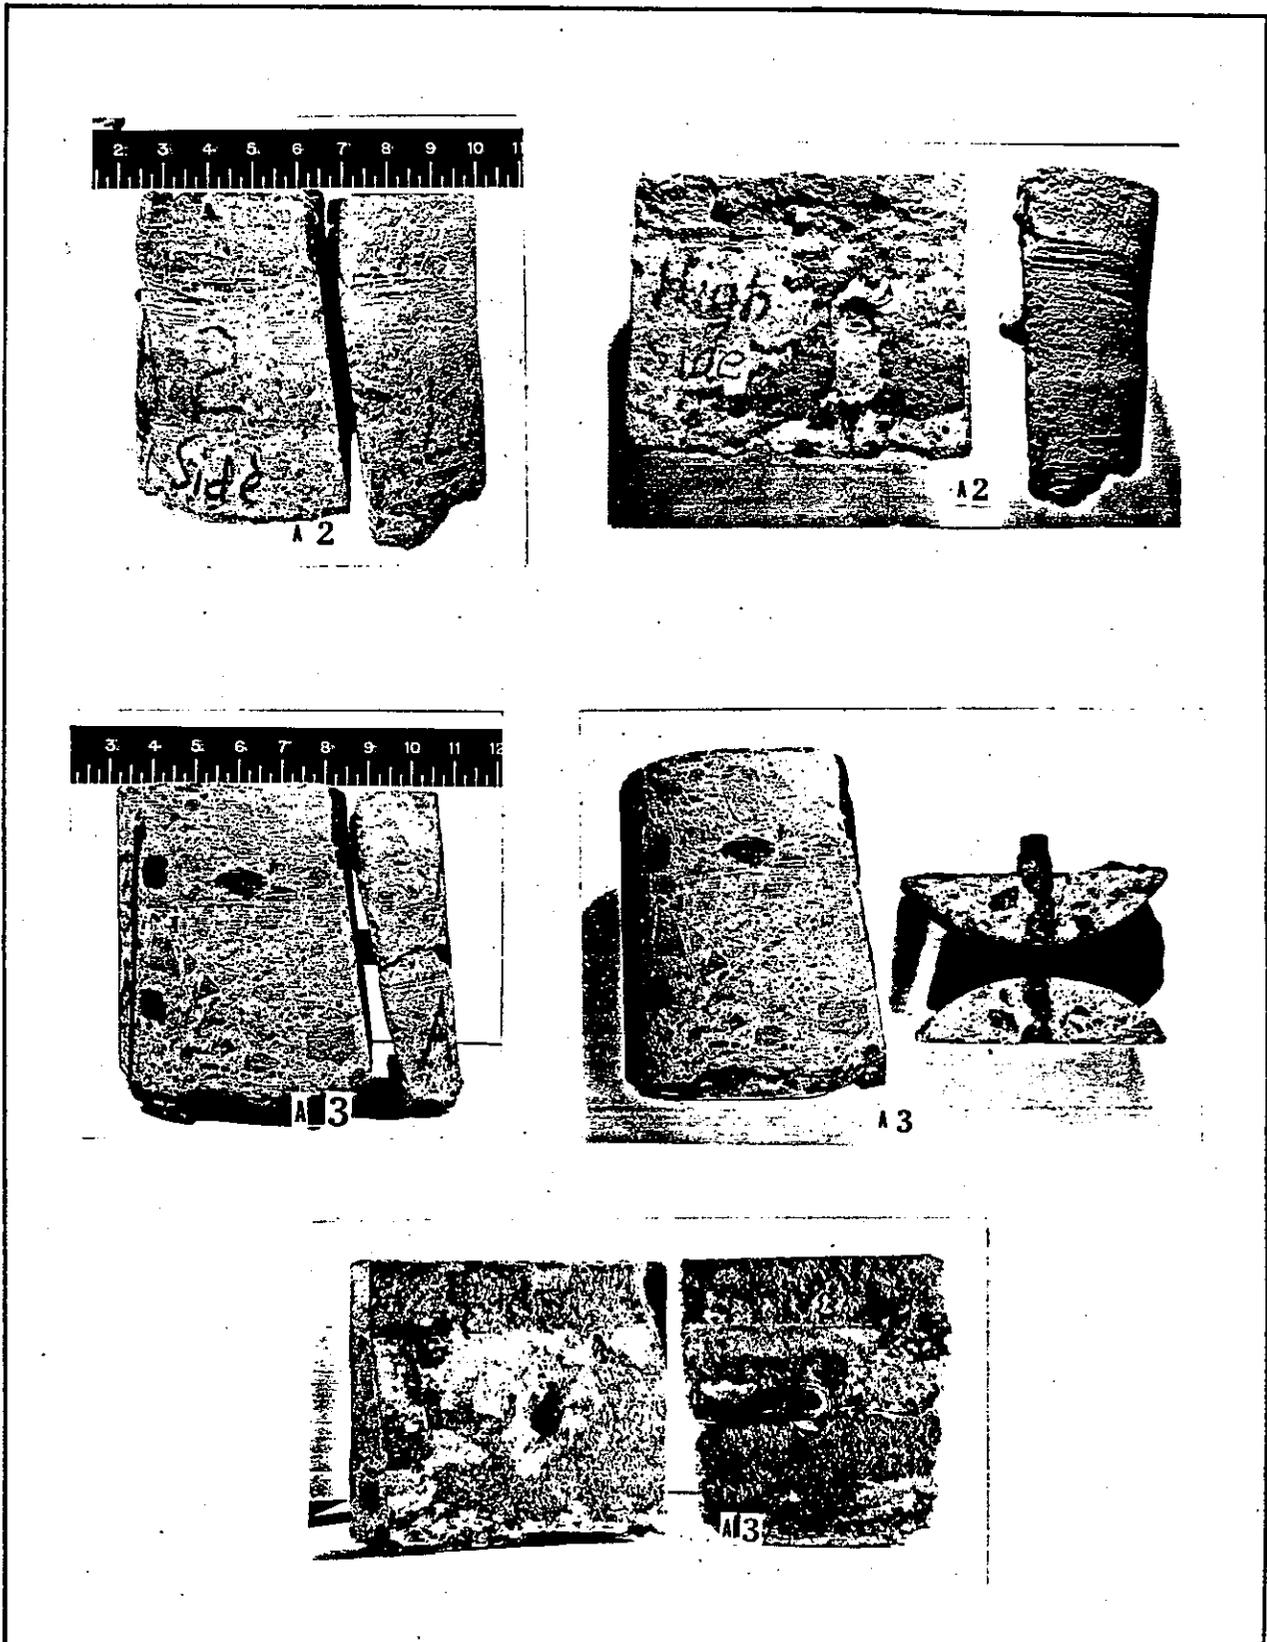
CONDITIONS OF DOWELS AND JOINT ALIGNMENT  
AS INDICATED BY CORE SPECIMENS

A-3	<p>From X-Sol-7-B, Contract No. 410CN2, constructed in 1932. Core was cut from same joint as A-2 above, 5' from A-2. Top 2" of filler was in good condition; below 2" there was only a very thin coating which had many sand grains in it. This core was offset in order to avoid transverse steel, so that the joint was not in the center. A section of the dowel "chair" was encountered however. Mudjack mortar is plainly evident in all three photographs of this core. The smaller section of core broke at the dowel while the core was being removed from the slab. This section contained the dowel sleeve in which the dowel was solidly "frozen" by rust and corrosion. Originally a <math>3/4</math>" dowel, pitting, wear and corrosion had reduced it to <math>9/16</math>" at the sheared end. The projecting section of dowel <math>7/8</math>" long shows a definite upward bending and the hole opposite to it has been worn oval shaped (with the vertical measurement being <math>1-1/4</math>").</p>

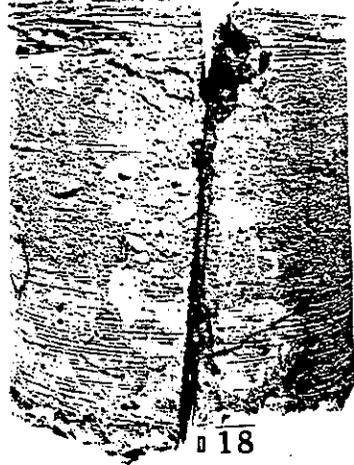
D 18

<u>Core No.</u>	<u>Remarks</u>
D-18	<p>From IV-SM-68-A, Contract No. 44TC8, constructed in 1933. This core was cut from an expansion joint that was faulted 3/16". Pavement was constructed with gravel drain under the joints and some of this rock is evident in the first two photographs. The dowel was intact and free in the sleeve. The dowel itself was slightly bent but showed small evidence of wear. It was remarkably free of rust, although the lower part was pitted and somewhat eroded at the joint itself. The sleeve was very rusty and the lower section was rusted completely away. The third photograph is a close-up of the sleeve and the dowel hole on the outer surface of the core. Note that the lower right hand section of the sleeve is completely gone. This is probably due to corrosion and rust, since the dowel did not bear on this section of the sleeve at the time the core was cut. Filler material was in good condition.</p>

In the first two photographs, there is some honeycomb showing in the upper section of the core. However, most of the evenly spaced horizontal lines which appear to be defects in the pavement are actually grooves cut in the core surface by the Calyx bit and chilled steel shot.

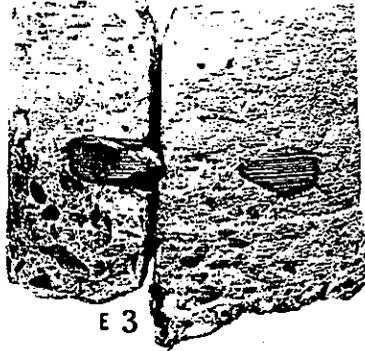
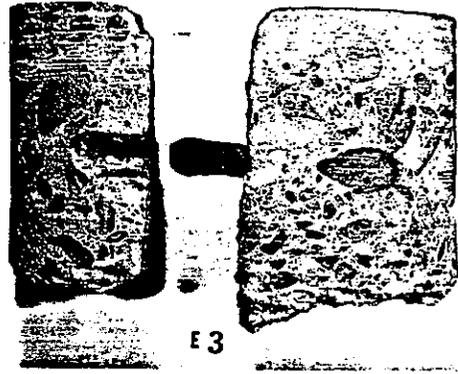
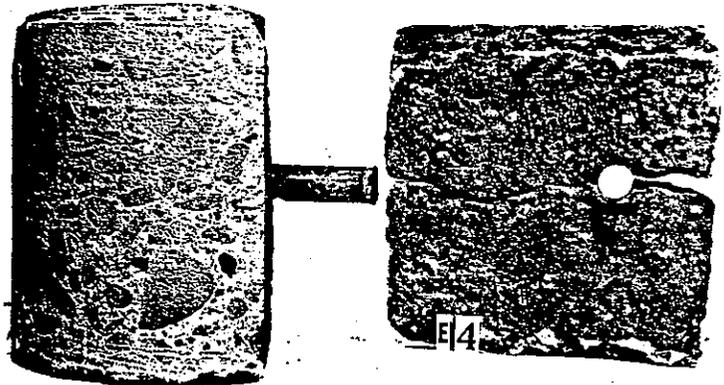
E4

<u>Core No.</u>	<u>Remarks</u>
E-3	From IV-SC1-5-A, Contract No. 94EC3 constructed in 1928, the core was cut from an expansion joint that was faulted 1/8". The dowel was cut in the edge of the core and was intact. The sleeve was badly rusted and many small pieces had broken away and fallen down around the dowel. The dowel itself was rusted and pitted, particularly close to the joint face. Filler material was quite hard and about 1/8" thick and had been extruded about 1" into the subgrade. There was considerable sand and small gravel in the filler material.
E-4	From IV-SC1-5-A, Contract No. 94EC3 constructed in 1928, This core was cut from an expansion joint that had faulted 1/8" and was 60 ft. from joint of which E-3 was cut. There was a horizontal crack in the concrete at the dowel on the side opposite to the sleeve. The dowel was badly corroded and pitted on the lower side near the joint but the balance was in good condition. Rust stains are evident for approximately 3/4" into concrete on the side opposite to sleeve in the third photograph. The dowel is rusted into the sleeve side of core for 1/4". Filler material was in fairly good condition but contained many sand grains and small gravel particles.

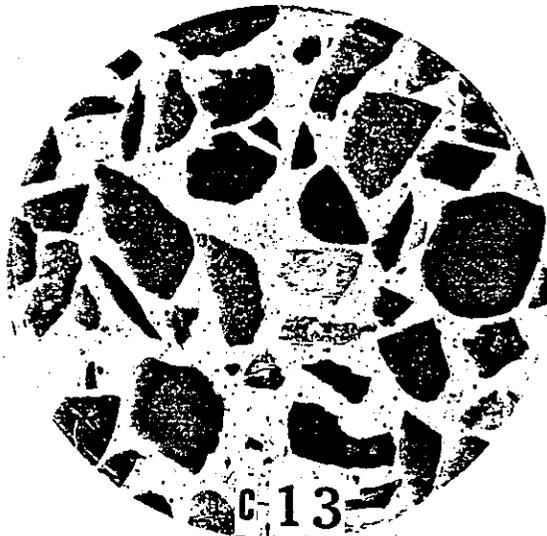
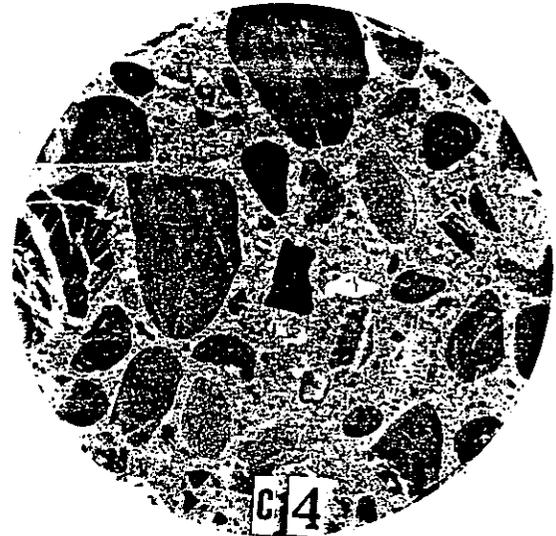
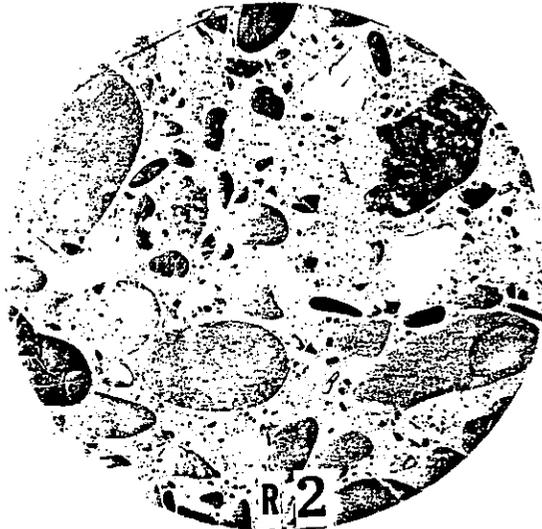
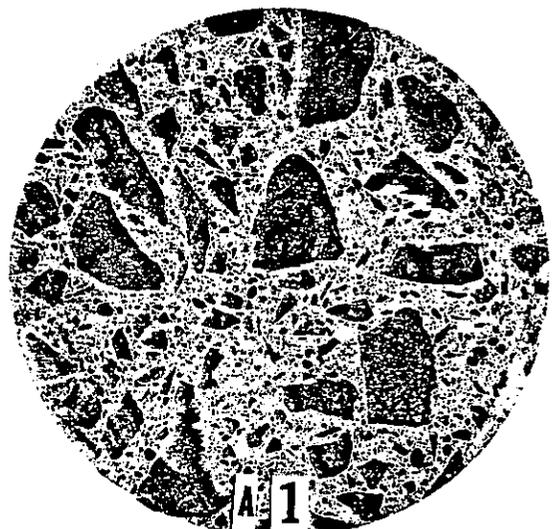
CROSS SECTIONS OF CONCRETE CORES

Coarse aggregate from Granite Rock, Logan. Fine aggregate from Kaiser, Olympia. Pavement less than two years old when sampled, with no cracking or faulting. Pavement placed to convert 1928 pavement to 4 lane divided highway. Classified in Joint Faulting Group No. 4.

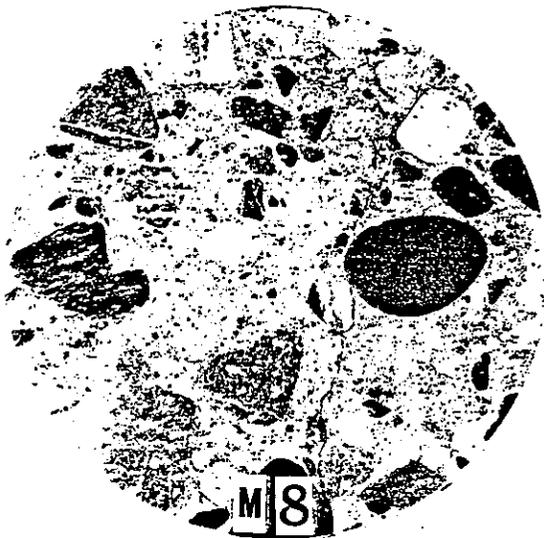
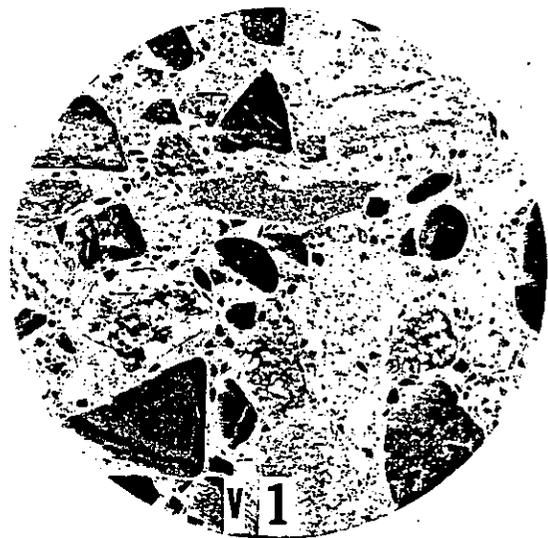
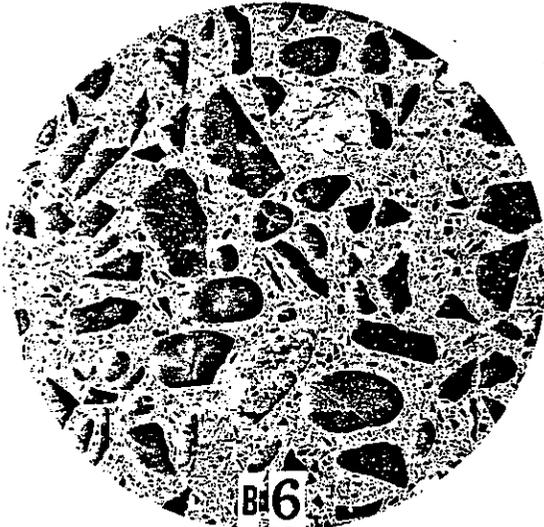
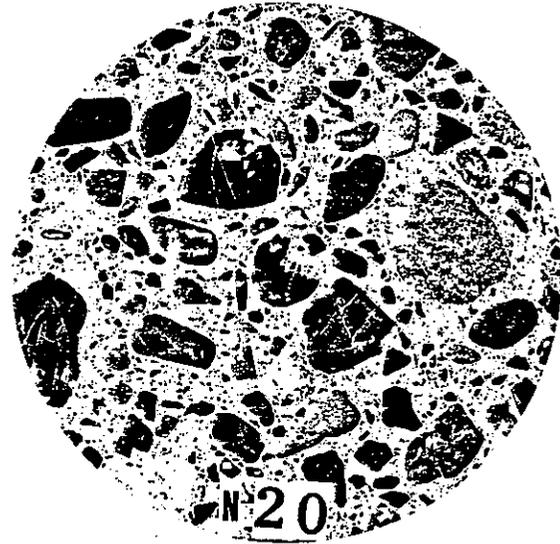
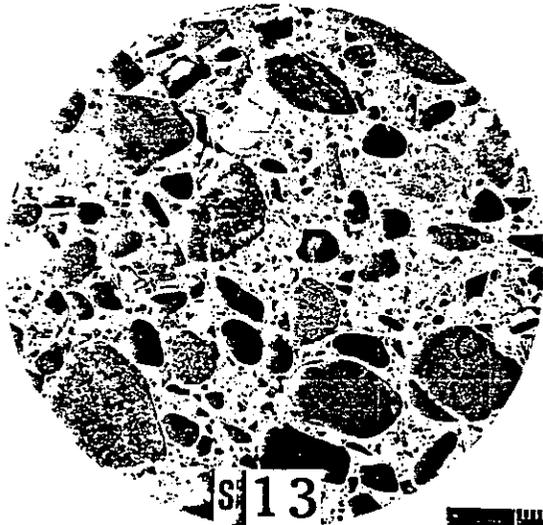
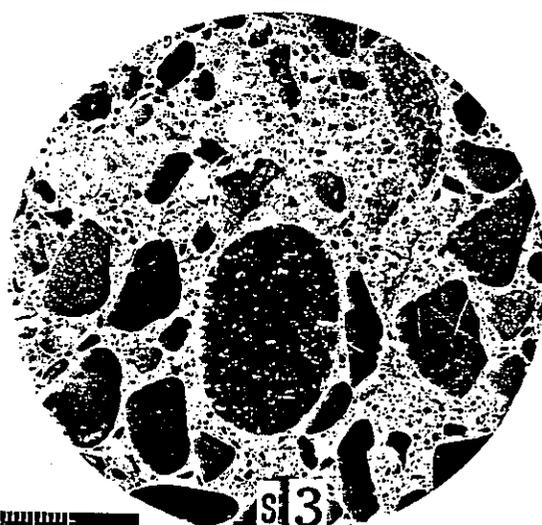
CROSS SECTIONS OF CONCRETE CORES

Coarse and fine aggregates from Graham, Orange Co. & Consolidated, Orange Co. This pavement was considered the smoothest laid in California in 1937. Area was flooded during winter of 1937-38 and pavement curled soon after. Now has very severe permanent curl. (6,10) Pavement in good condition otherwise with very little faulting. Classified in Joint Faulting Group No. 2.

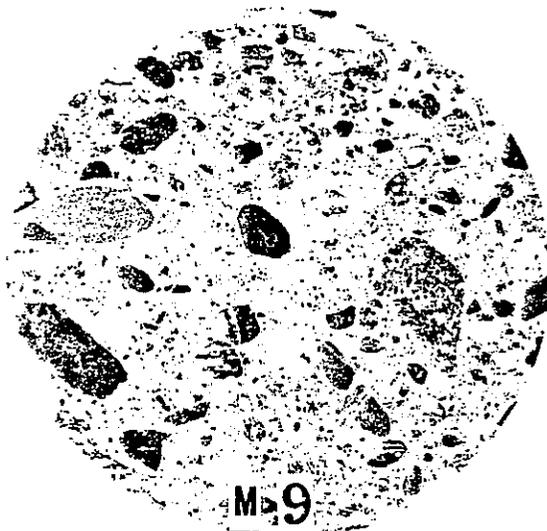
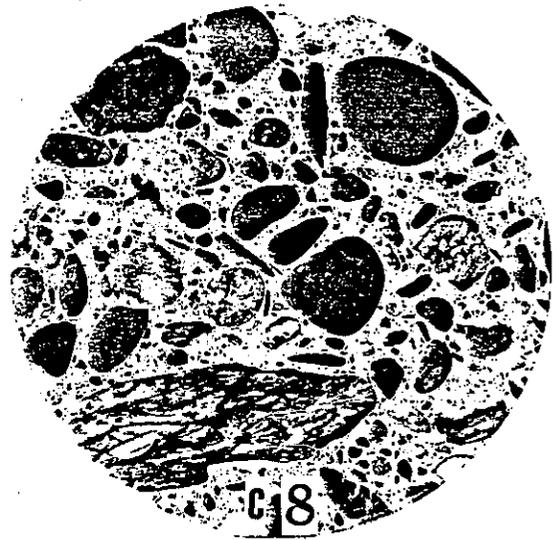
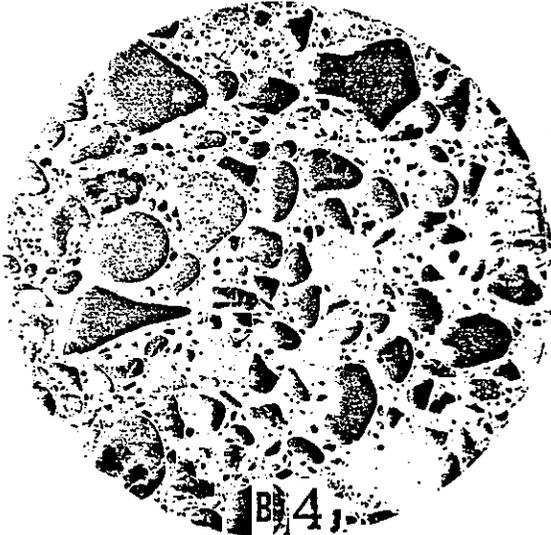
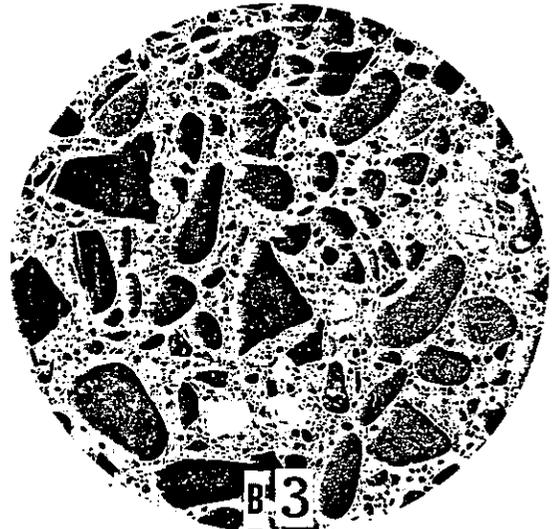
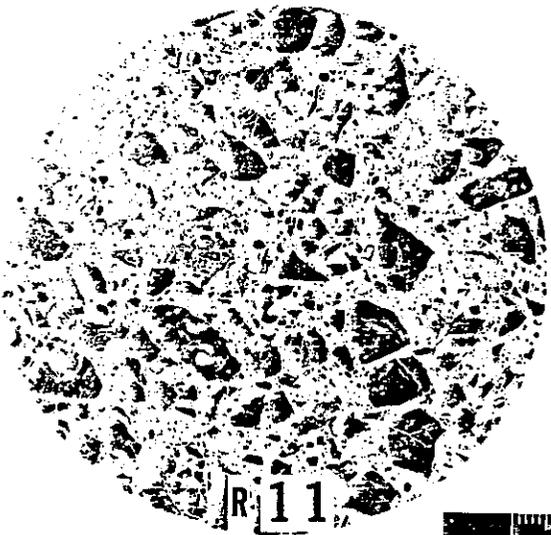
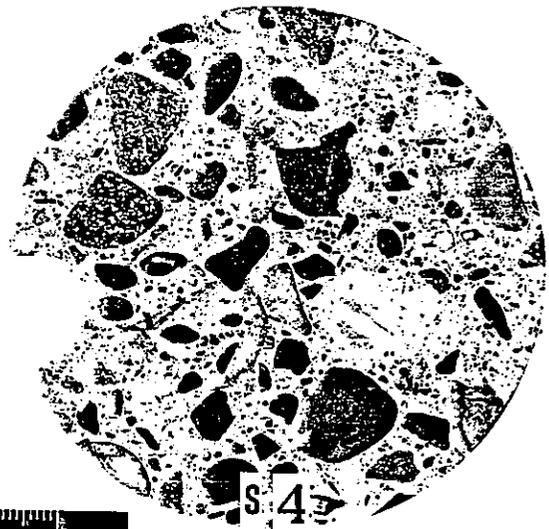
CROSS SECTIONS OF CONCRETE CORES

Coarse and fine aggregates from Graham, Orange Co. & Consolidated, Orange Co. Pavement was considered the smoothest laid in State in 1937. Area was flooded during winter of 1937-38 and pavement curled soon after. Now has very severe permanent curl (6,10). Pavement in good condition otherwise with very little joint faulting. Classified in Joint Faulting Group No. 2.

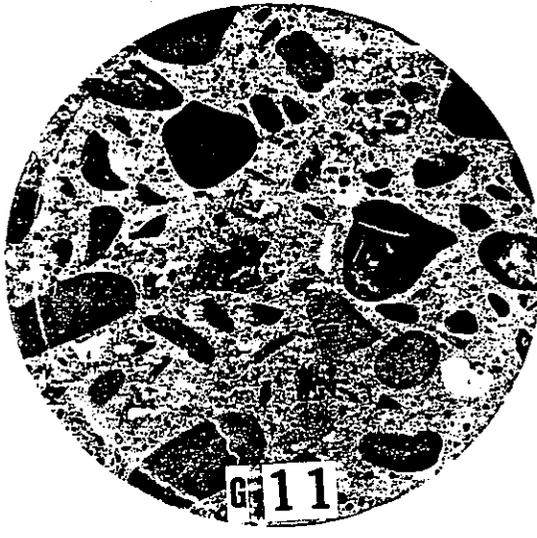
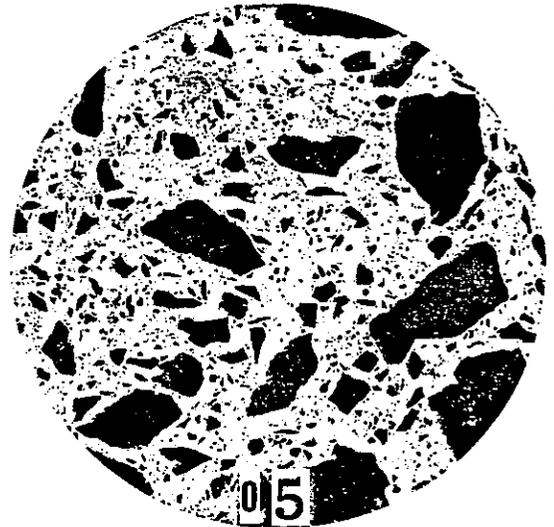
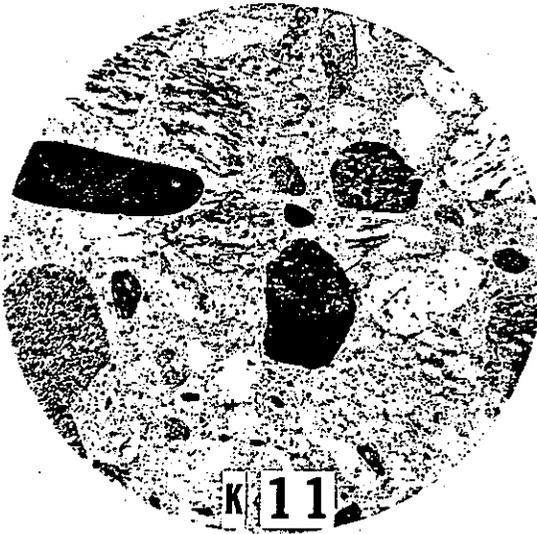
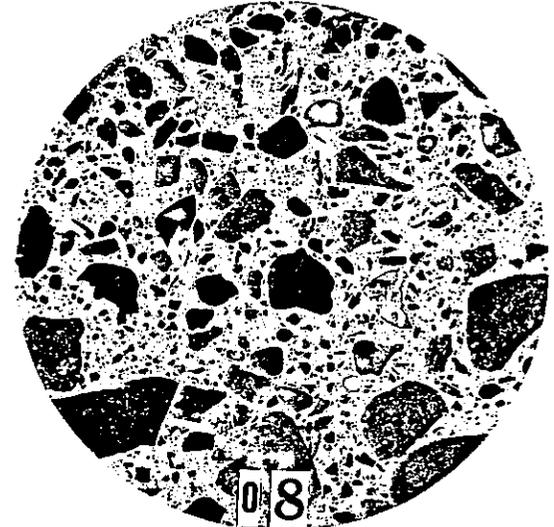
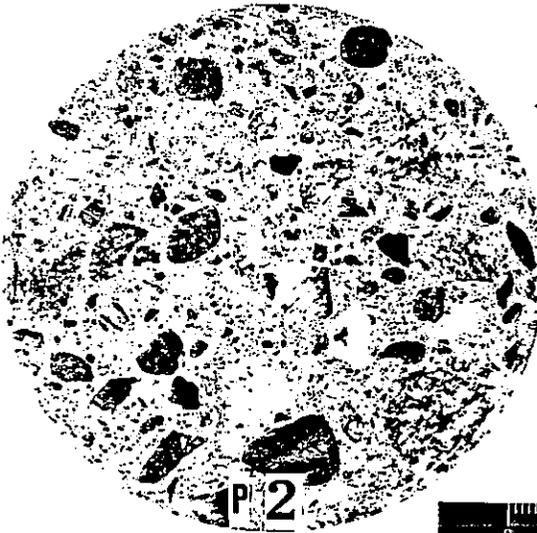
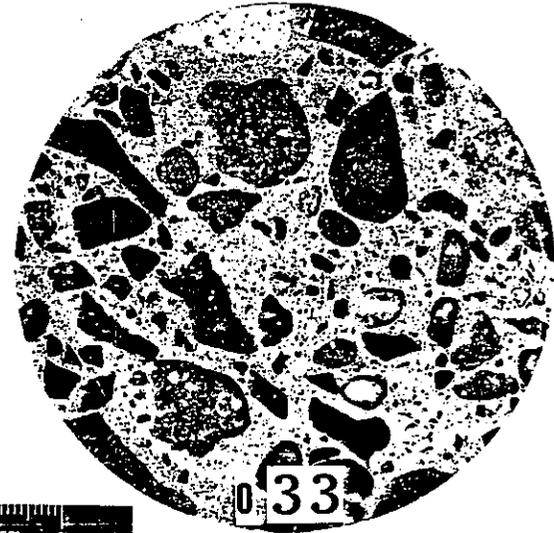
CROSS SECTIONS OF CONCRETE CORES

Coarse aggregate from Lakeside, San Diego River. Fine aggregate from Fenton Materials, Otay Plant. Pavement is in good condition, with no cracking. There is some slight joint faulting. Classified in Joint Faulting Group No. 5.
