A Survey of the Condition of the Corrugated Metal Culverts in District 1

March 1955

R.F. Stratfull

State of California  
Department of Public Works  
Division of Highways  
Materials & Research Department

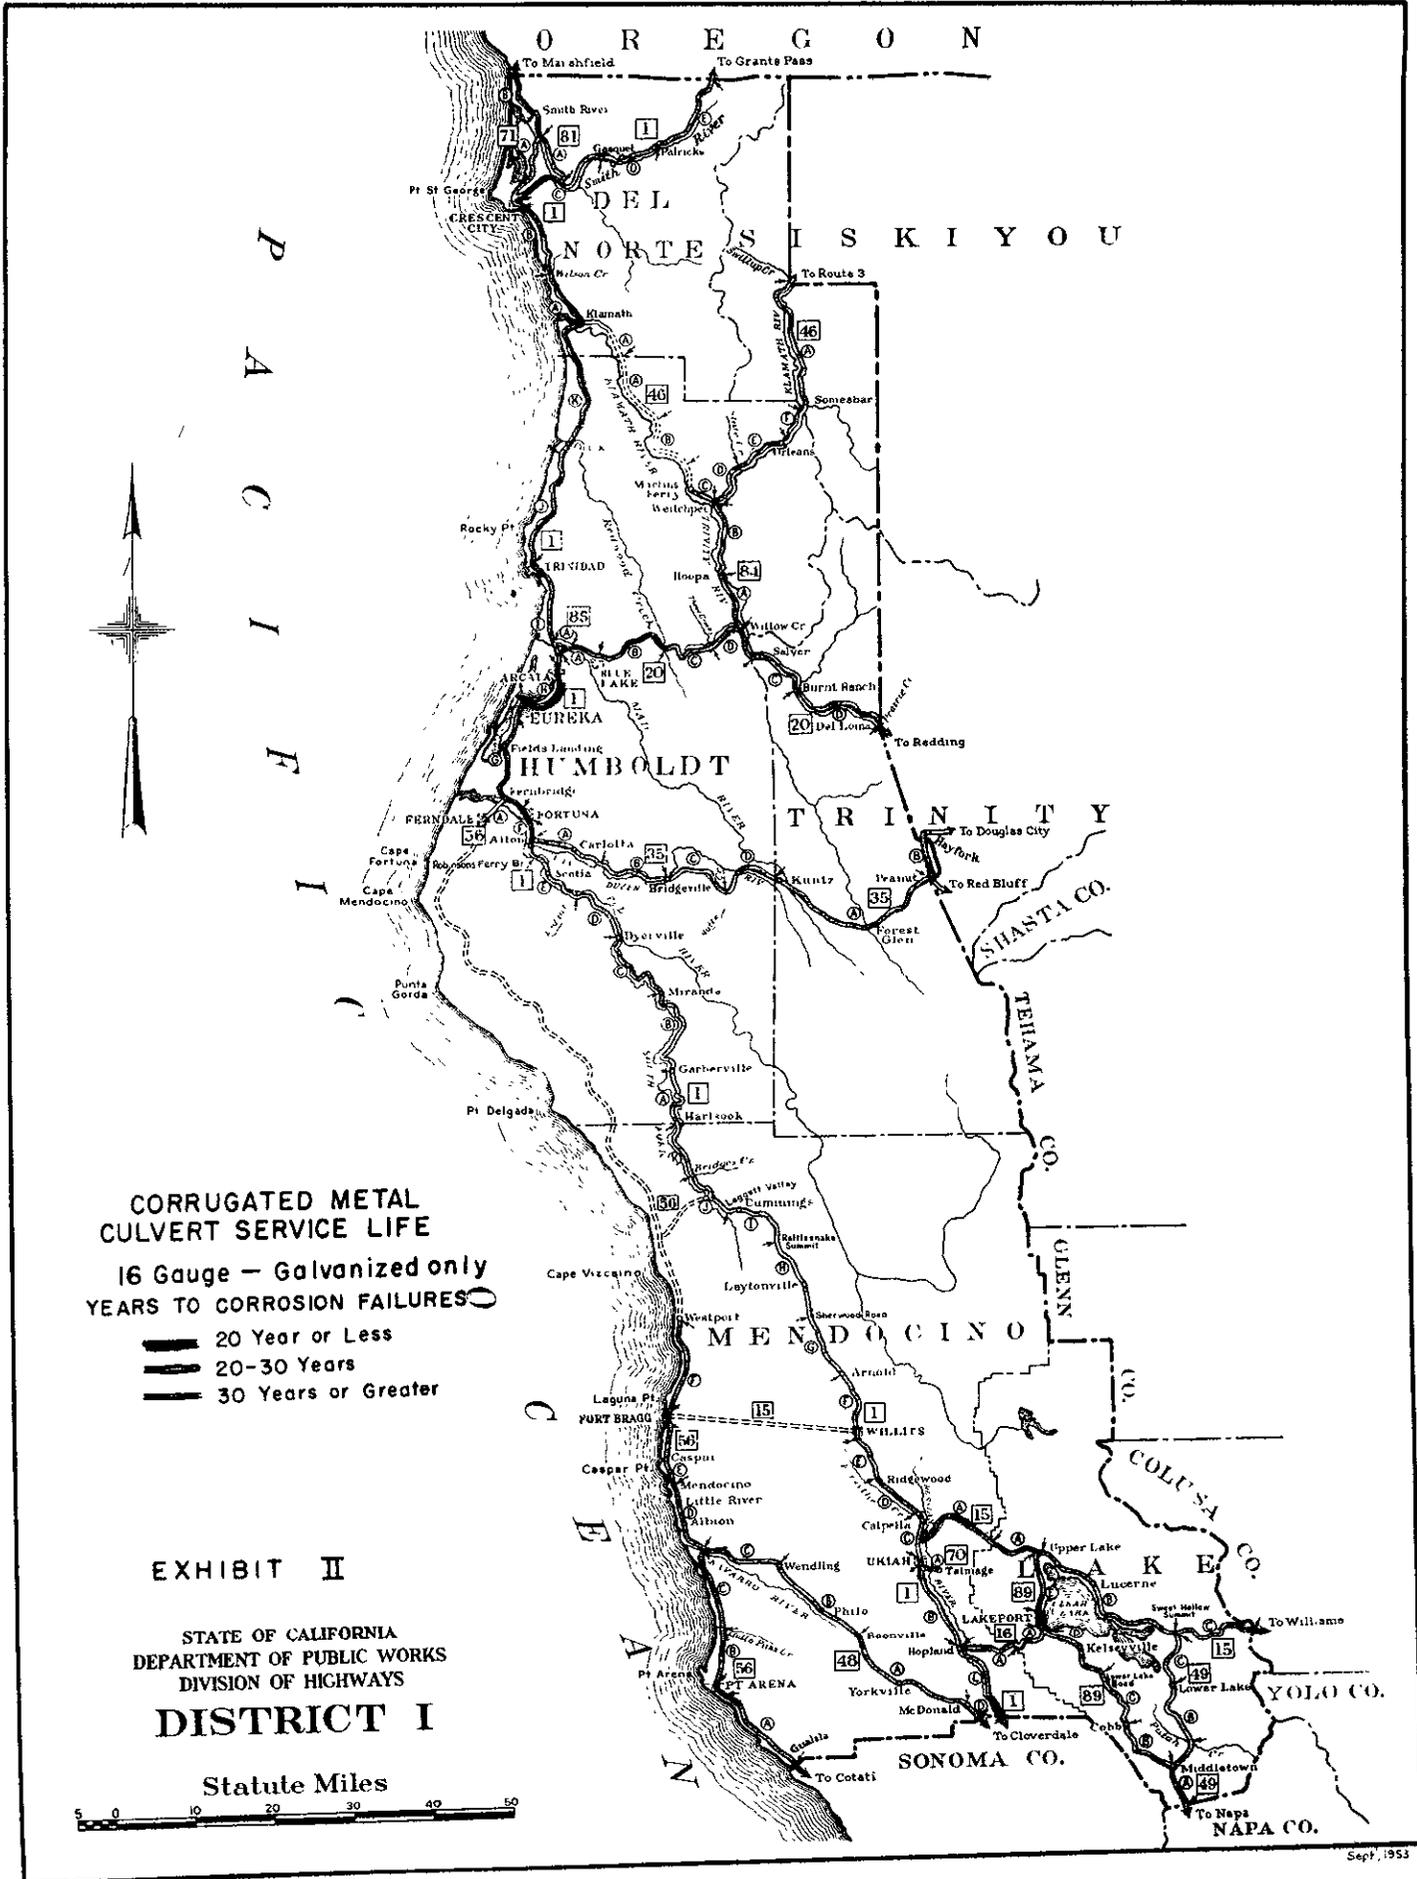
EXHIBIT II

It is an exceptional occurrence when all the culverts in adjacent watersheds have the same corrosion rate. However, it is quite likely that a reasonable percentage of culverts in adjacent watersheds will have a similar corrosion rate. The "Corrosion Area" map was prepared with this knowledge, and reflects the service life to be expected of a substantial number of 16 gage galvanized metal culverts in each of the areas indicated.

This "service life" is an expression of probability that a substantial number of culverts in the localized area will not exceed the service life indicated. Hence, the risk of costly replacement is reflected by the Corrosion Area map, but it does not necessarily mean that all culverts in a given area will have the service life shown.

On the attached "Map", the apparent rate of corrosion decreases with distance from the sea coast. Since this study did not include complete analysis of the factors affecting corrosion, the significance of this in relation to salt air or annual rainfall is not known. It was found, in the culvert survey, that the outer galvanized areas of the culverts exposed to sun and air rarely showed signs of corrosion in less than 20 years. However, this was not true if the culvert was exposed to direct sea spray or water immersion. Attached is Exhibit VI, which is a typical comparison of culvert corrosion rates on I-MEN-56-A and I-MEN-16-A. Work charts of this type were made for all the sections of the highways and used to make the corrosion area map.

MATERIALS AND RESEARCH DEPARTMENT  
CORROSION AREA MAP
