Full Scale Tests of Concrete Bridge Rails Subjected to Automobile Impacts

December 1955

State of California  
Department of Public Works  
Division of Highways

Presented at the 35th Annual Meeting of the Highway Research Board Washington D.C., January 17-20, 1956

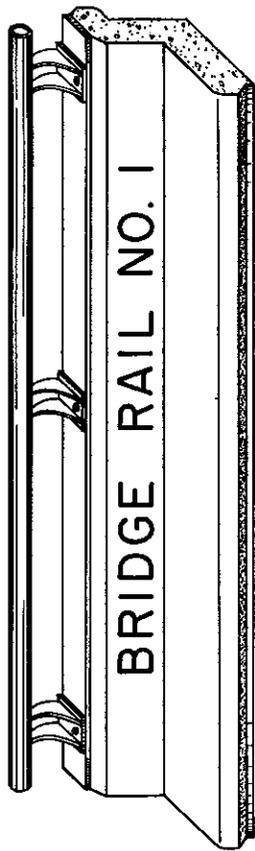
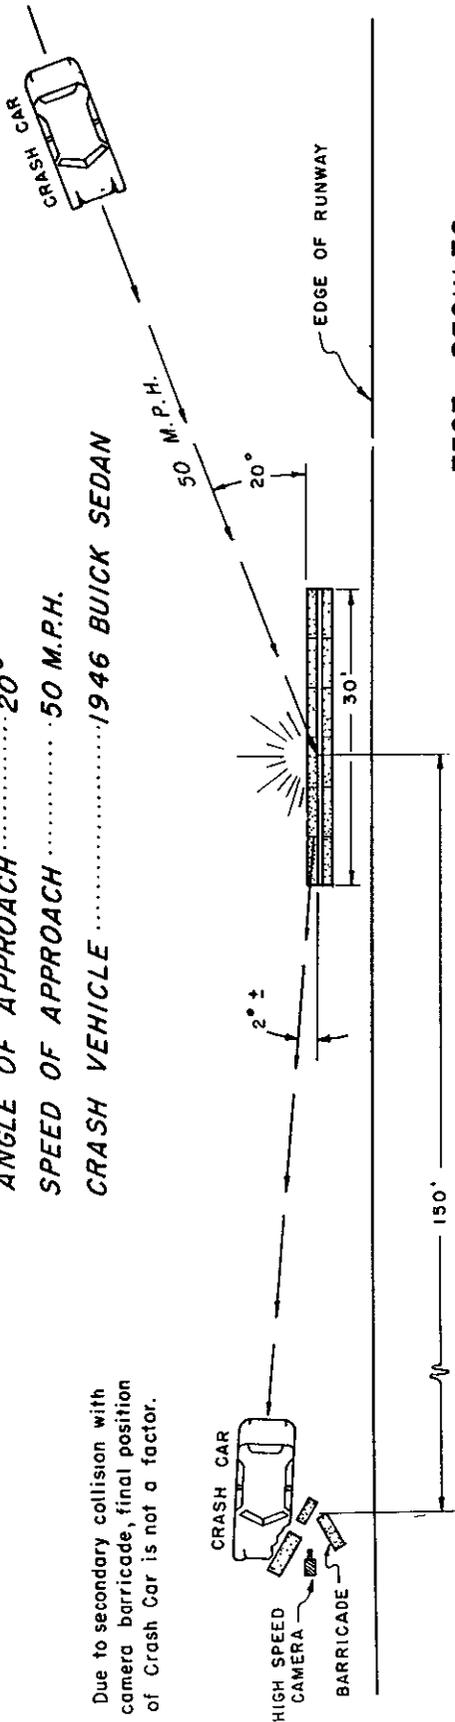
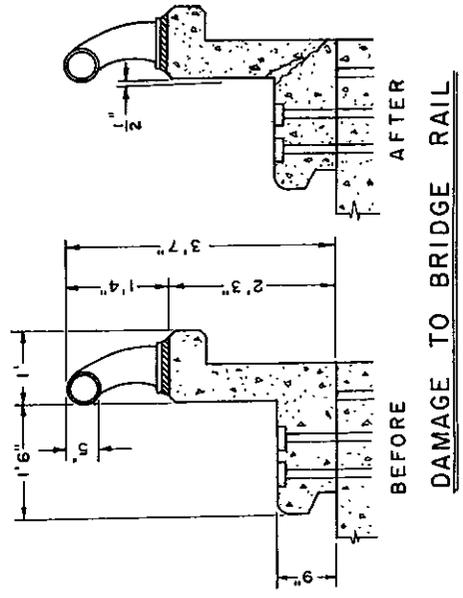
Figure 9

ANGLE OF APPROACH ..... 20°

SPEED OF APPROACH ..... 50 M.P.H.

CRASH VEHICLE ..... 1946 BUICK SEDAN

The crash vehicle was deflected by the bridge rail at an angle of approximately 2°. The collision caused only a slight hesitation in the car forward travel with minor tipping action noticeable as the car deflected along and then away from the bridge rail. The car mounted the 9" curb readily and then slid along the rail for 10' before leaving the Bridge Rail. It appeared that the pipe rail prevented excessive tipping of the car.

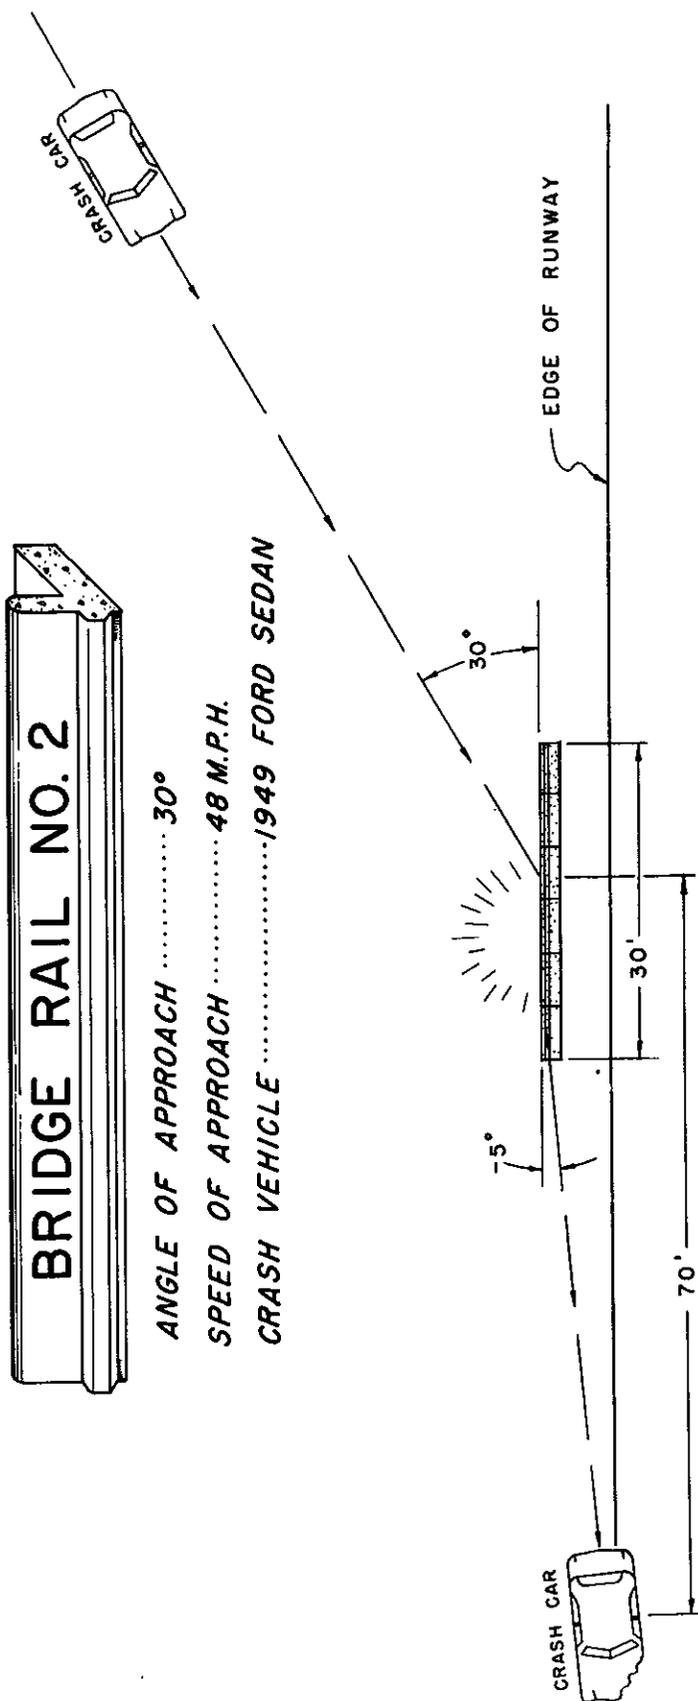
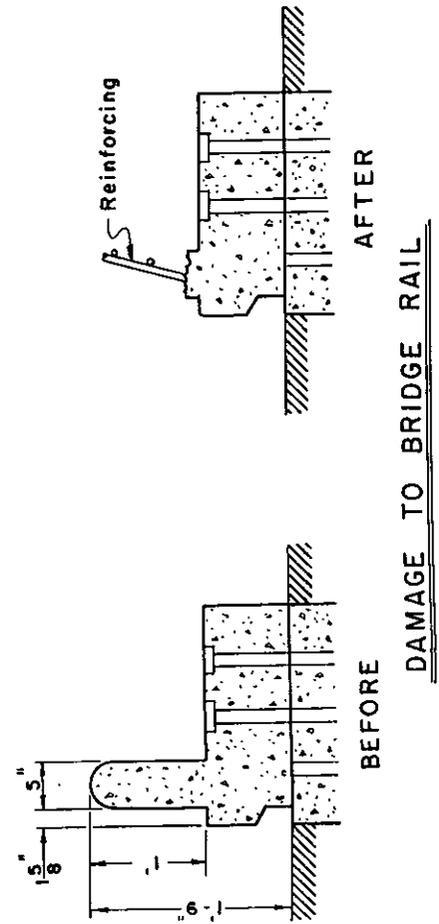
Figure 10

Analysis of the motion pictures shows that the most solid point of collision occurred when the front end of the crash car frame contacted the top edge of the rail. This caused an initial failure of the concrete apparently in direct punching shear, probably highly concentrated due to the unsupported edge of the railing slab. From this point of beginning the failure seemed to progress rapidly as further pressure was applied by the moving crash car.

To check the possibility of weak concrete, cores were taken from the broken concrete specimens of this railing. They indicated the concrete to have had a compressive strength of approximately 4800 lb. psi. Test cores of the concrete taken of all of the bridge rails indicated this to be about the average strength of the concrete in all test units. This also checks the test cylinder data taken during fabrication.

ANGLE OF APPROACH ..... 30°  
 SPEED OF APPROACH ..... 48 M.P.H.  
 CRASH VEHICLE ..... 1949 FORD SEDAN

The crash vehicle broke out 9' of the bridge rail on the initial collision. This allowed the car to straddle the rail, and then continue on through the rail at an exit angle of approximately - 5°.

DAMAGE TO BRIDGE RAIL

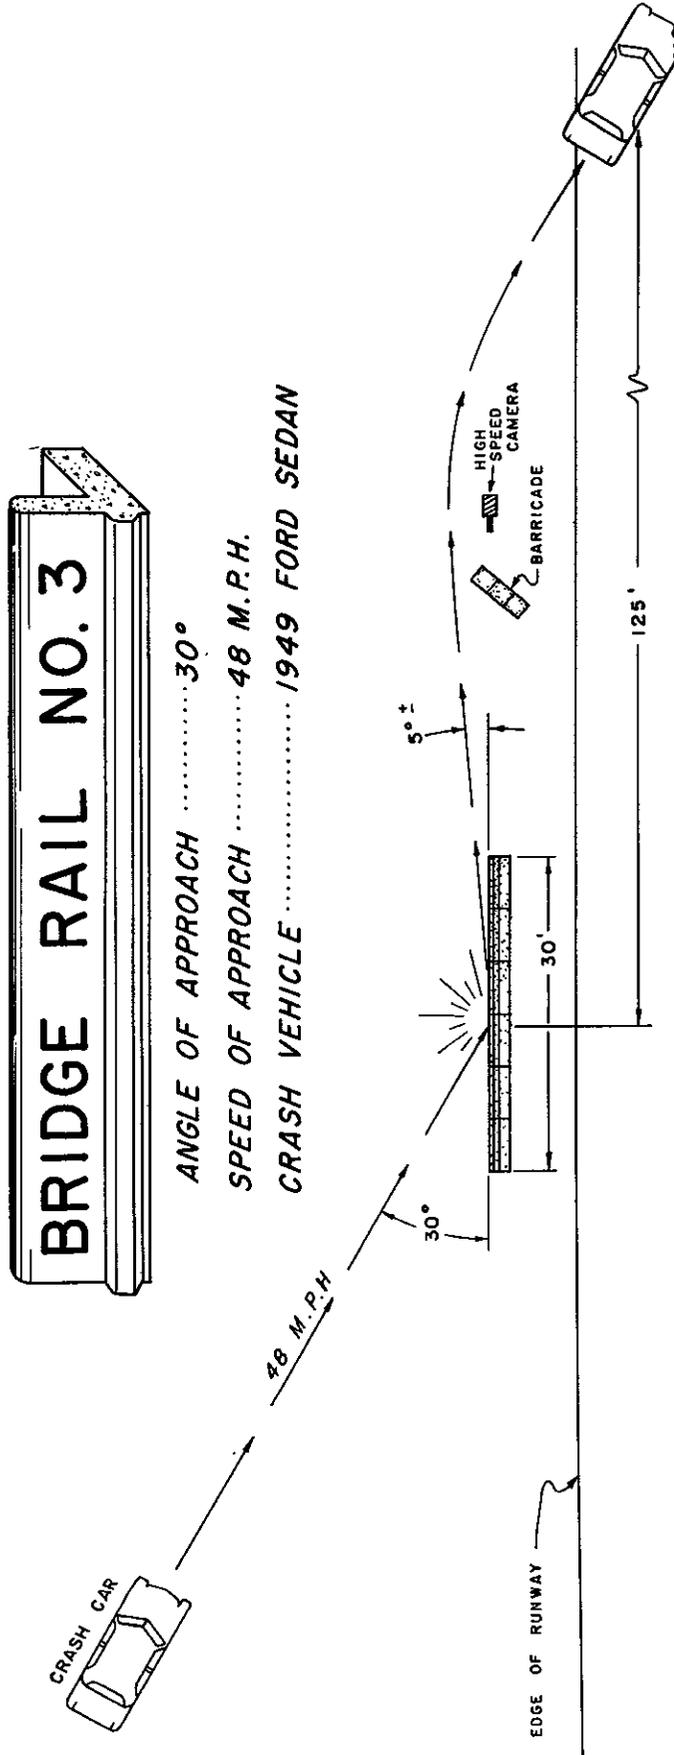
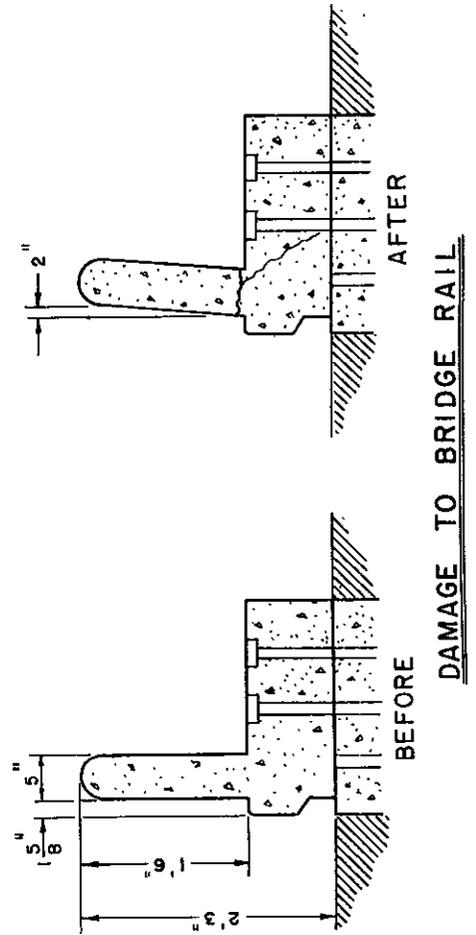
Figure 11

The crash vehicle was deflected by the bridge rail at an angle of approximately 5°. The collision caused only a slight hesitation in the cars forward travel with minor tipping action noticeable as the car deflected away from the bridge rail.

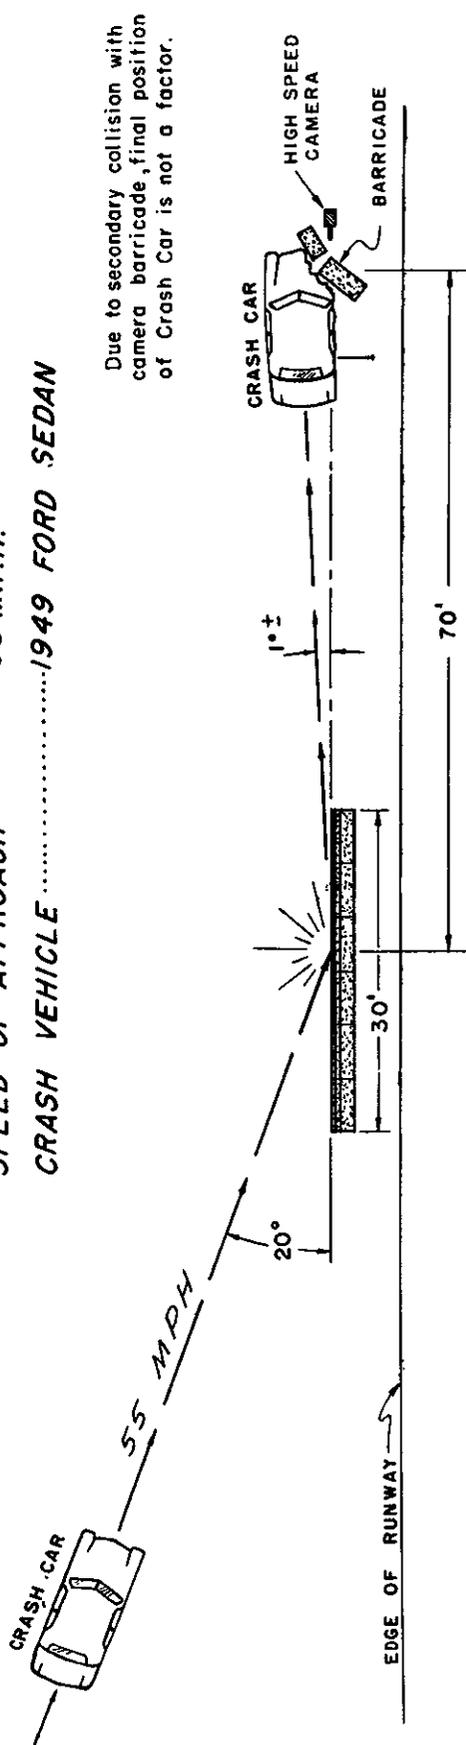
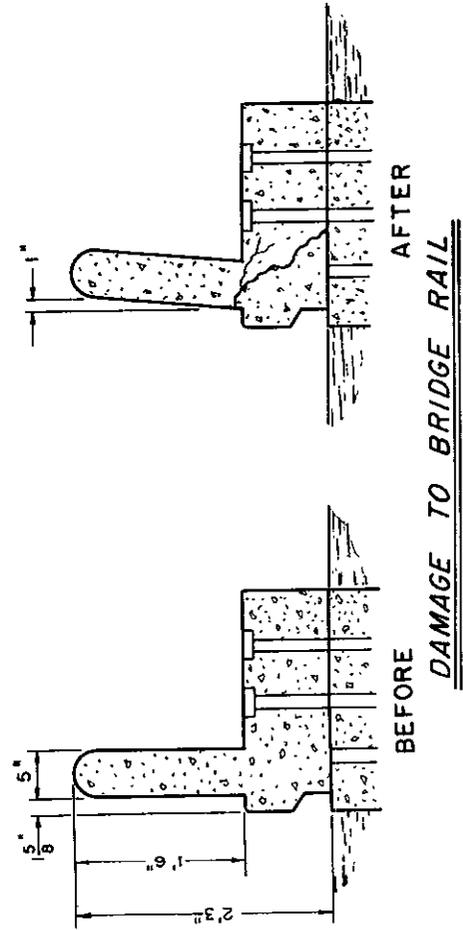
SPEED OF APPROACH ..... 55 M.P.H.

CRASH VEHICLE ..... 1949 FORD SEDAN

The crash vehicle was deflected by the bridge rail at an angle of approximately 1°. The collision caused only a slight hesitation in the cars forward travel with minor tipping action noticeable as the car deflected away from the bridge rail.

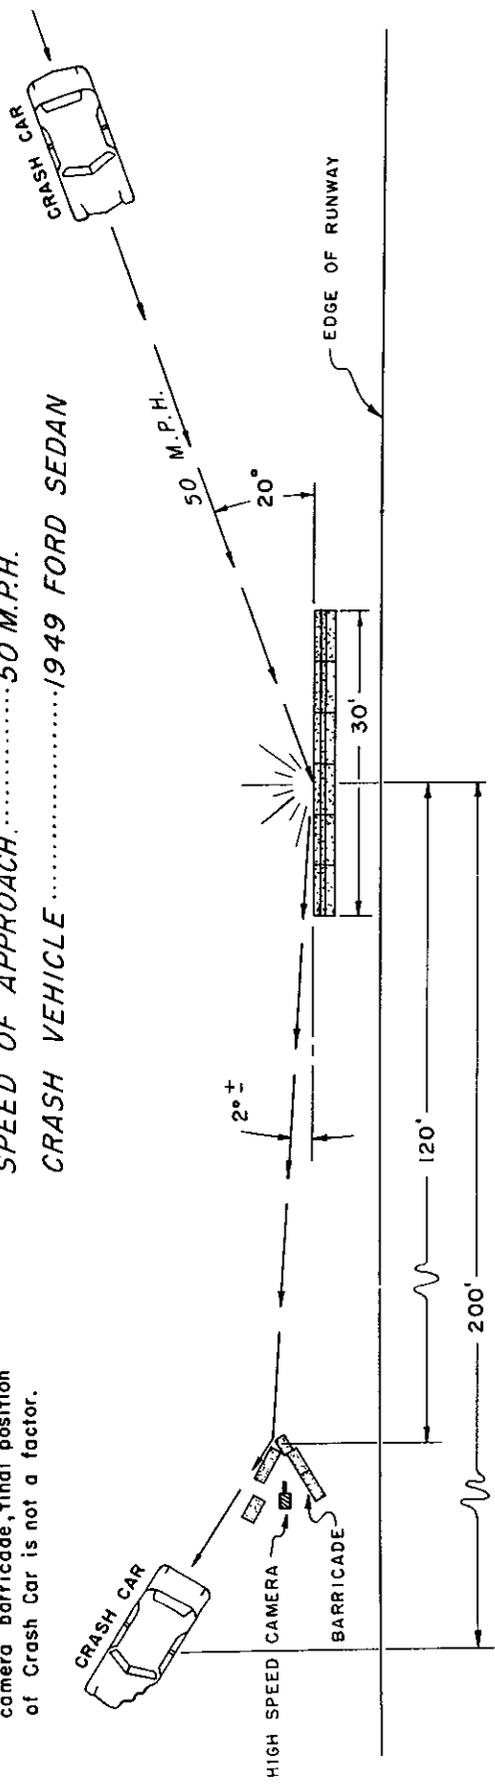
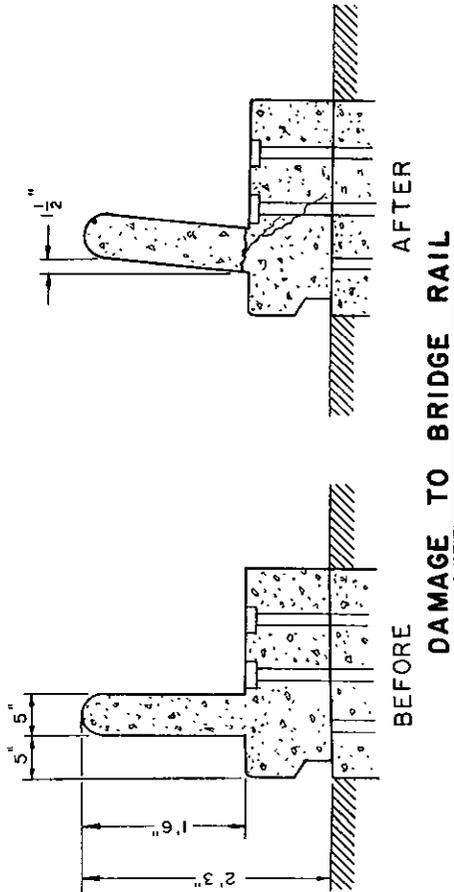
Figure 13

ANGLE OF APPROACH ..... 20°  
 SPEED OF APPROACH ..... 50 M.P.H.  
 CRASH VEHICLE ..... 1949 FORD SEDAN

The crash vehicle was deflected by the bridge rail at an angle of approximately 2°. The collision caused only a slight hesitation in the cars forward travel with minor tipping action noticeable as the car deflected away from the bridge rail.

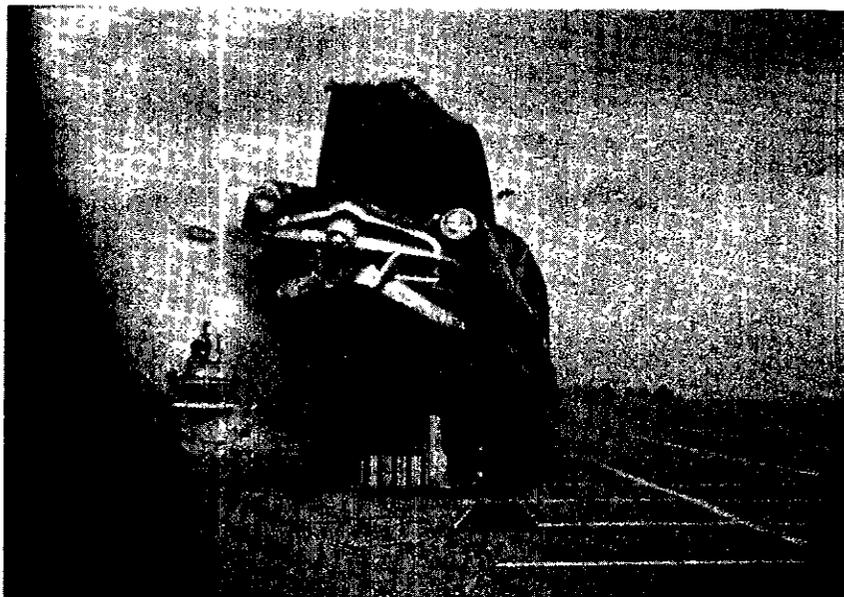
Figure 14. Test collision shortly after initial contact. Note recording movie camera in foreground.
