Report on Slide Investigation at Emerald Bay on Road III-ED
-38-B Station 243+- to 250+-

SLIDE INVESTIGATION AT EMERALD BAY

STATION 243± TO 250±

December 17, 1957

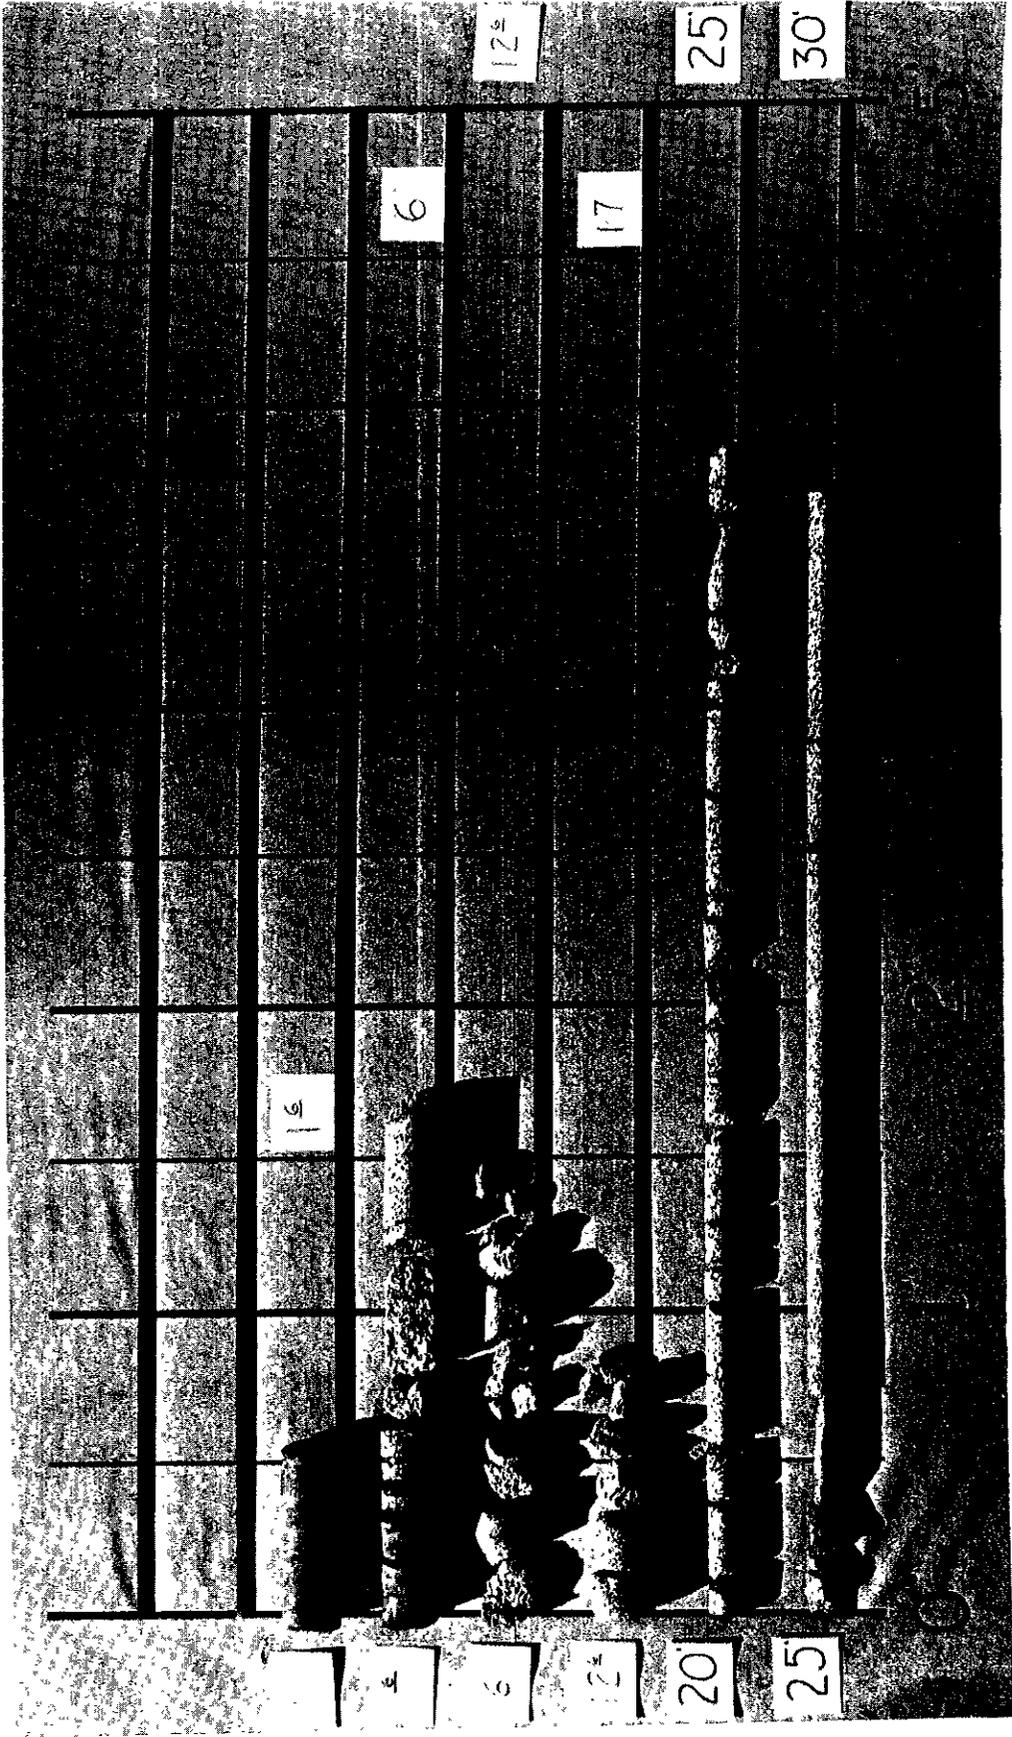
Emerald Bay Slide Investigation
Road III-ED-38-B
Boring R-1; 1' to 30'

R-1 Vertical boring, at roadway, depth 30'.

Generally the upper sixteen feet of the material was badly broken or decomposed granite. The remaining fourteen feet was a moderately hard fractured and jointed granite.

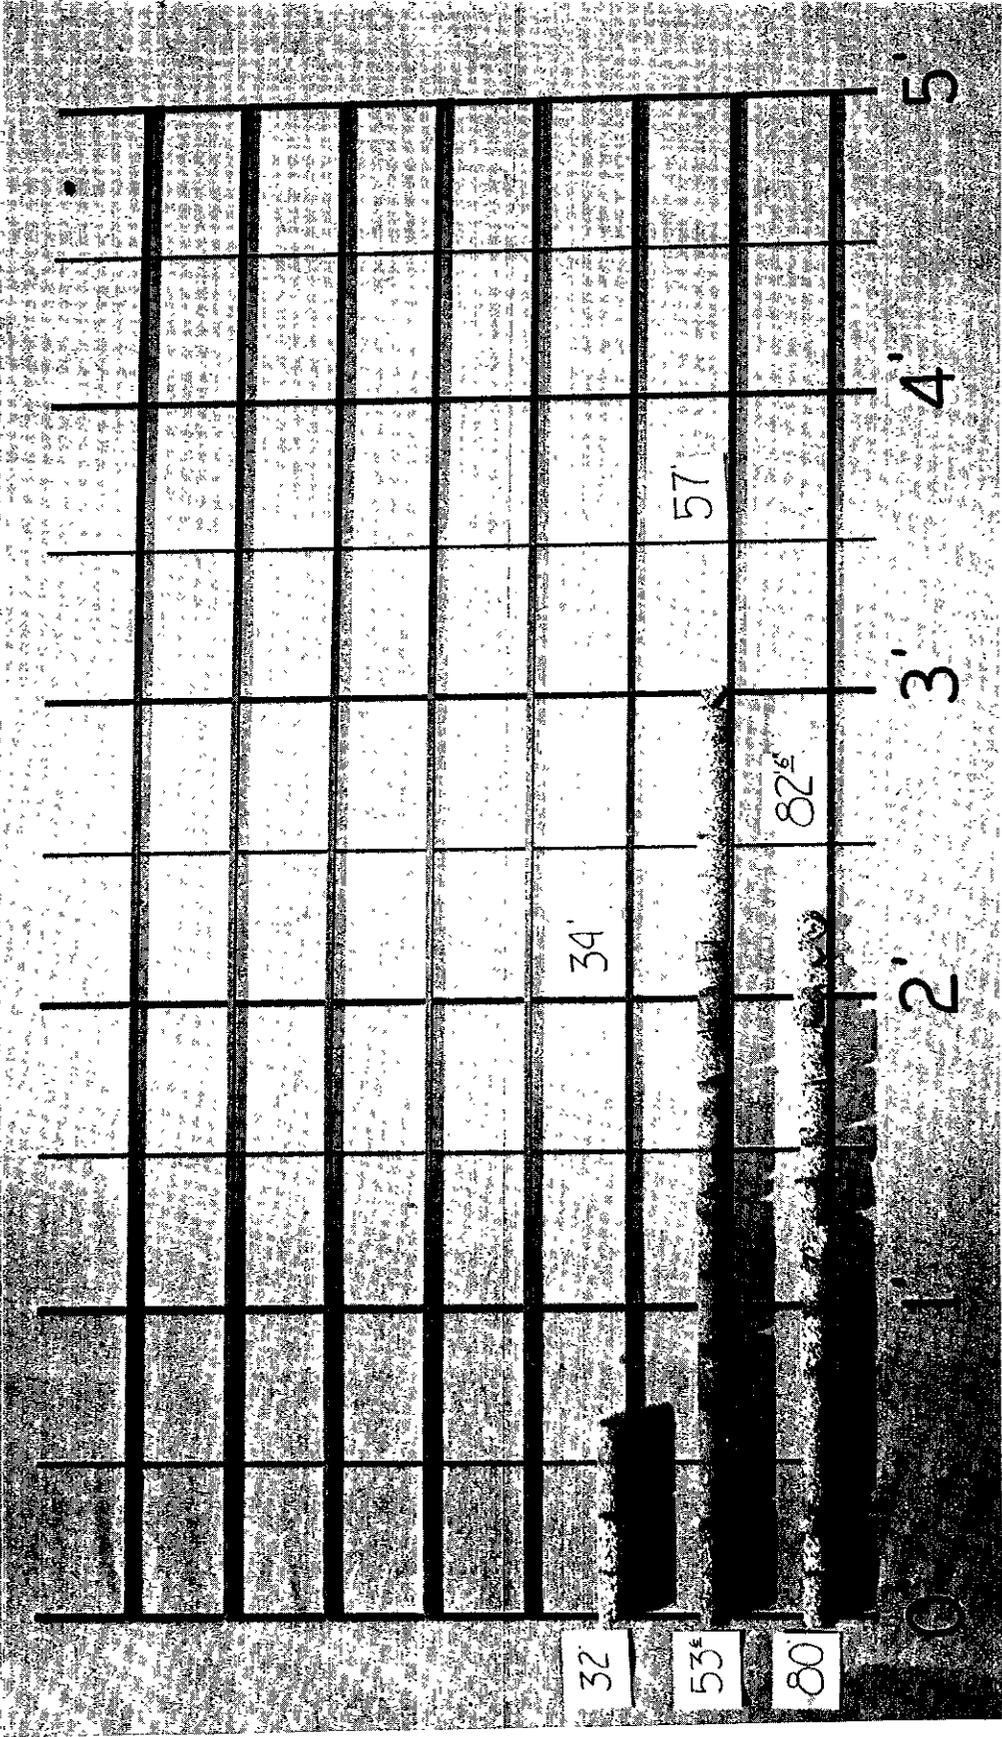
Emerald Bay Slide Investigation
 Road III-ED-38-B
 Boring R-2, 32' to 82'6"

R-2 Vertical boring, 125' above roadway, depth 90'.

The upper forty feet of material was composed of badly broken granite with considerable loose decomposed granite. Below forty feet the material appears to be in-place fractured and jointed granite with layers (2" to 6") of decomposed granite.

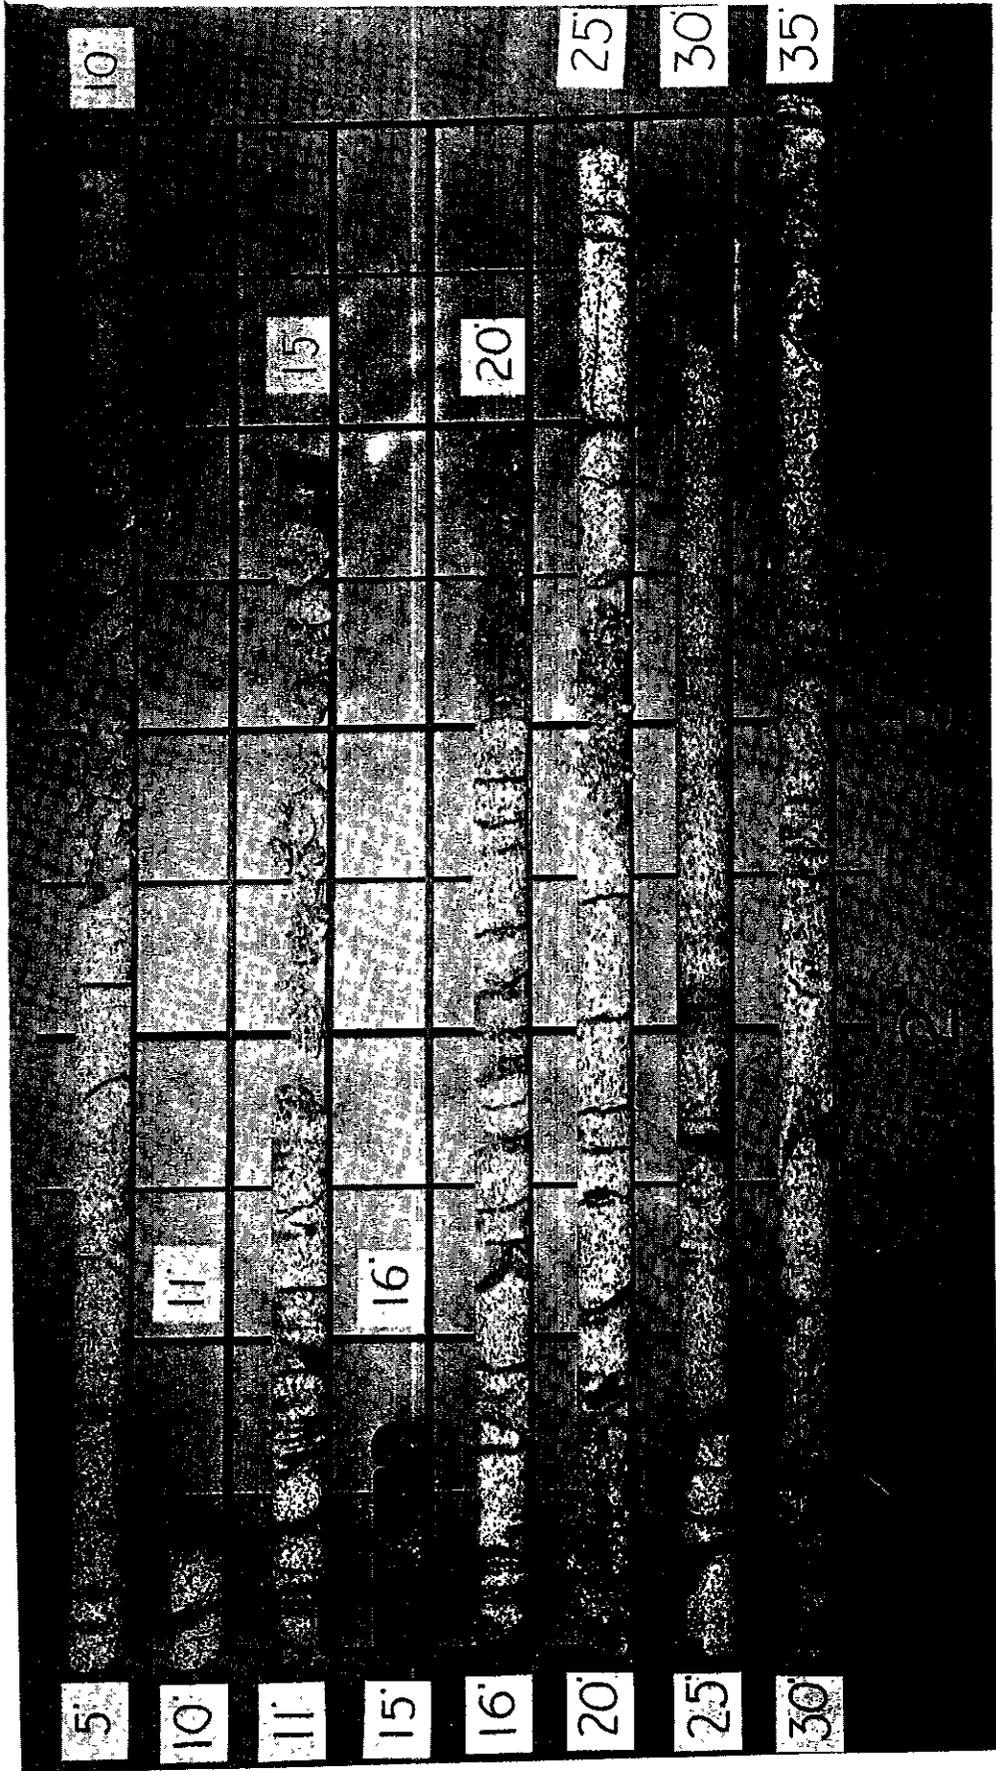
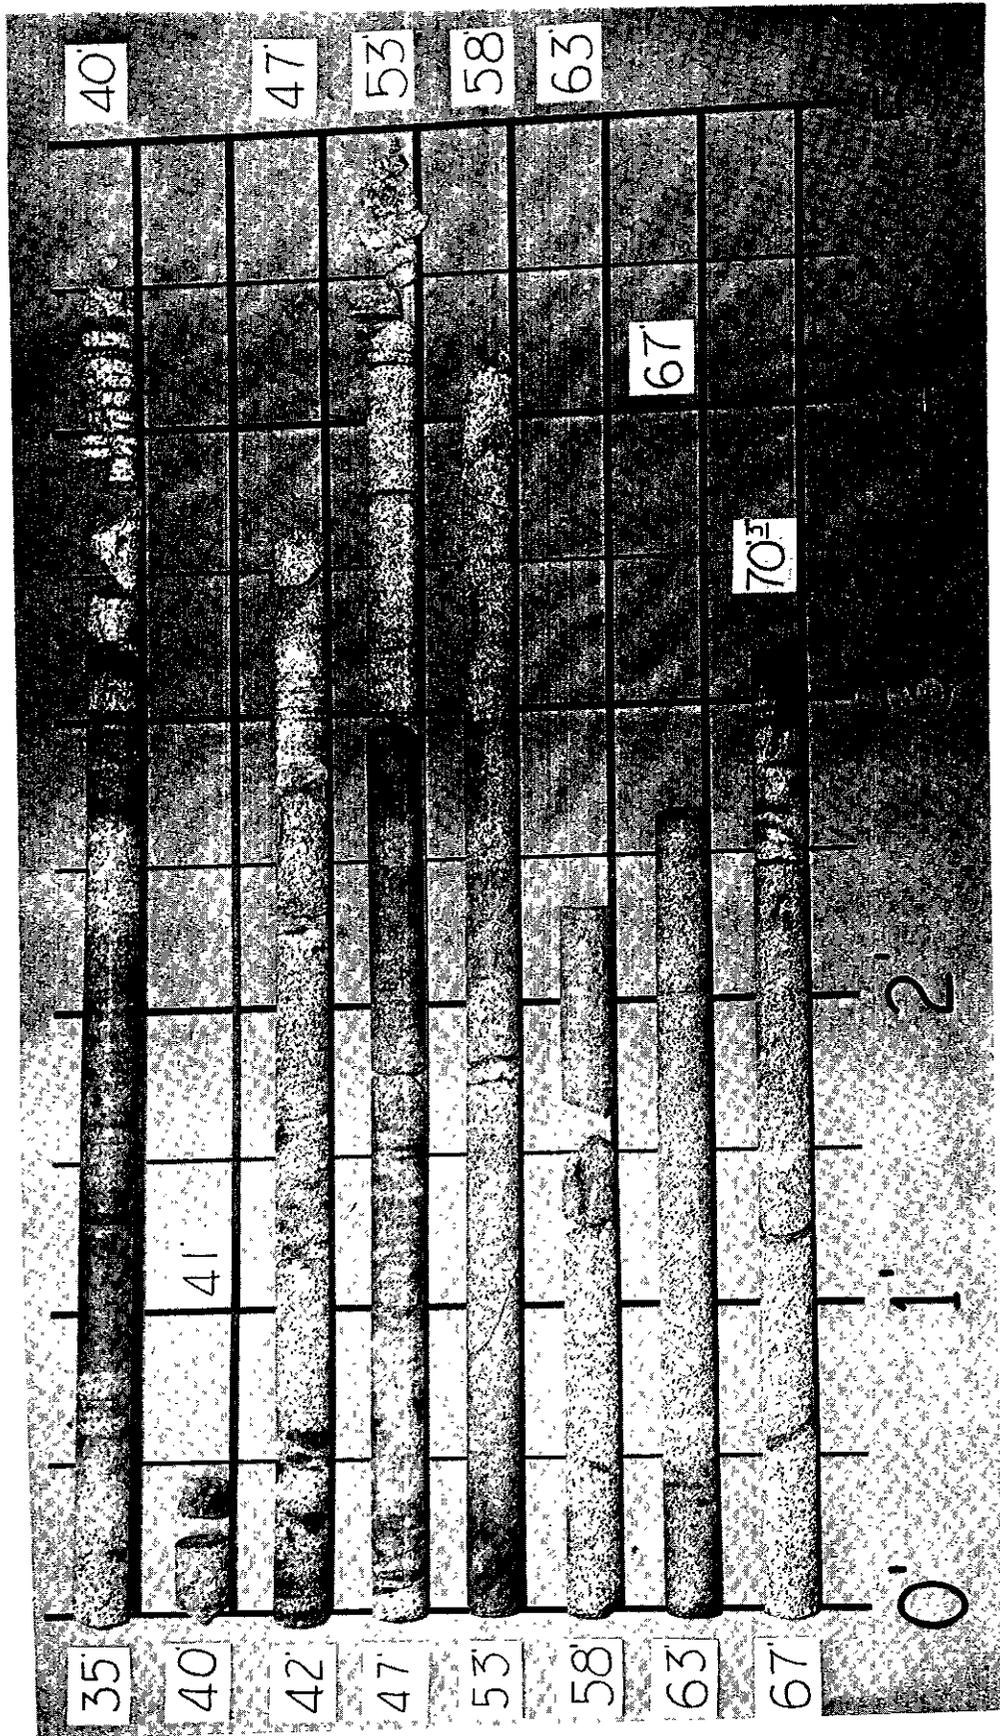
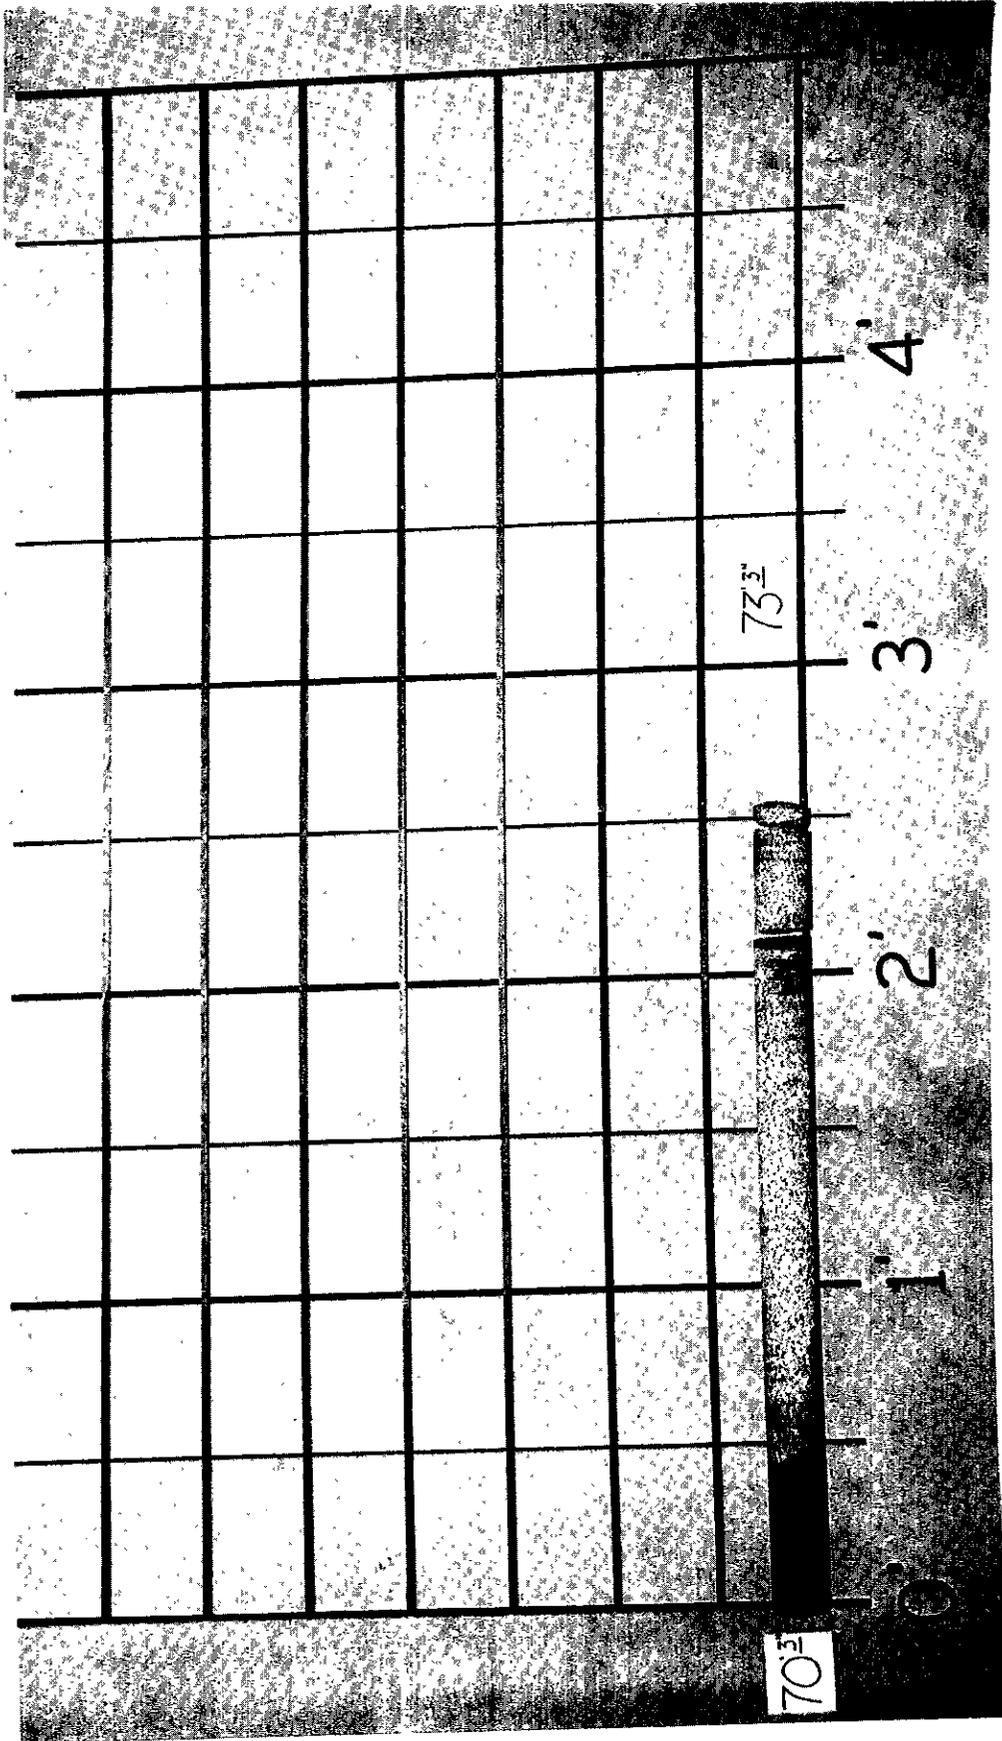
R-3 Horizontal boring, -14% grade, at roadway, depth 78'.

The material appears in-place, being fractured and jointed with some weathering or decomposition in the first twenty-five feet.

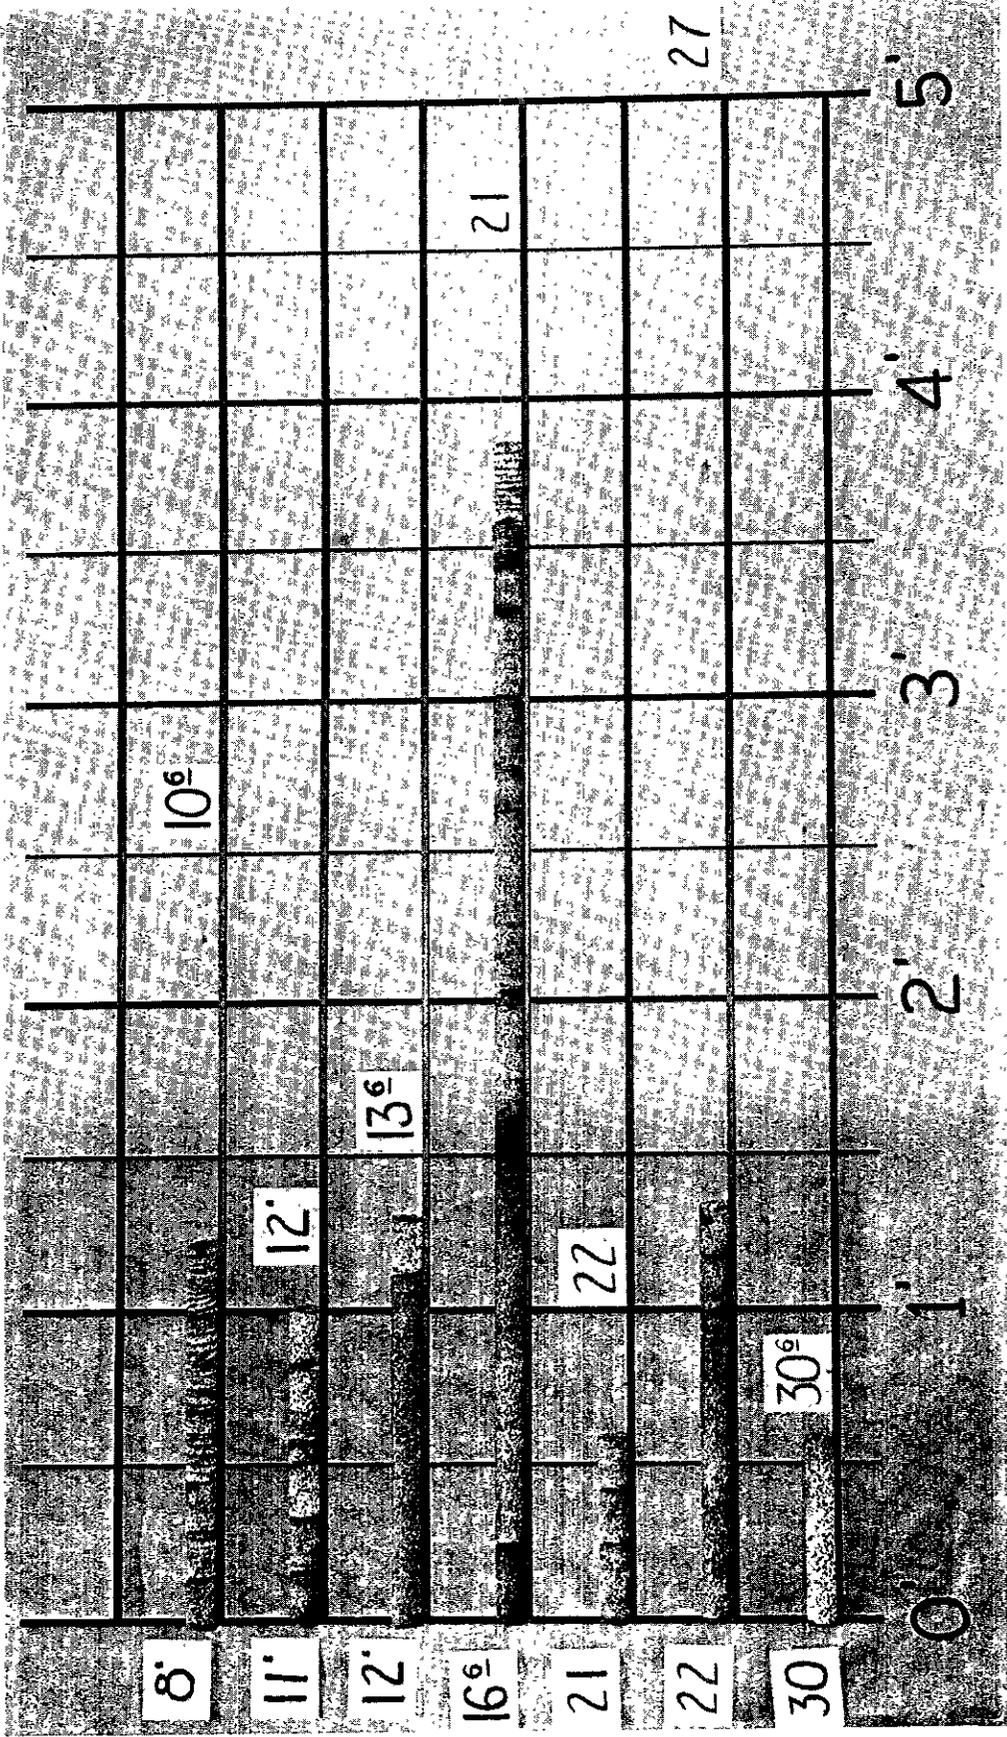
Emerald Bay Slide Investigation
 Road III-ED-38-B
 Boring R-4, 8'6" to 30'6"

R-4 Vertical boring, 130' above roadway, depth 31'.

The material varied from loose broken and decomposed granite to moderately hard fractured granite.

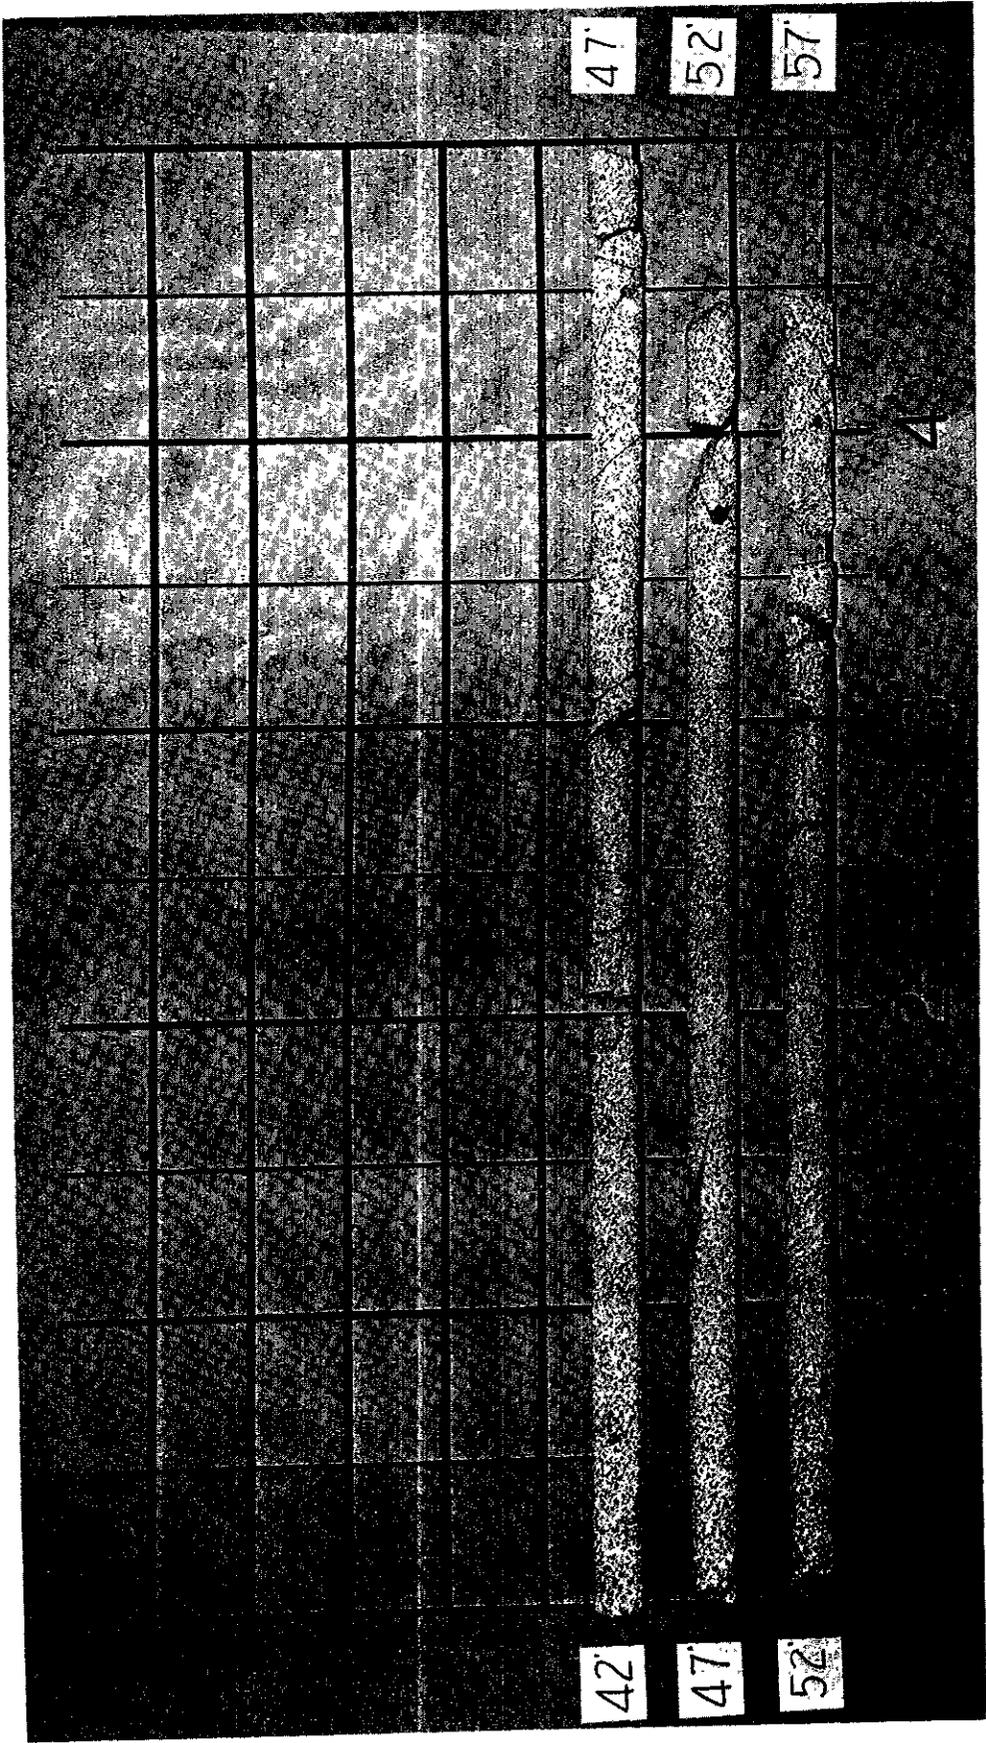
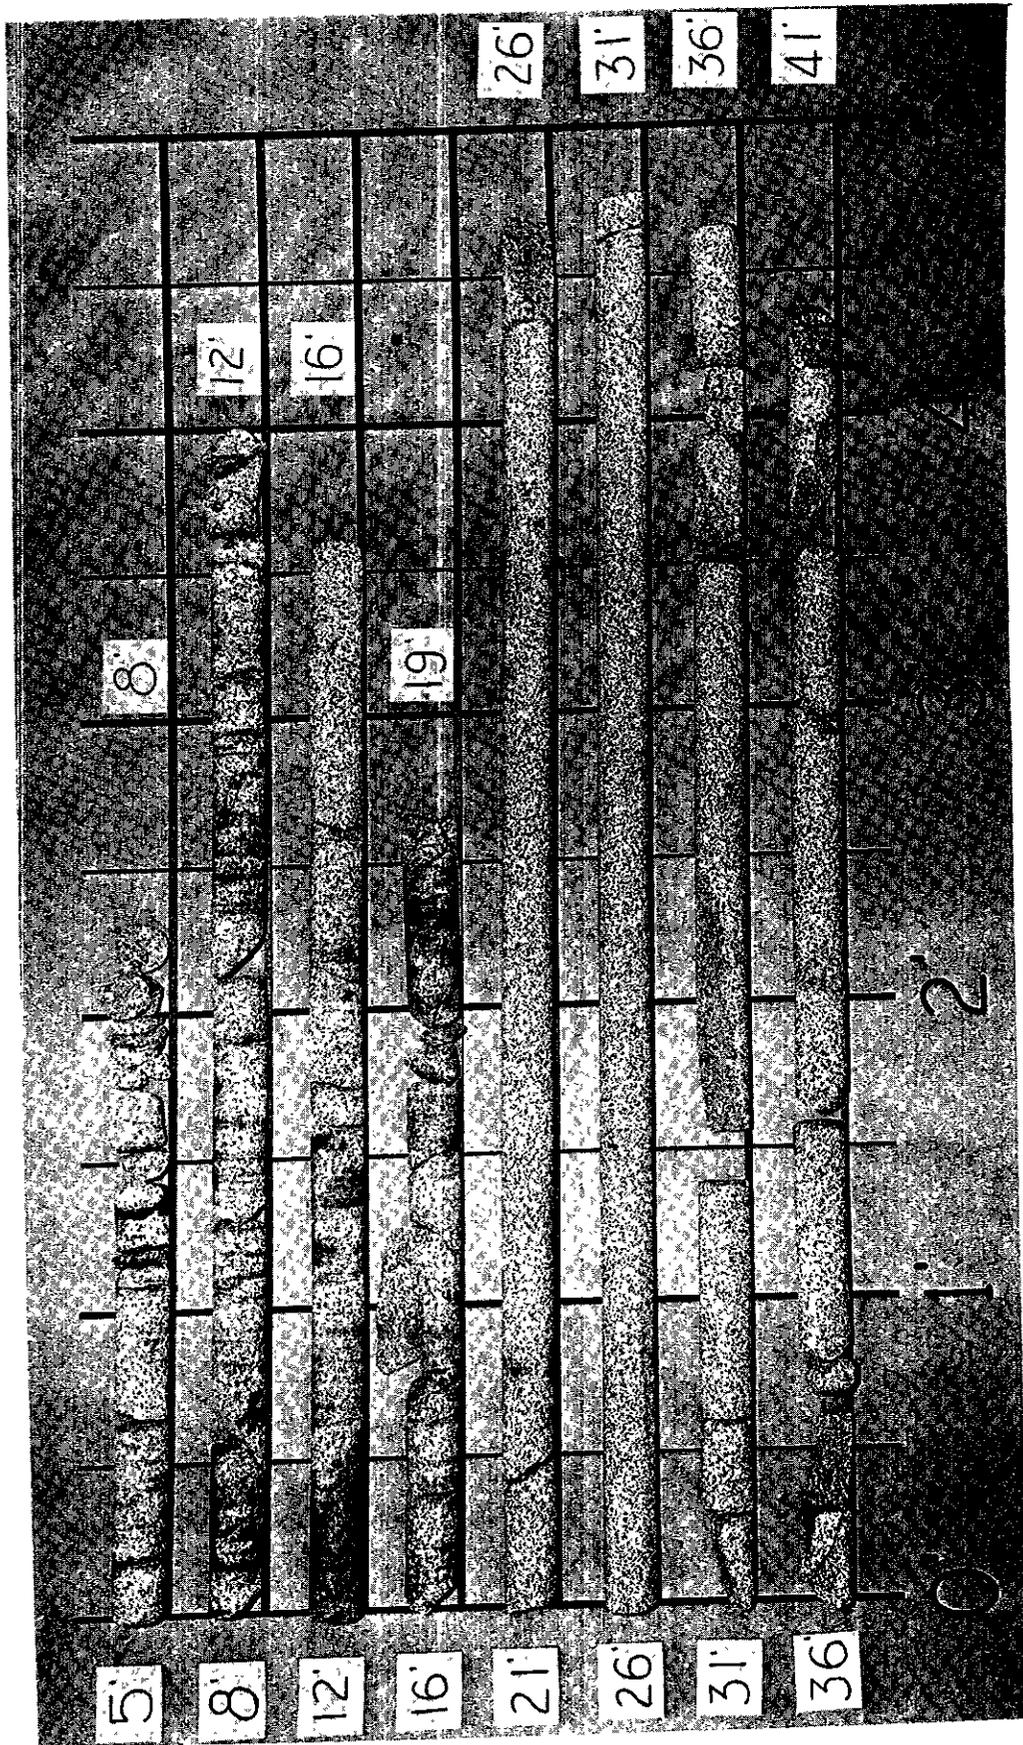
R-5 Horizontal boring, -14% grade, at roadway, depth 57'.

The material from this boring appeared to be in-place fractured and jointed granite with layers of decomposed granite.

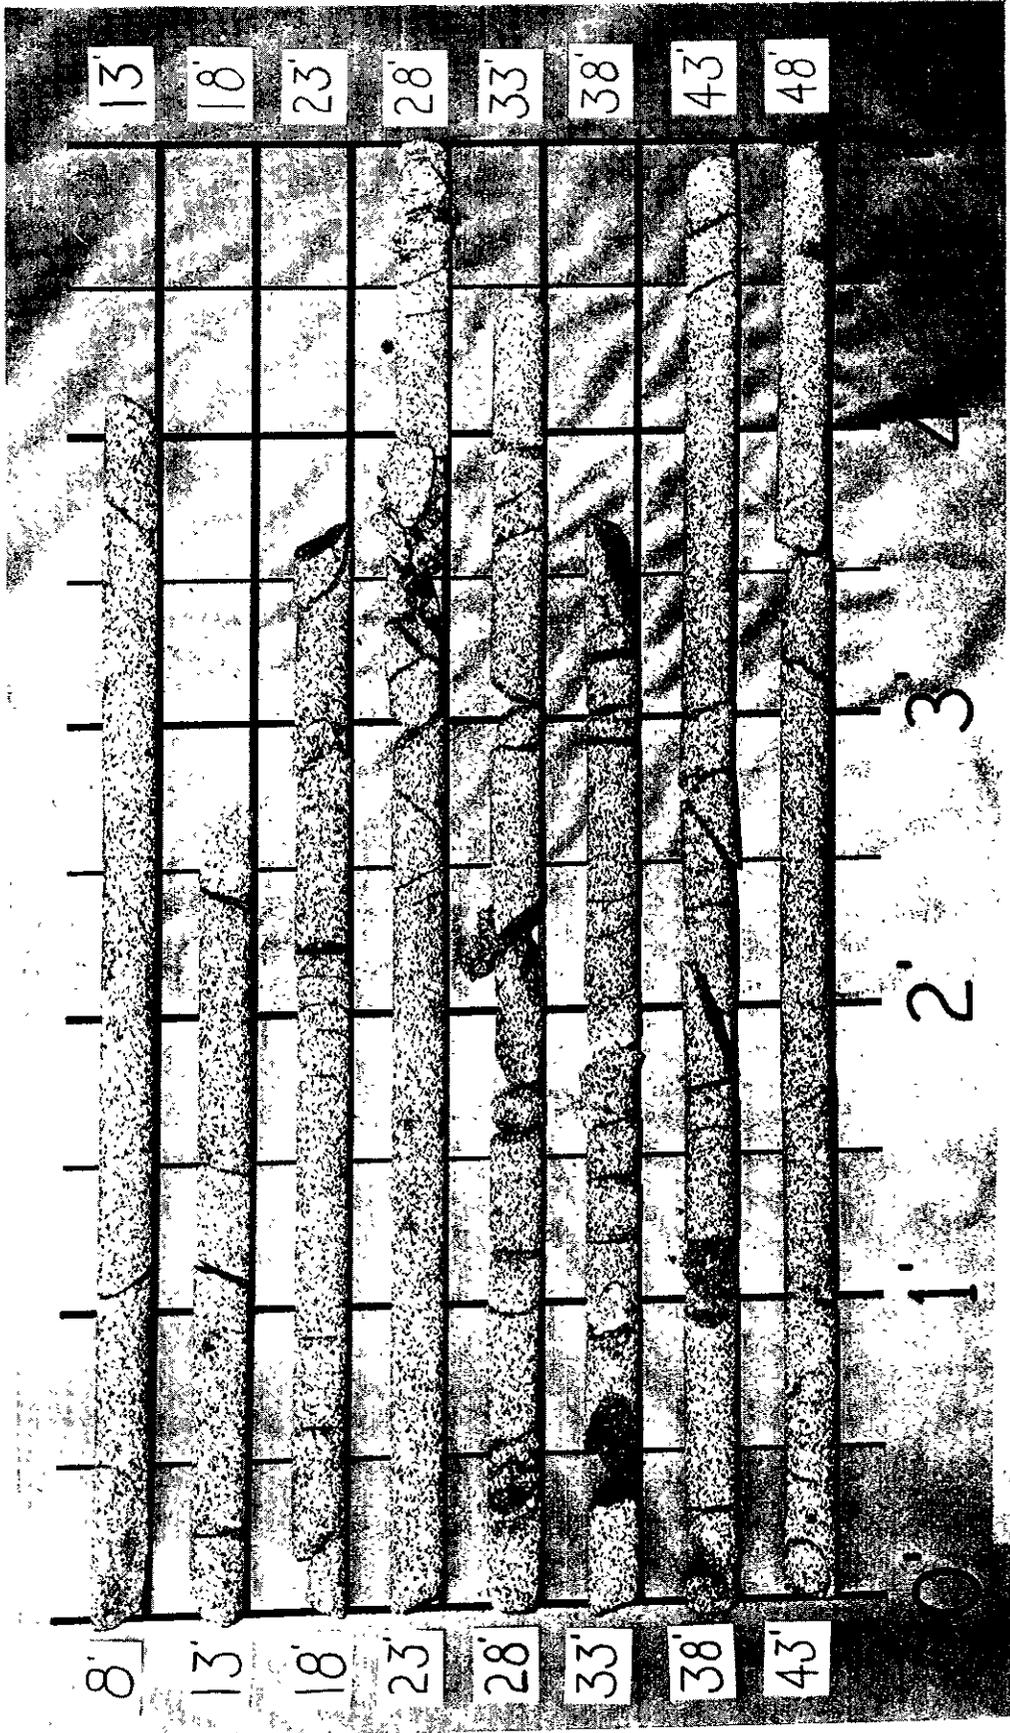
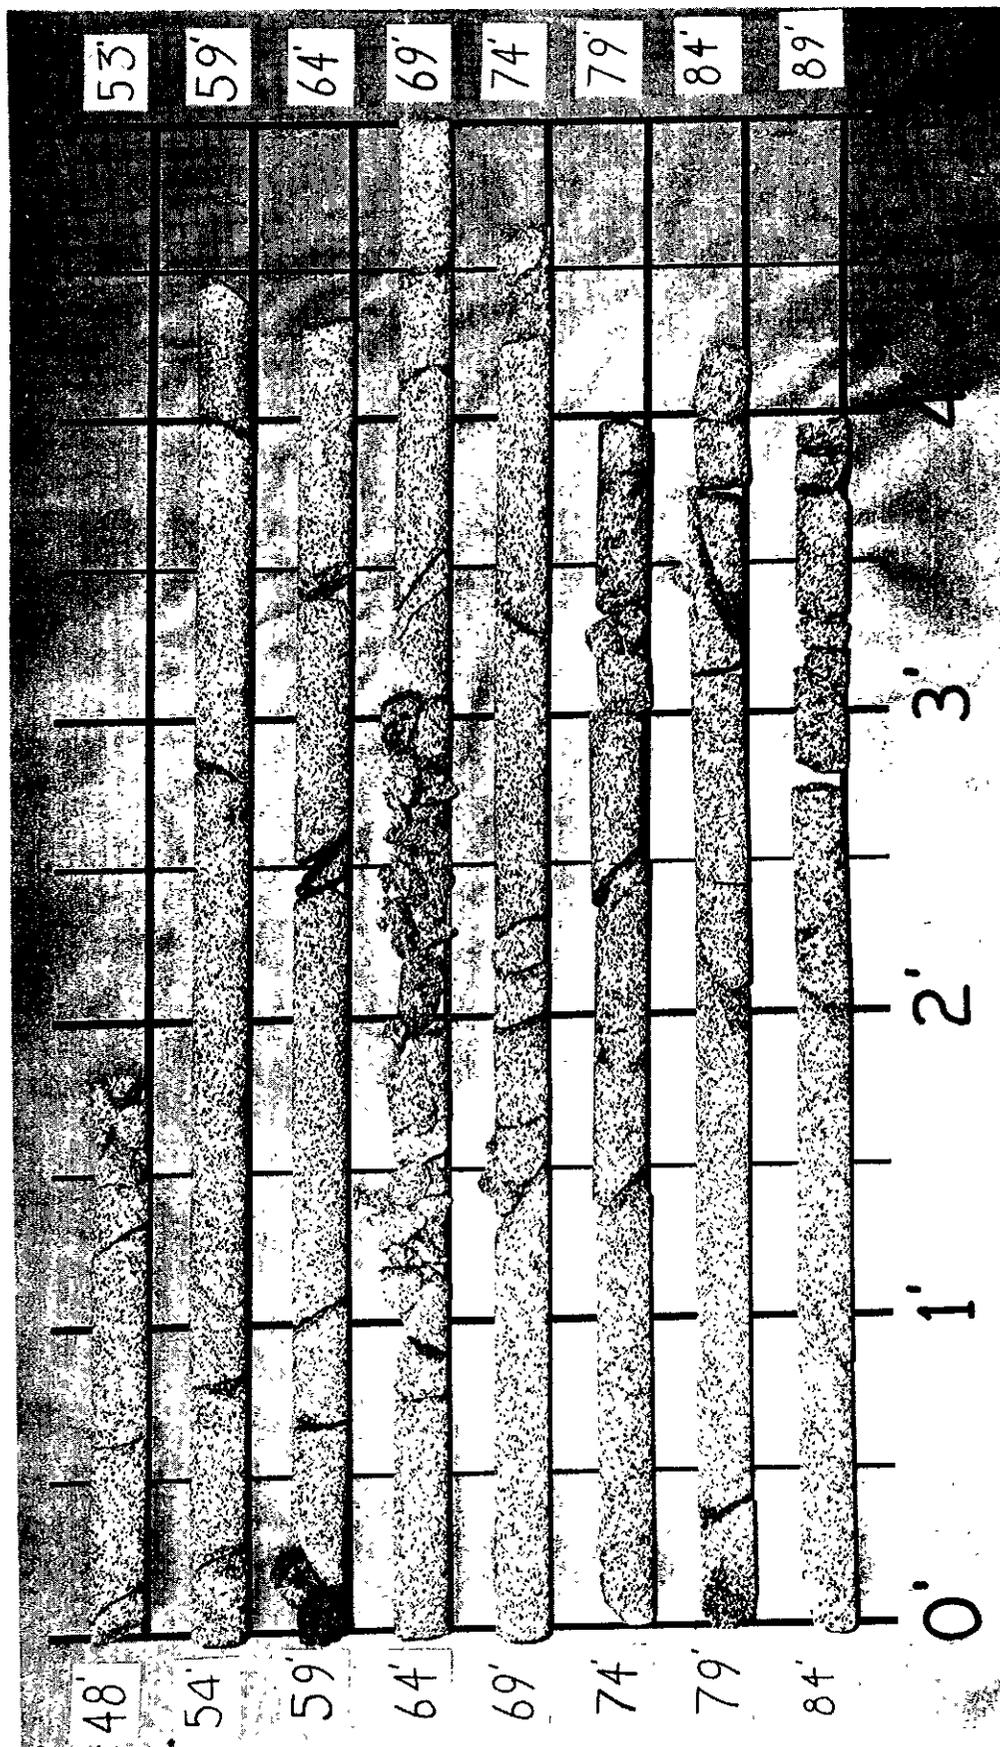
R-9 Horizontal boring, -14% grade, at roadway, depth 89'.

The material from this boring was a moderately hard fractured and jointed granite with layers of decomposed granite. Slickensides were found on the fracture planes at approximate depths of twenty-eight and thirty-five feet. It appears that the magnitude of the displacement of material was slight.
