Report on Slide Investigation at Emerald Bay on Road III-ED
-38-B Station 243+- to 250+-

SLIDE INVESTIGATION AT EMERALD BAY

STATION 243± TO 250±

December 17, 1957

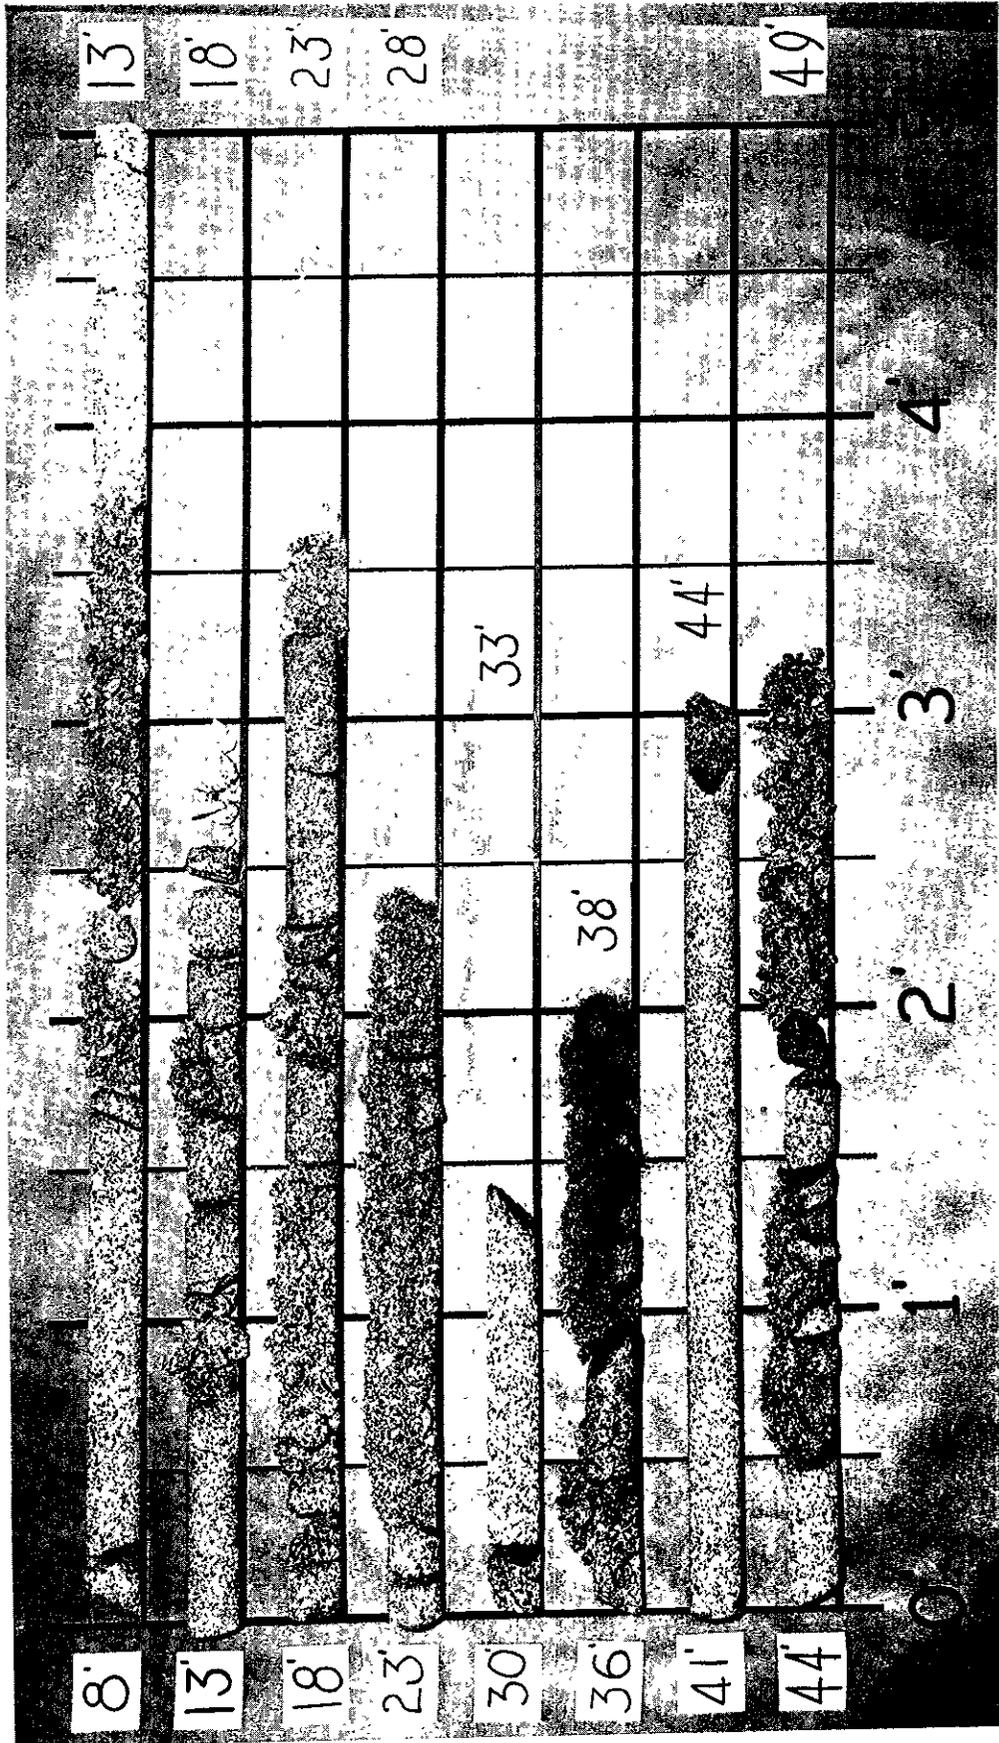
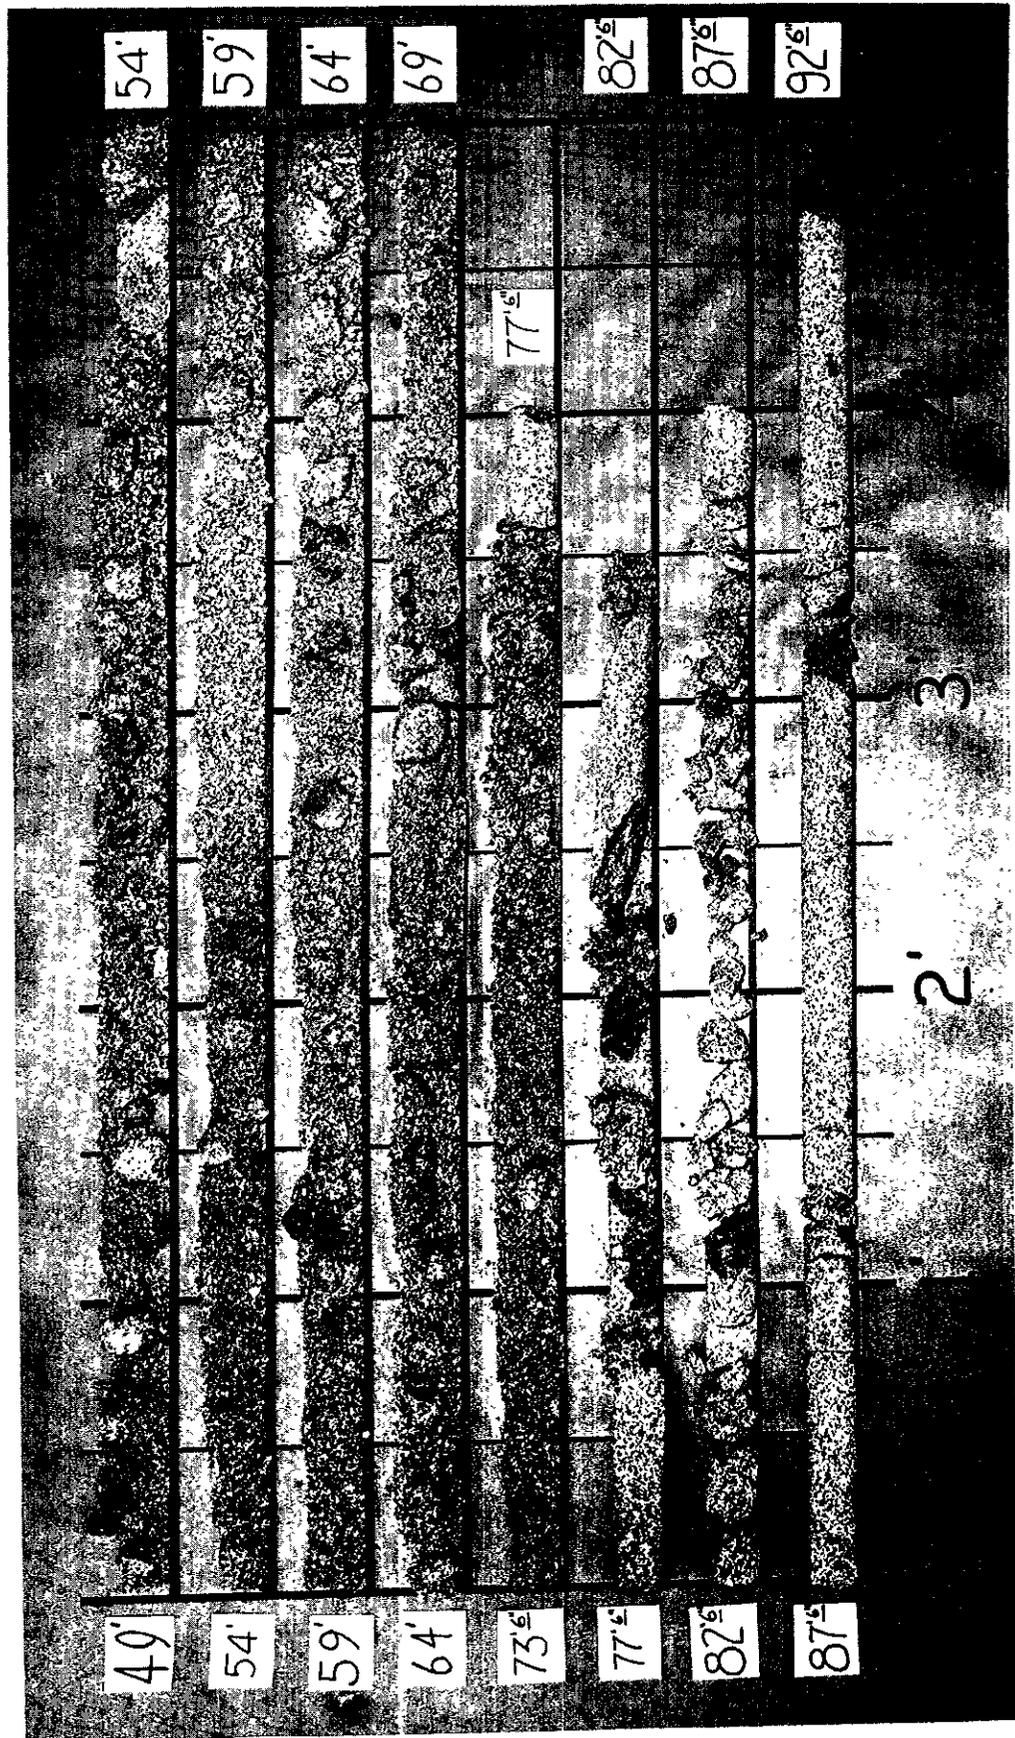
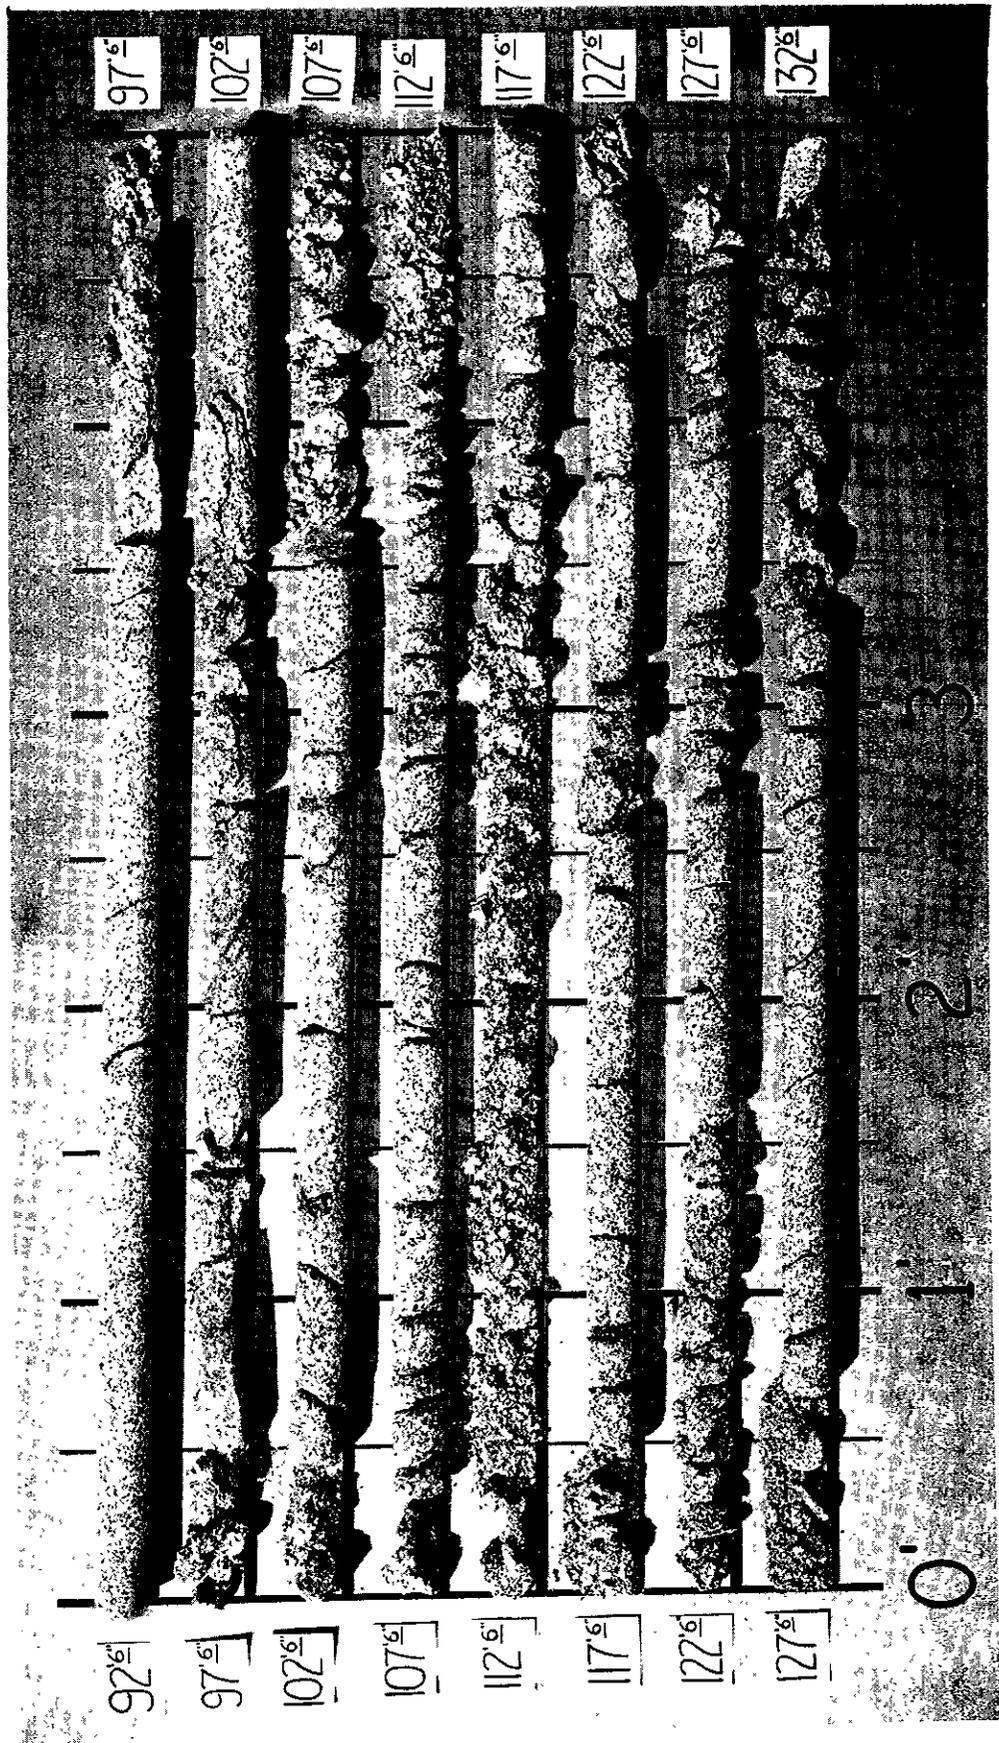
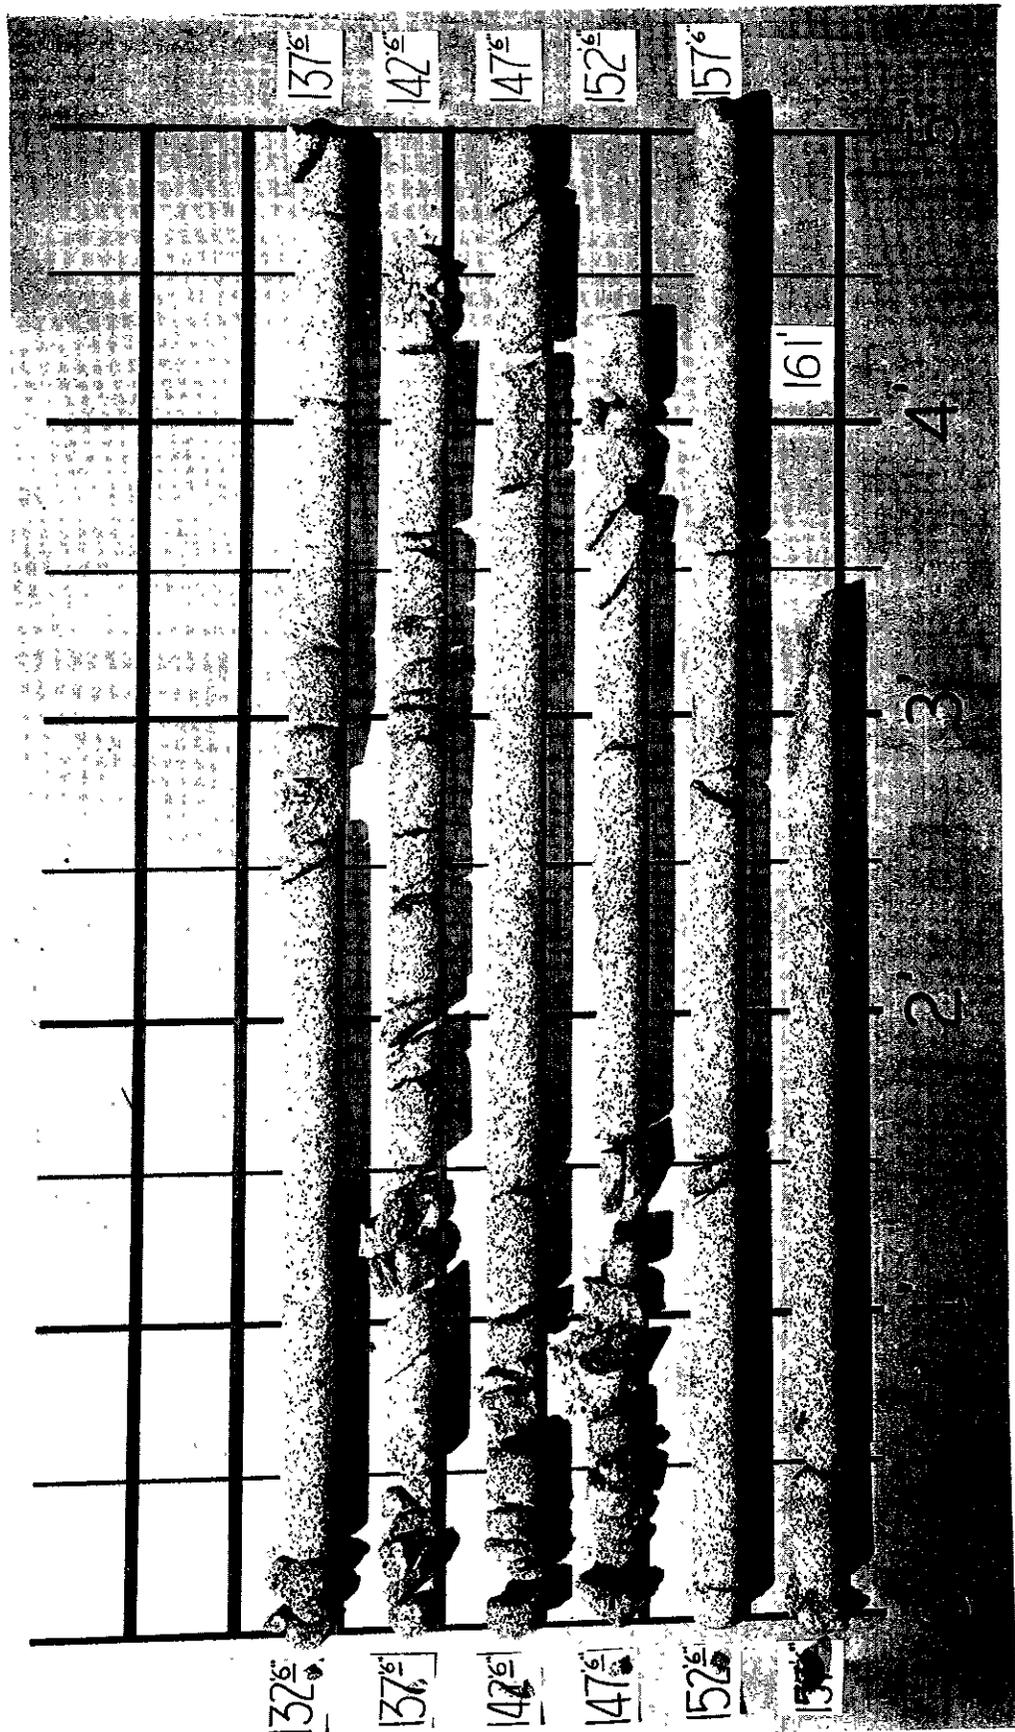
R-10 Horizontal boring, +15% grade, 130' above roadway, depth 161'.

The first fifty feet alternated between moderately hard granite and decomposed granite. From fifty to eighty feet the material was predominately decomposed granite of sand sizes. From 80' to 130' the material was a badly fractured granite with considerable degree of decomposition. In the remainder of the boring the granite was moderately hard fractured and jointed.

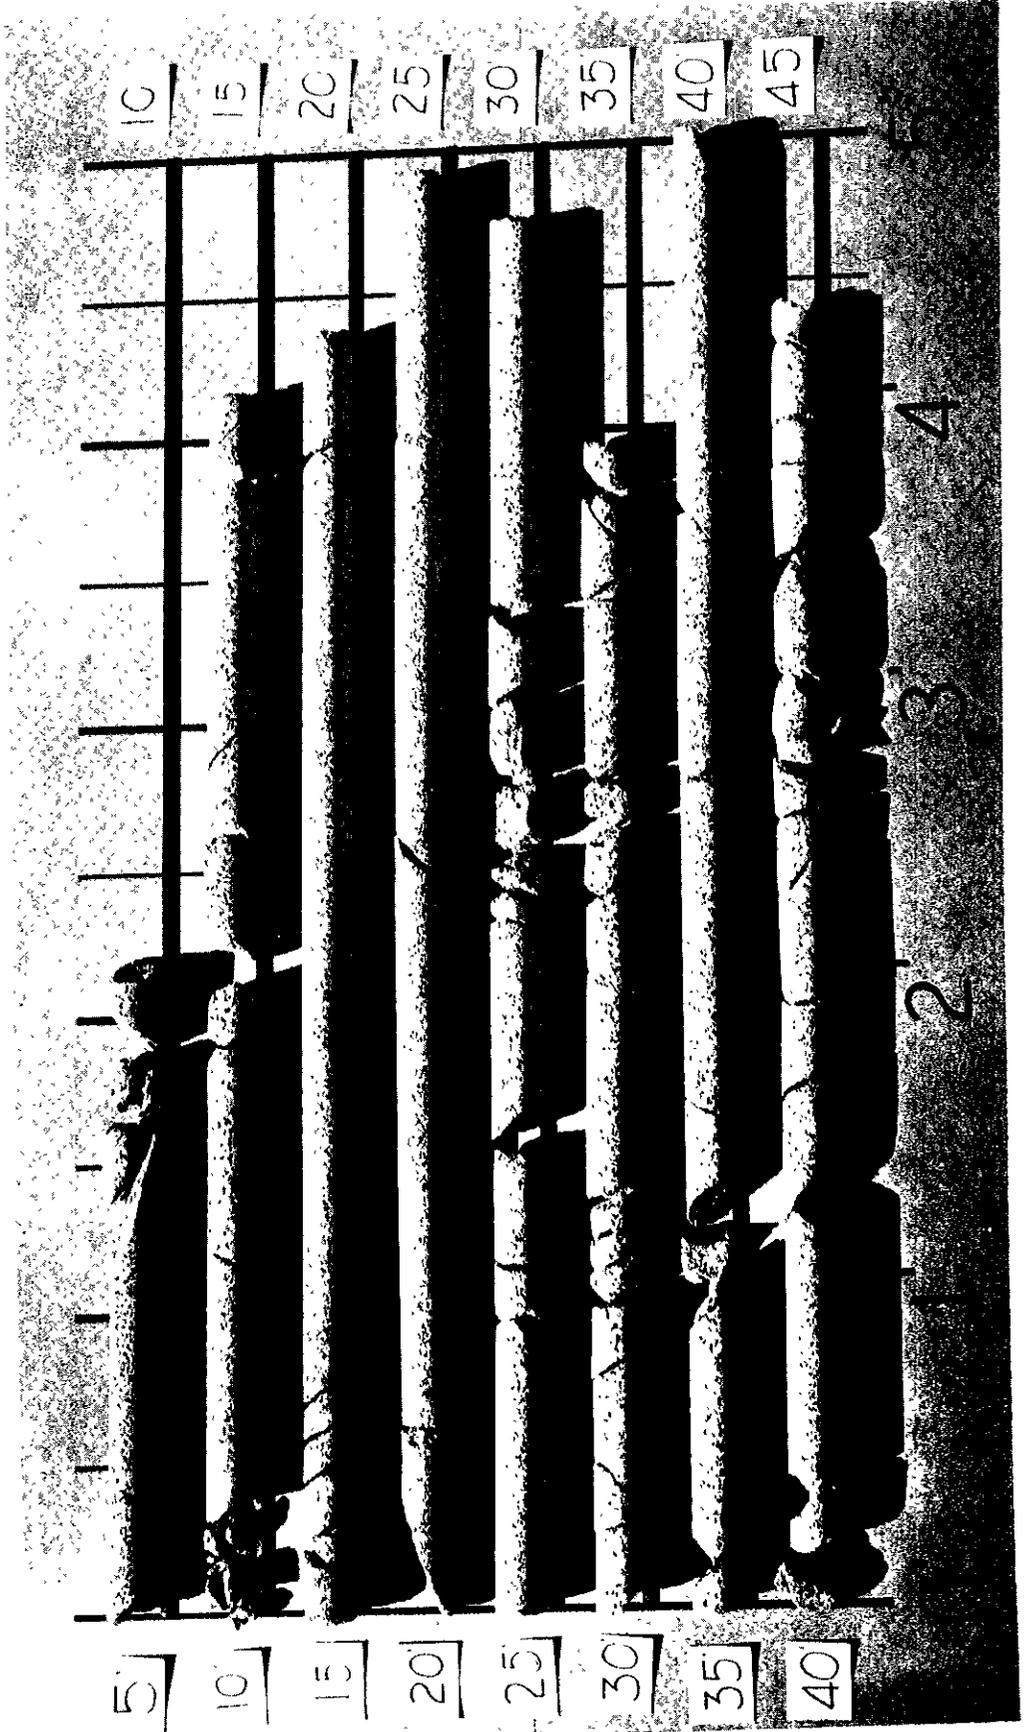
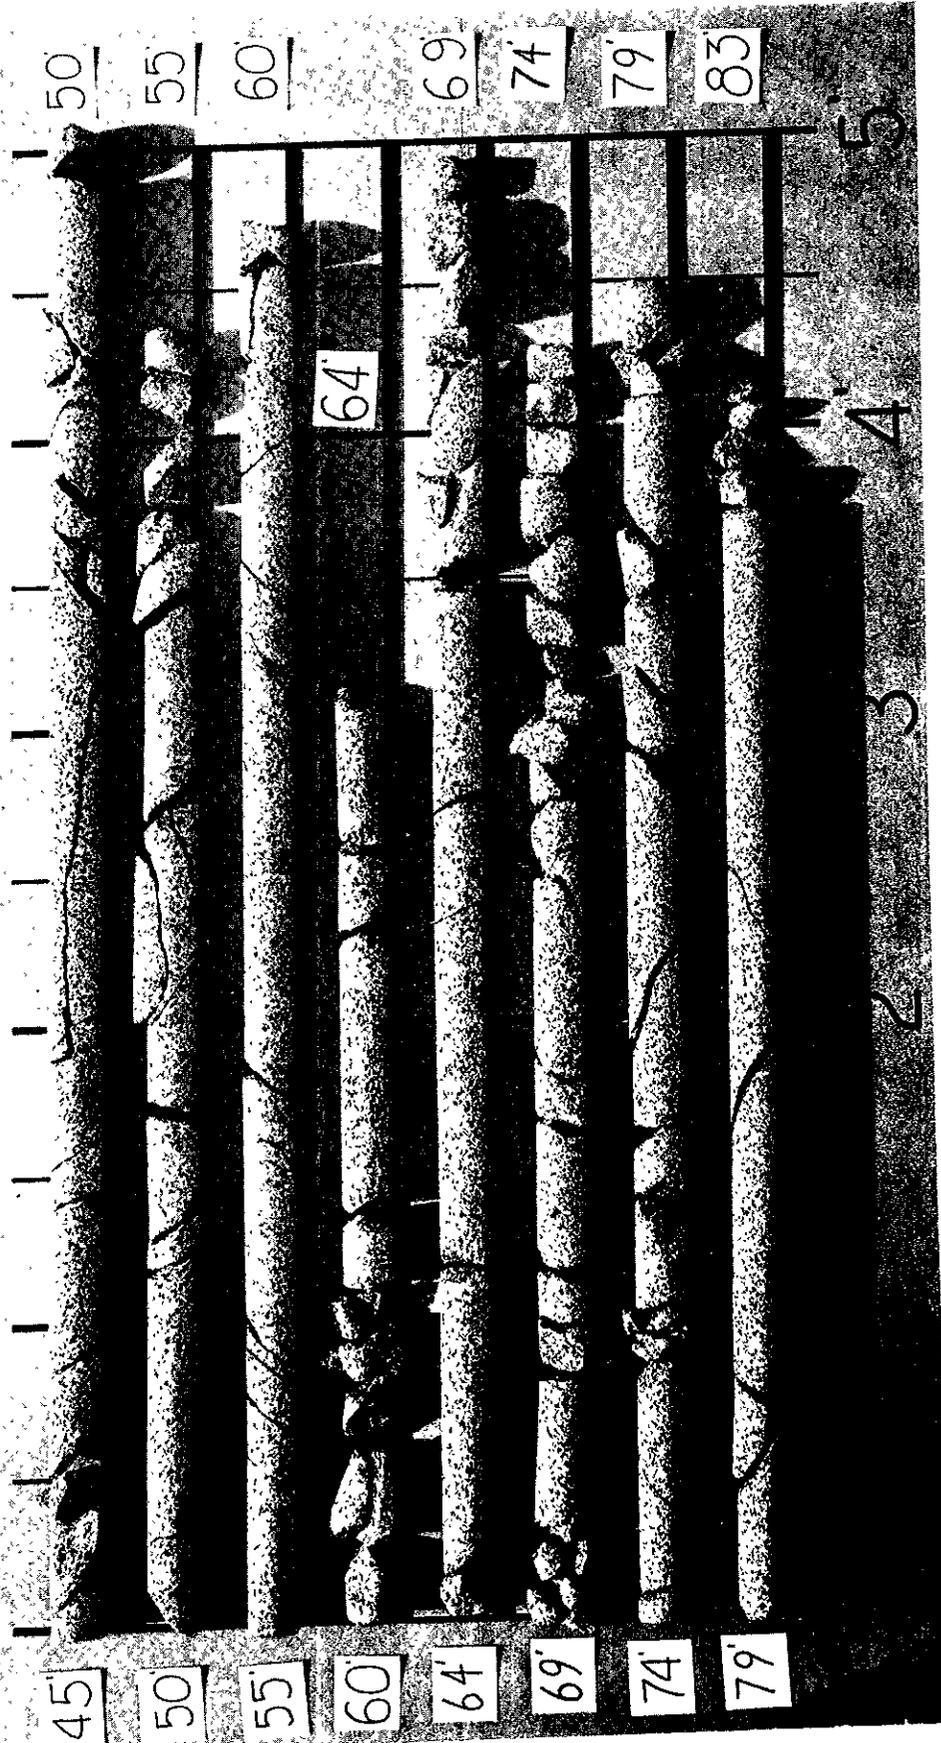
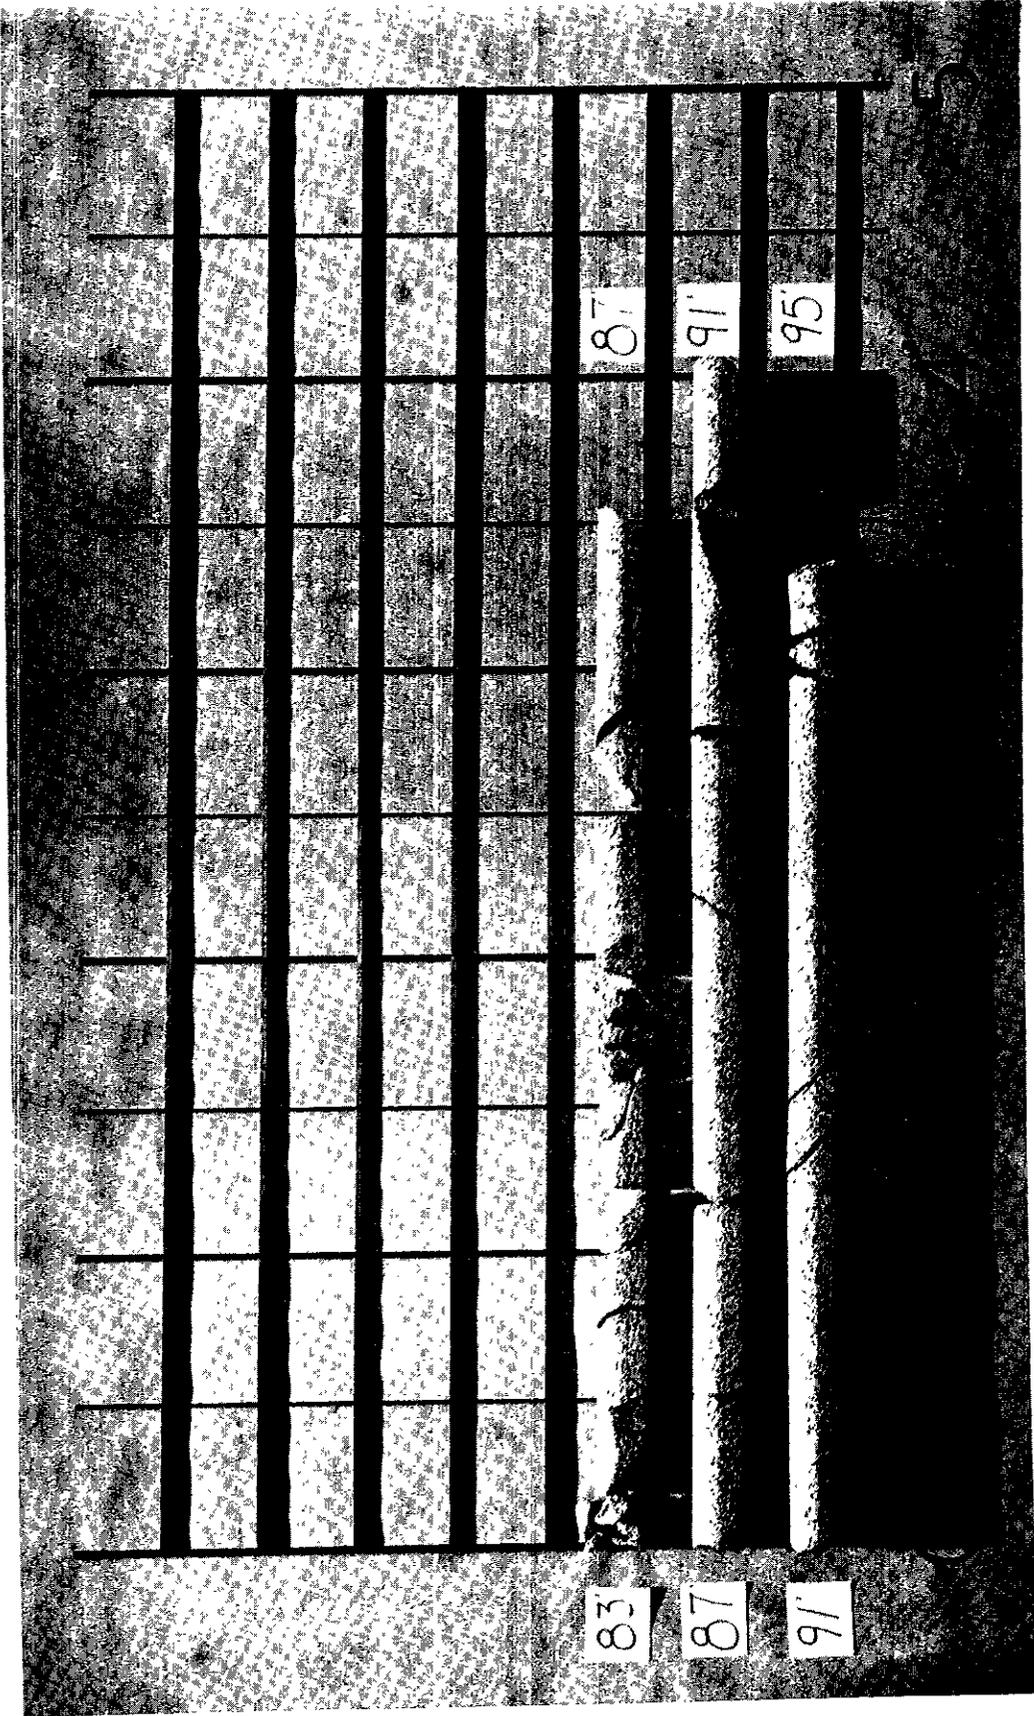
R-11 Horizontal boring, +17% grade, at roadway, depth 95'.

The boring was similar to the other three (R-3, 5, & 9) horizontal borings made at roadway with the exception that the material showed a greater degree of decomposition.

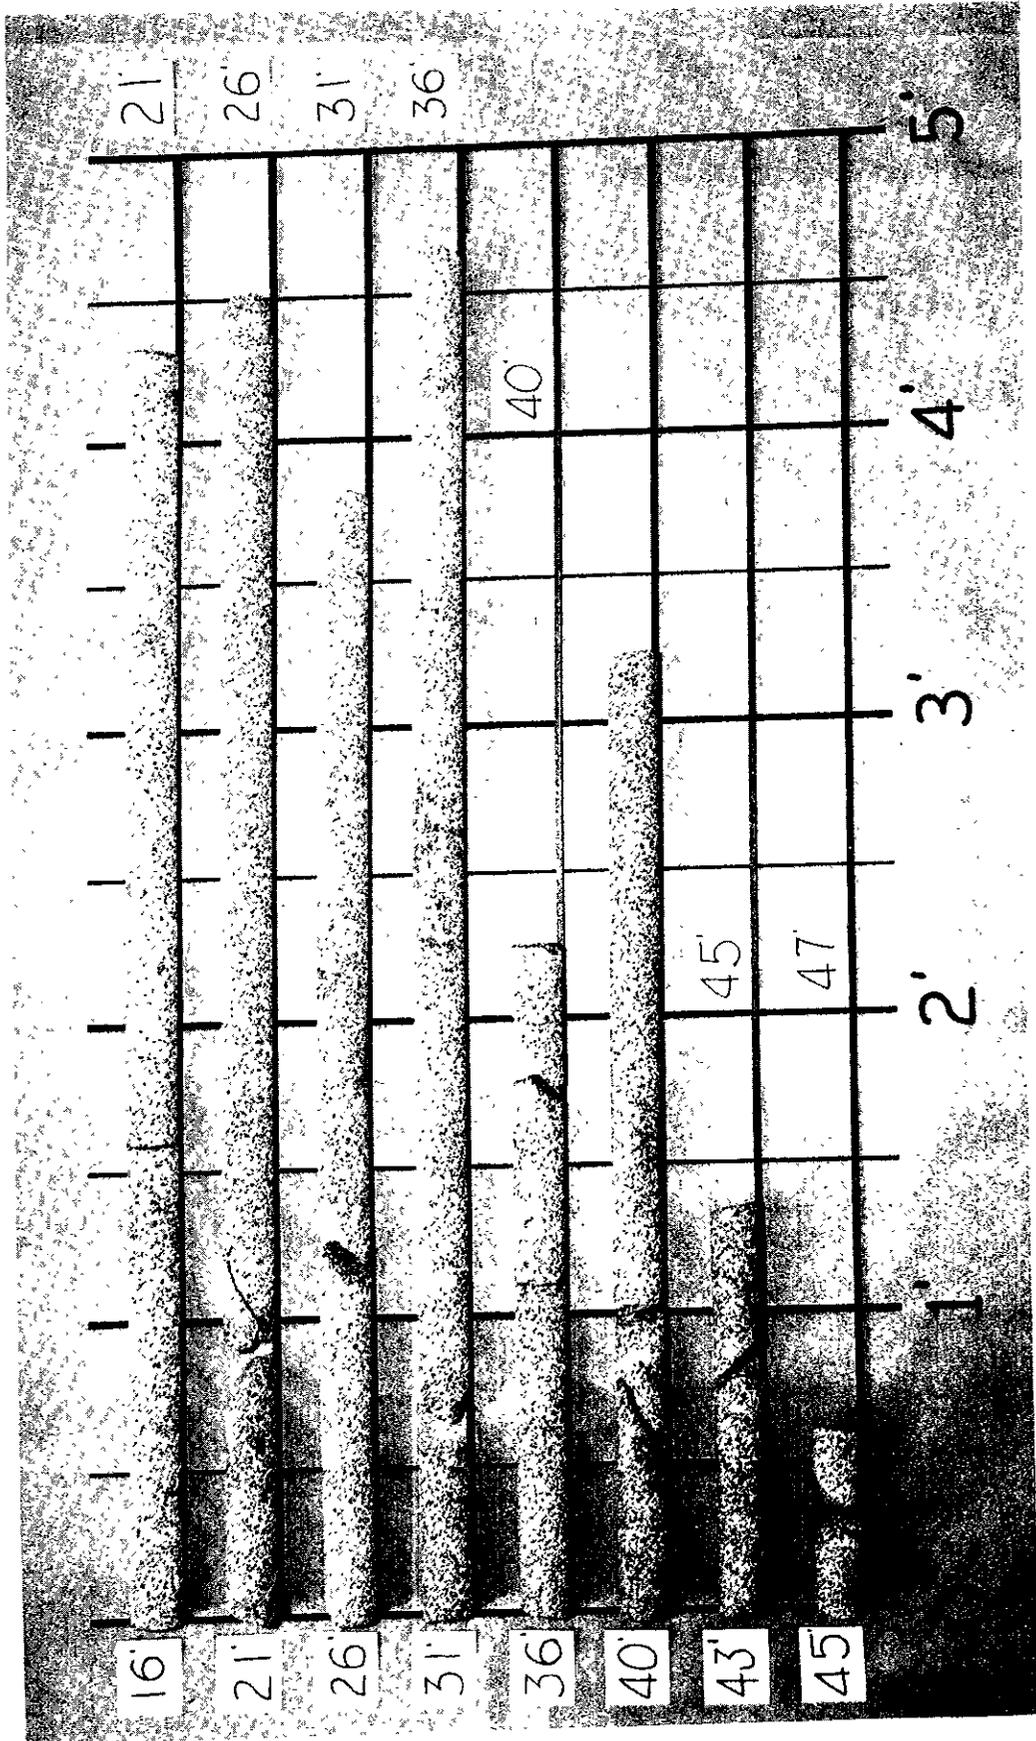
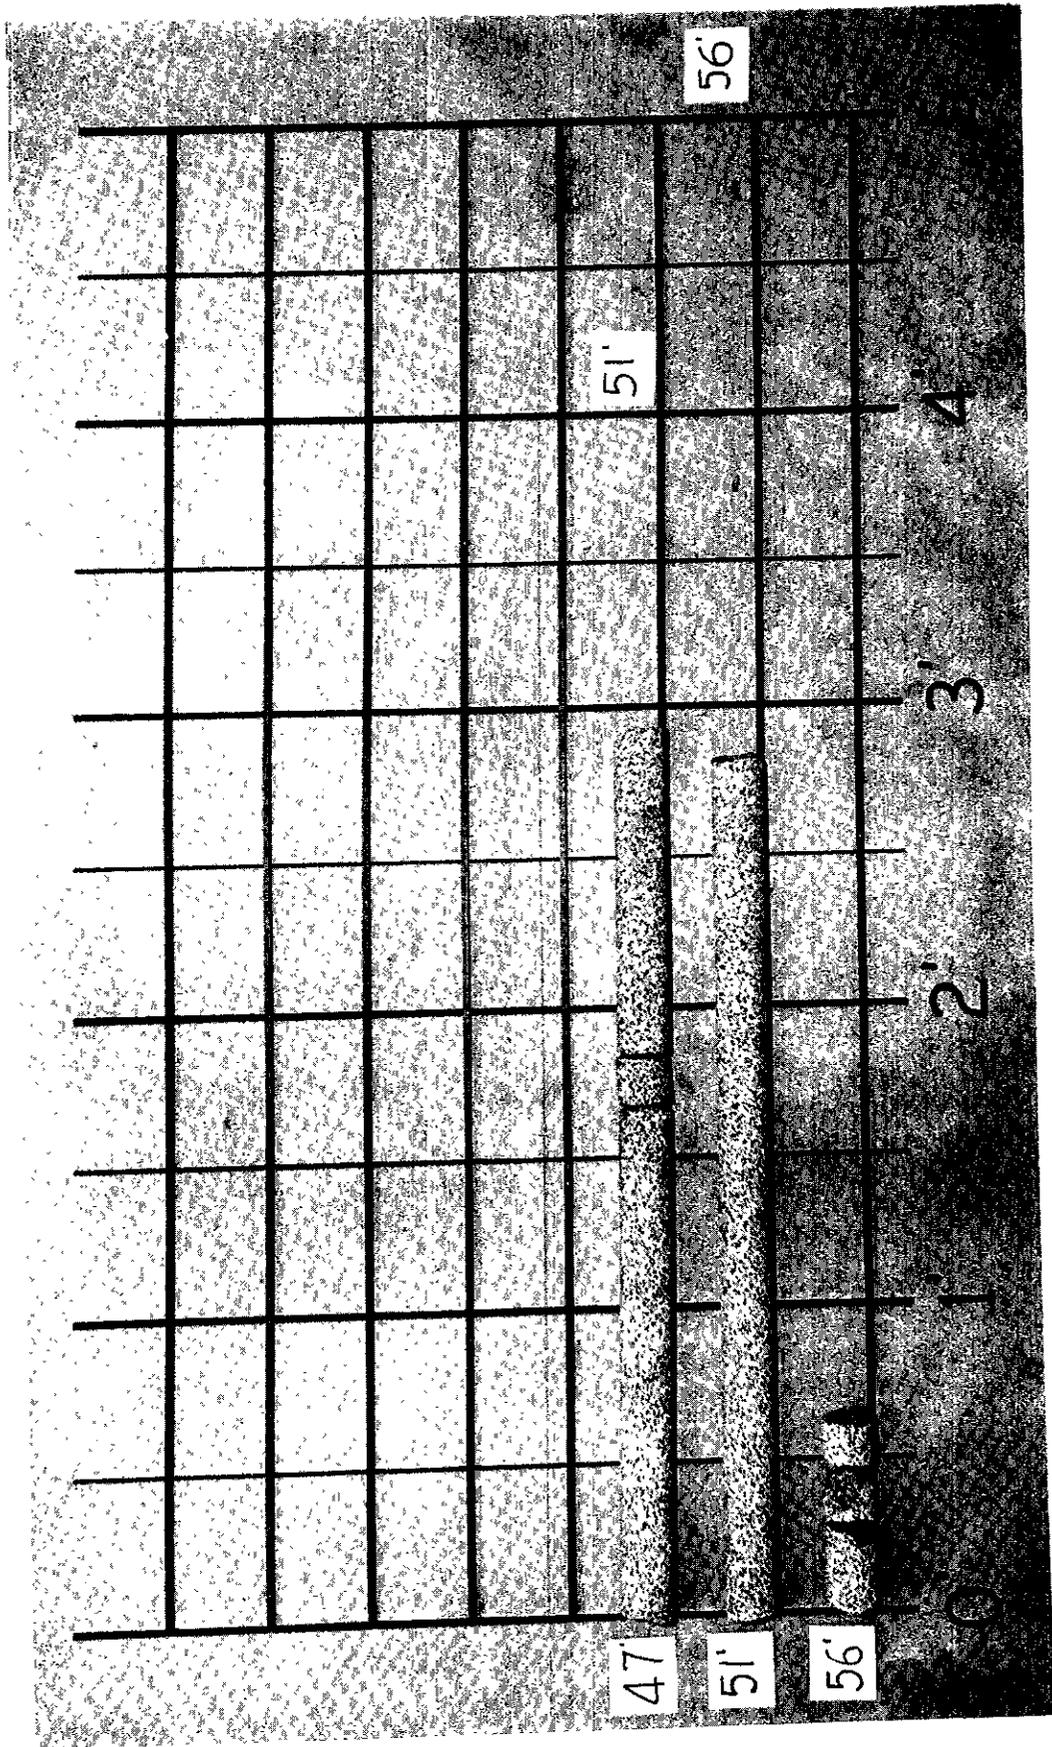
R-12 Horizontal boring, +20% grade, 130' above roadway, depth 59'.

Although this boring was only seventy feet south of boring R-10 the material was relatively fresh granite with some fractures and joints.

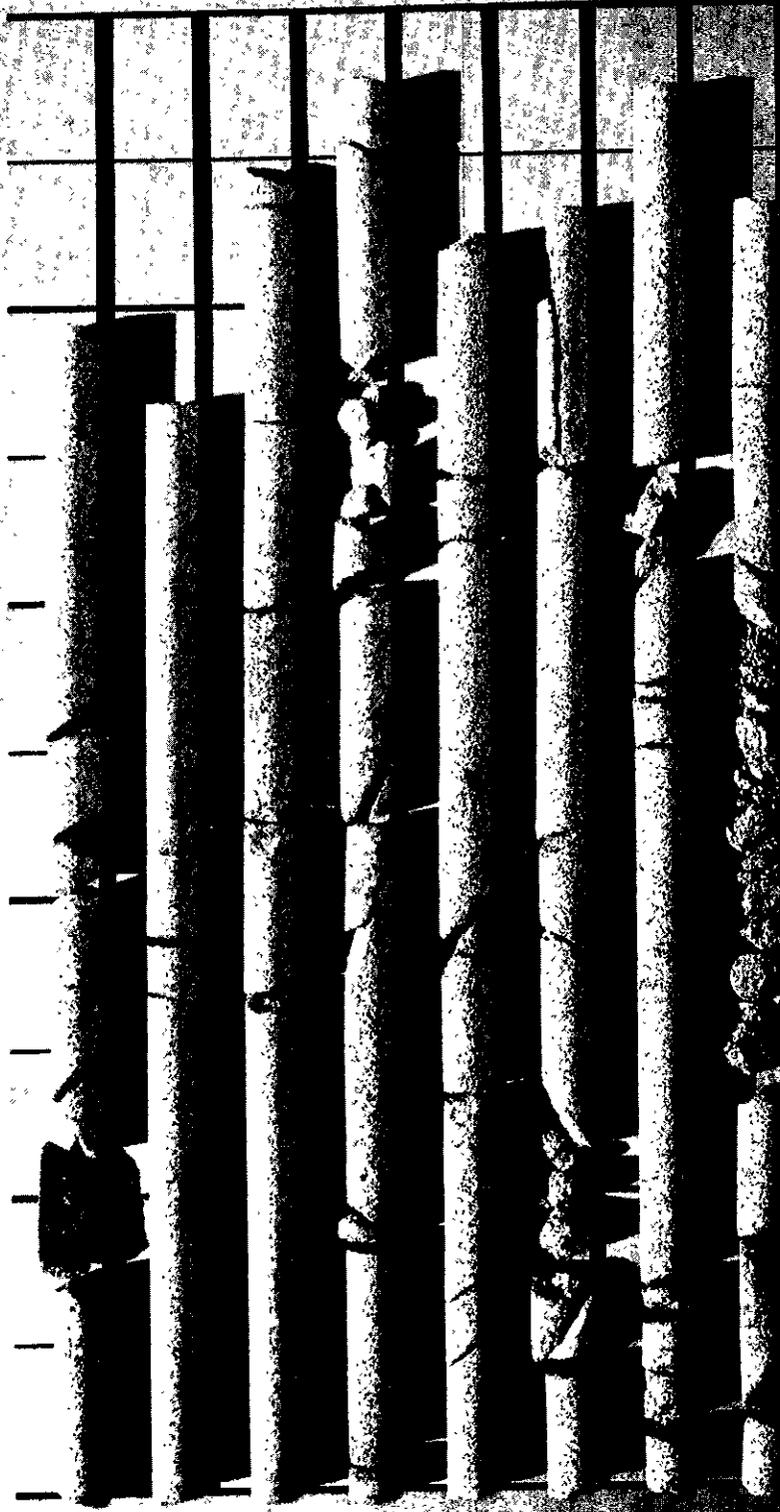
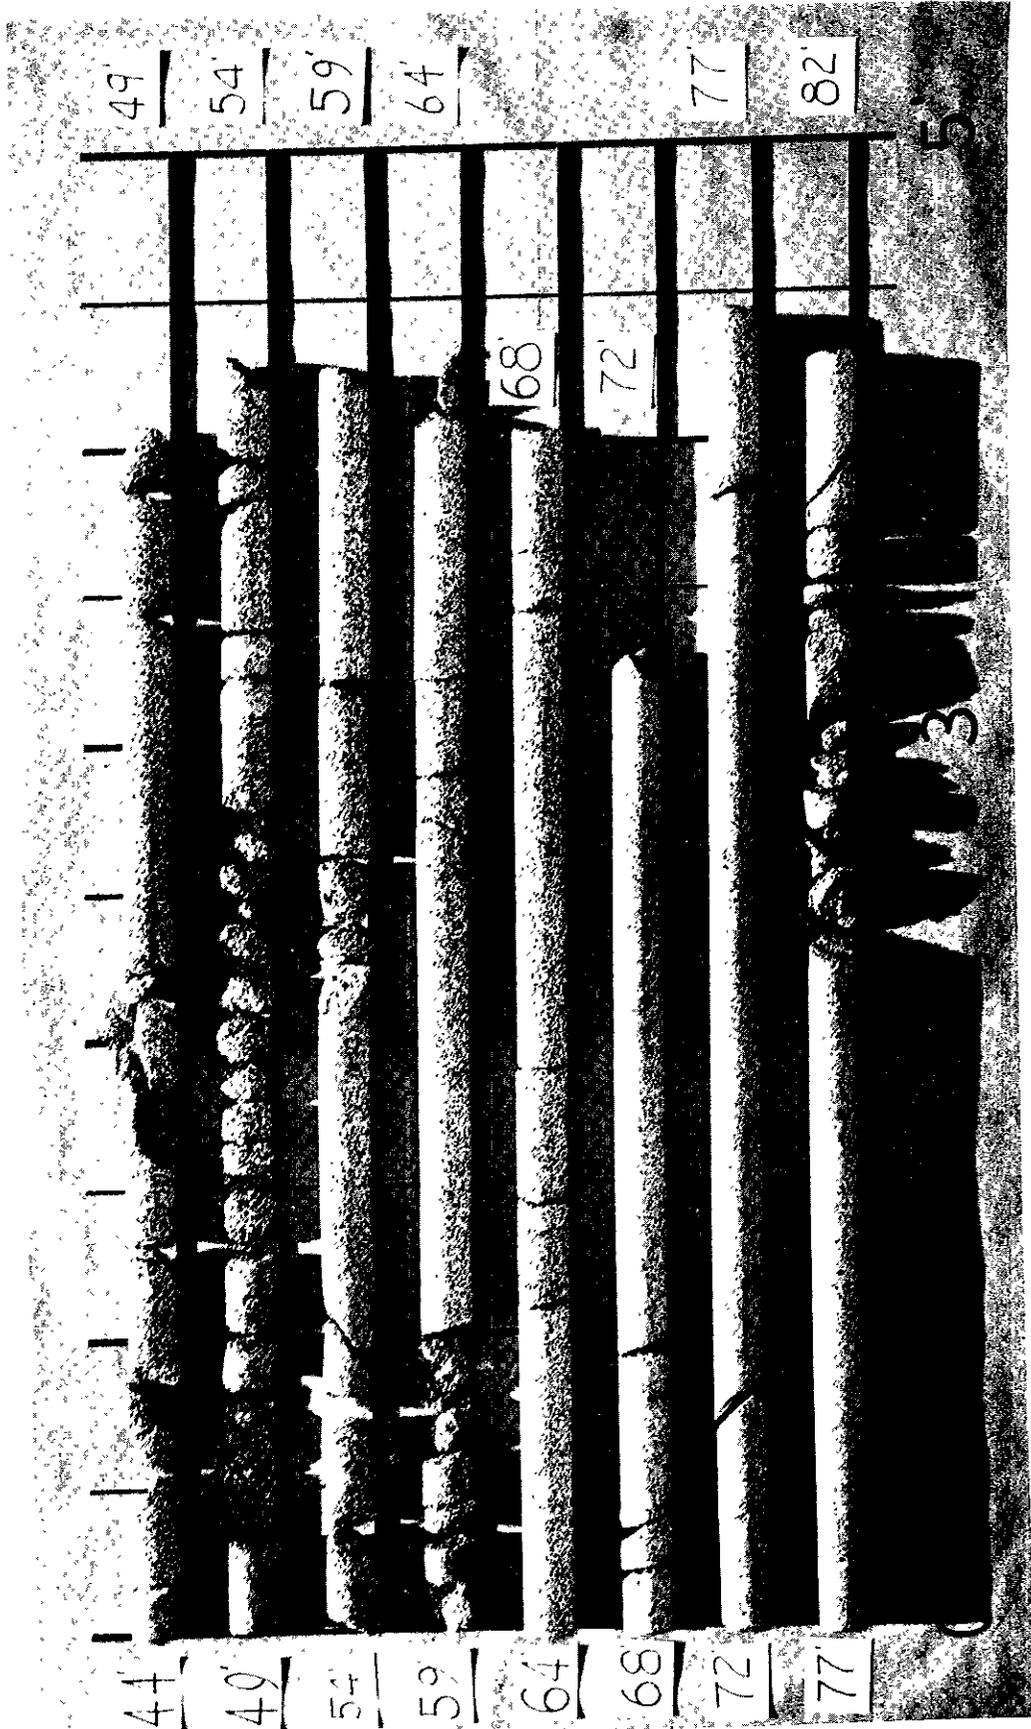
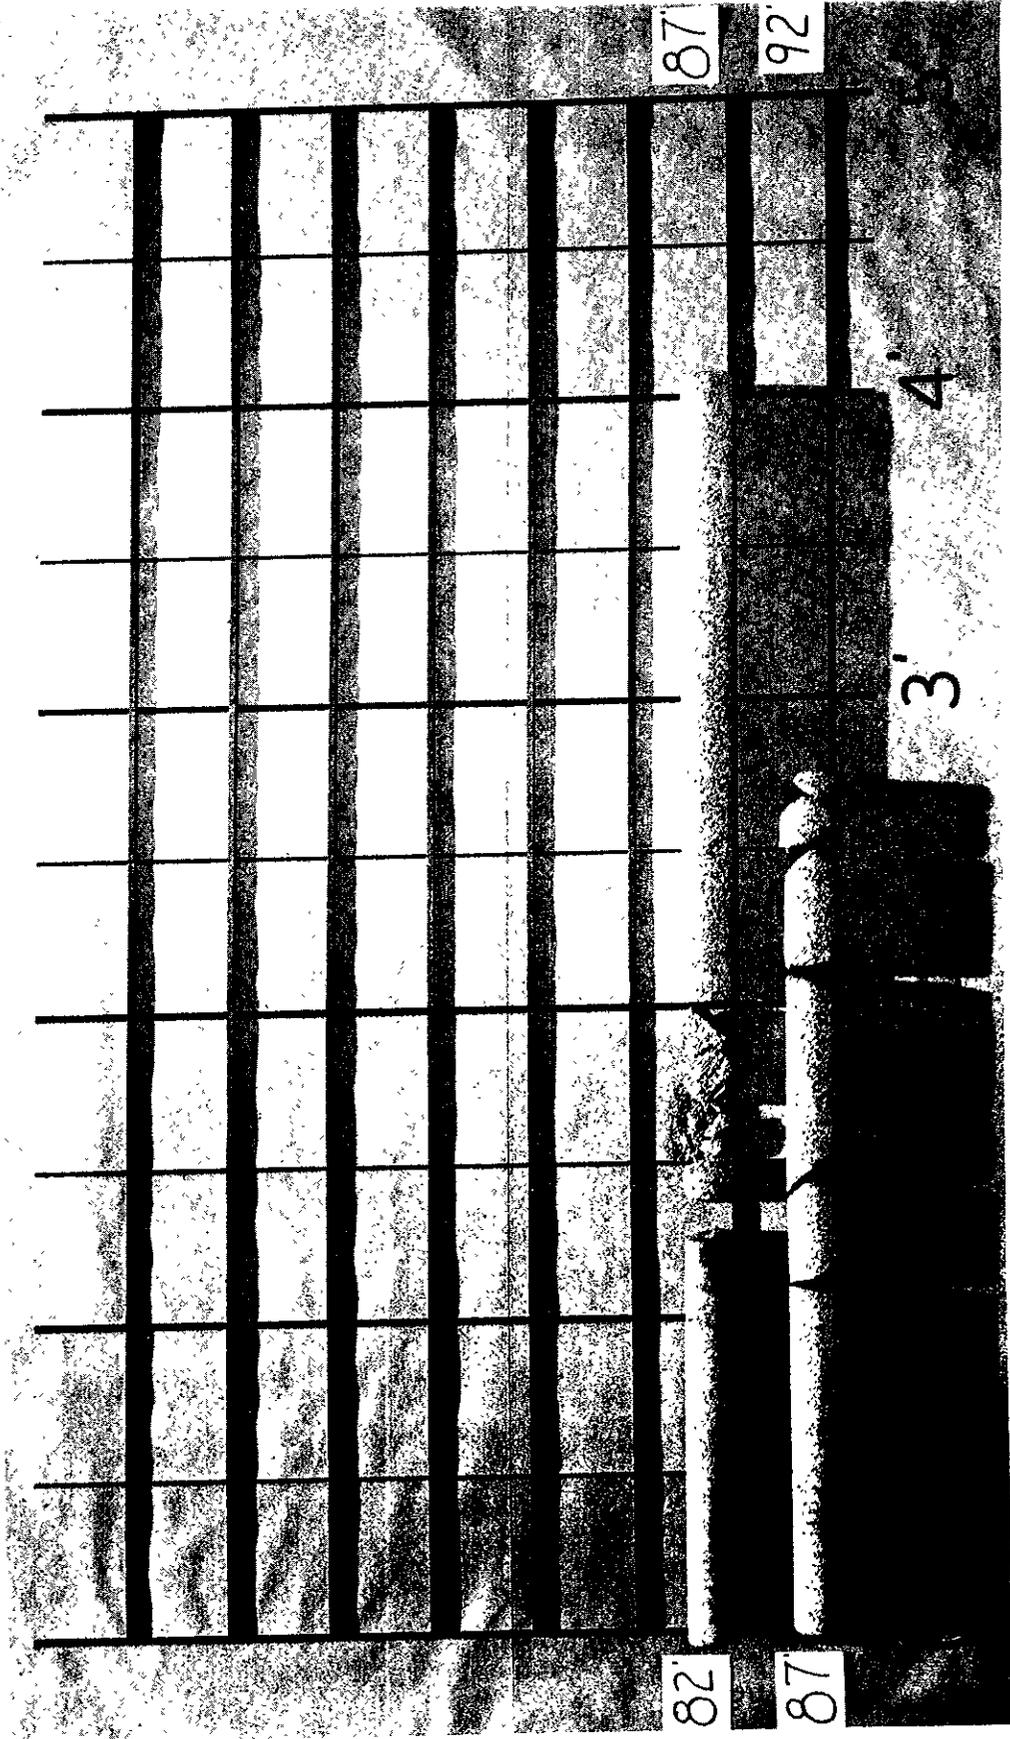
R-13 Horizontal boring, +12% grade, 400' above roadway, depth 92'.

The first forty and the last twenty feet of this boring was a moderately hard fractured and jointed granite with the intermediate material being badly fractured and moderately decomposed.
