A Preliminary Study of Aluminum As a Culvert Material

Nordlin, Eric F. and R.F. Stratfull

State of California
Highway Transportation Agency
Department of Public Works
Division of Highways

Presented at the 44th Annual Meeting of the Highway Research Board

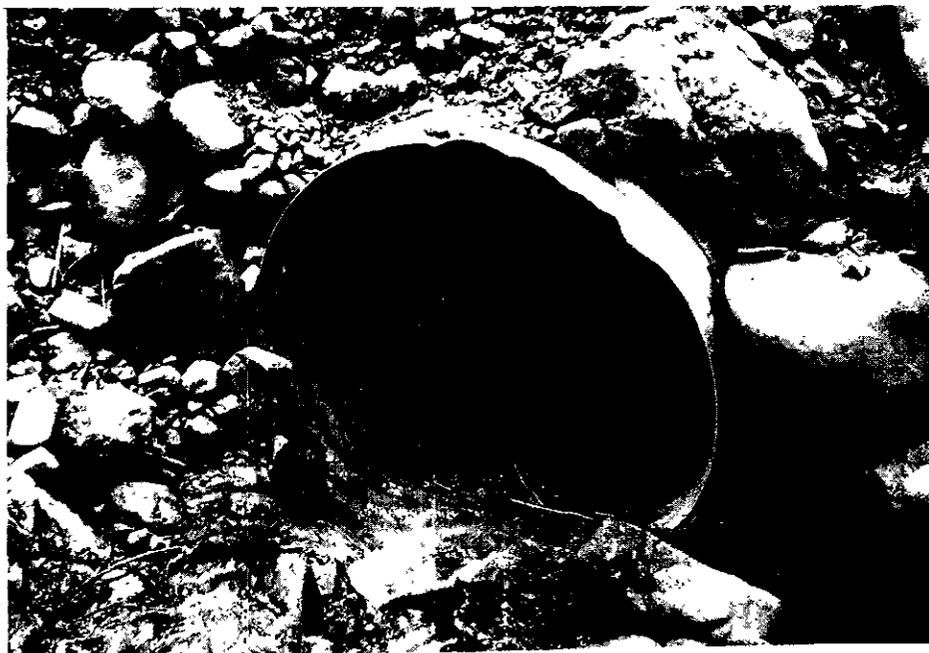
Field Test Site
I-Hum-35-C, Mile 1.19

Inlet of test
pipe - aluminum
section

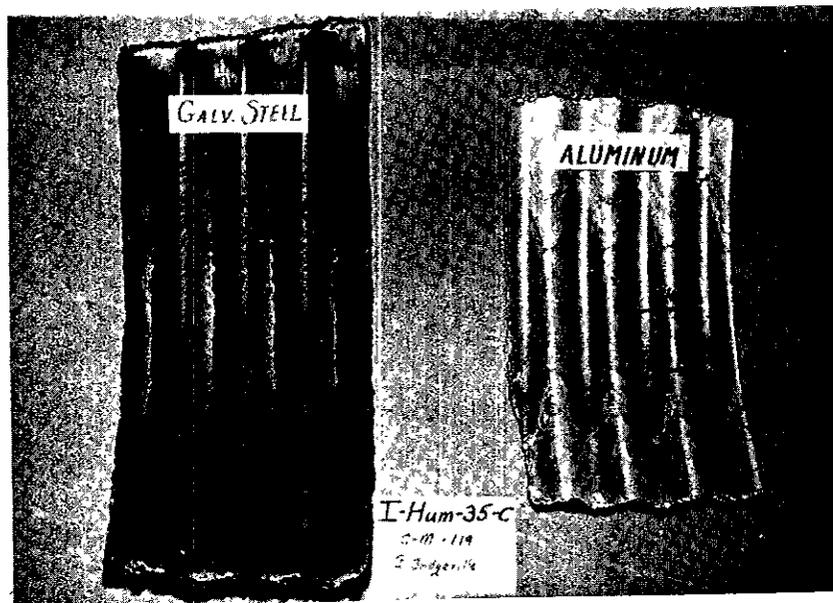
Samples removed
from invert after
2-year exposure

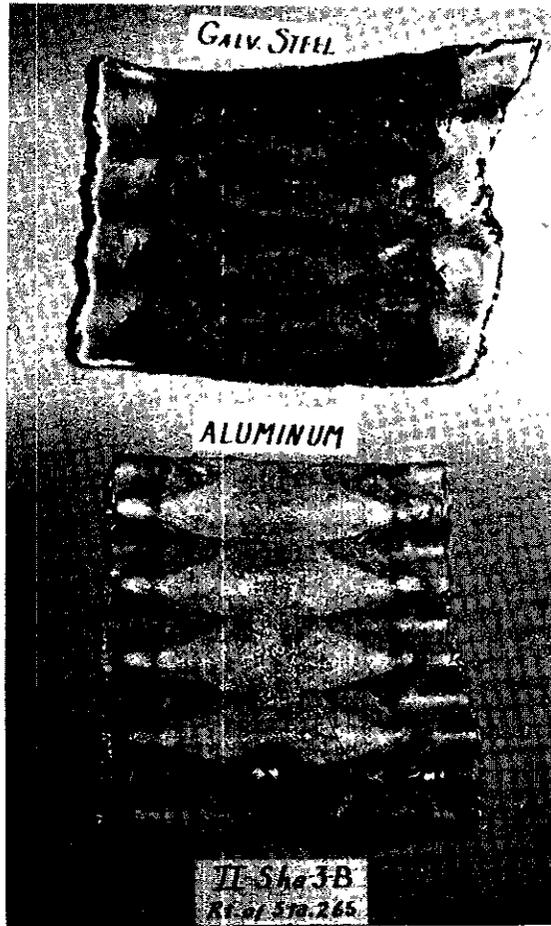
Typical invert samples
removed after approxi-
mately 1.5 years of
test

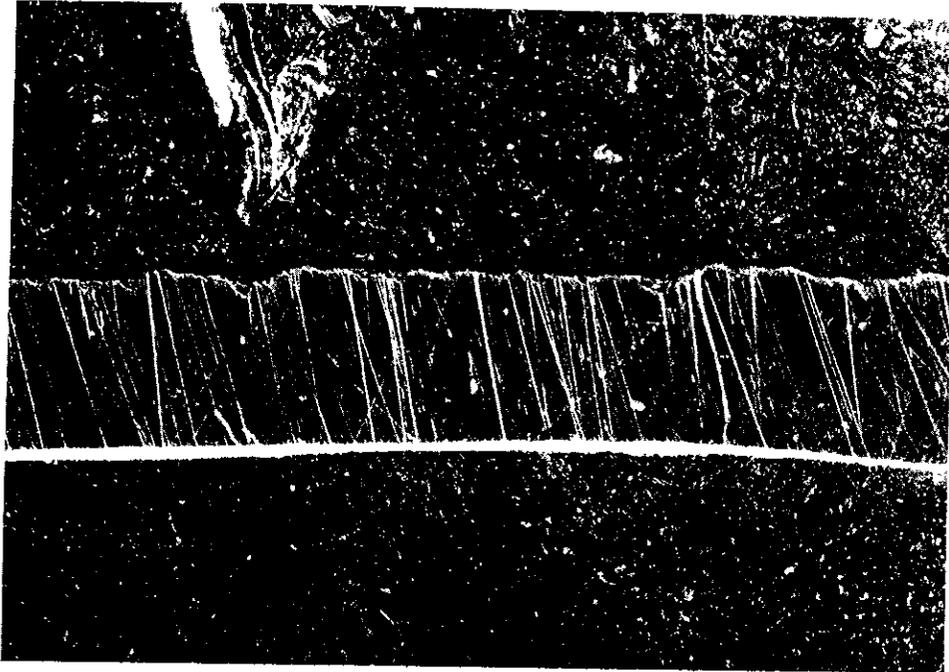
Cross-section of
steel after 1.5
years of test

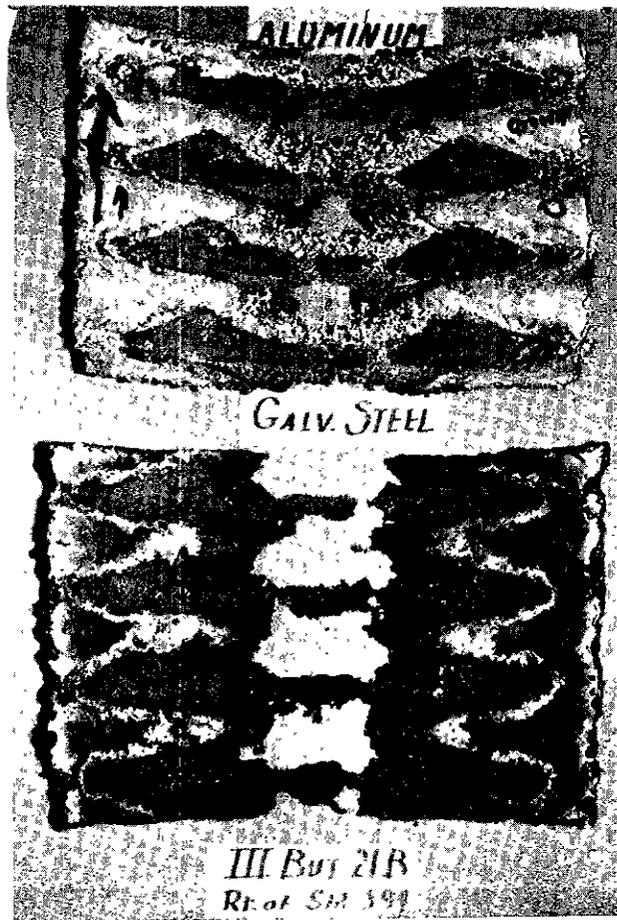
Invert samples removed after approximately 1.7 years of test. (Highly corrosive exposure.)

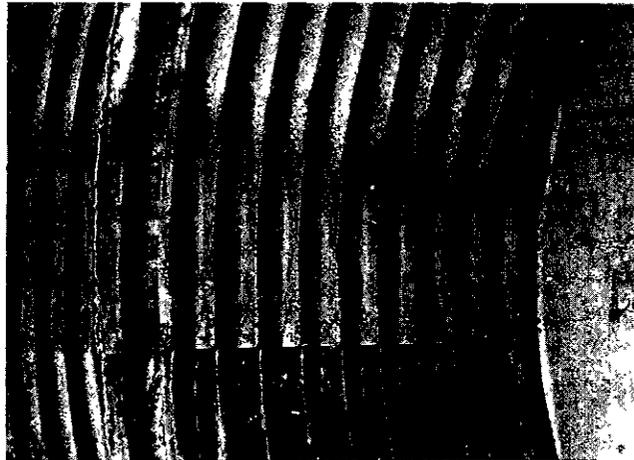
Samples of the invert galvanized steel section. Note wear of rivet heads.

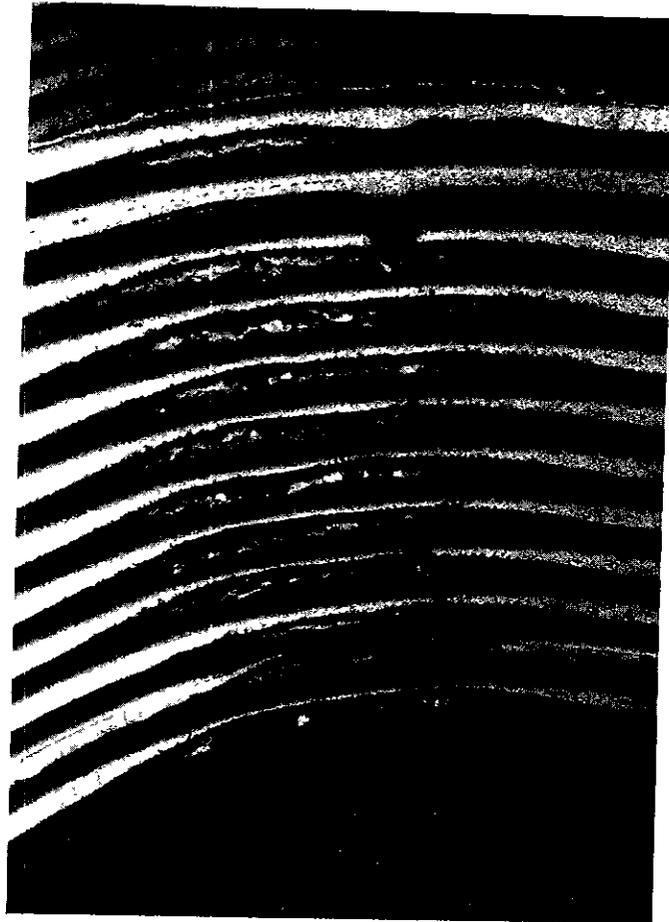
The reader should be aware that the results of erosion are exceedingly difficult to explain and objectively formulate to a mathematical certainty. For instance, the severely damaged test pipe located at IV-SC1-5-C may have had a calculated flow velocity in the range of 25 to 30 feet per second with a bed load of shattered rocks. The minor abrasion damaged culvert near Redding, California (II-Tri-20-A, Sta. 582+73), has a calculated flow velocity in the range of 20 to 25 feet per second, and has a bed load of rounded boulders. Therefore, it is obvious that even though flow velocities are highly important, the size and shape (rounded or shattered) and hardness of the bed material may be of greater consequence in the subsequent degree of abrasion of a culvert.

Severe abrasion of aluminum after 1.4 years of service

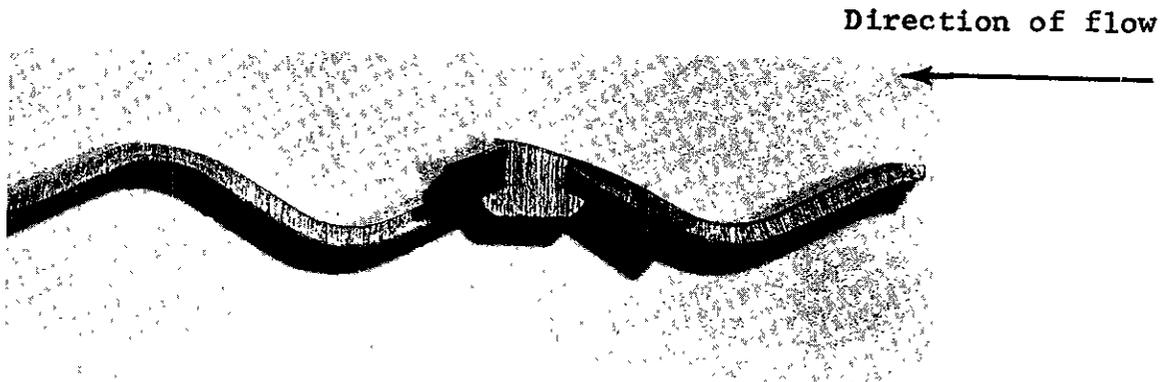
Severe abrasion of galvanized steel after 1.4 years of service. Note loss of head of rivet.

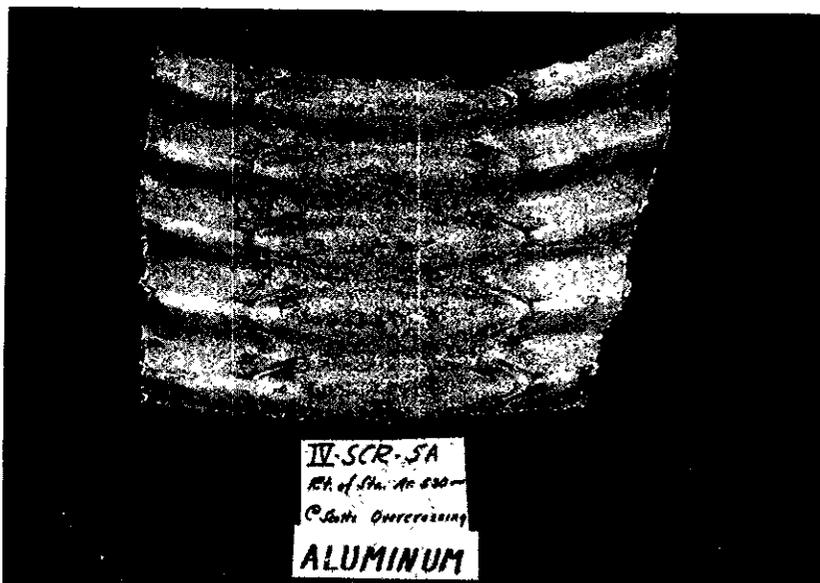
Aluminum invert
sample after
approximately
0.8 years of test.

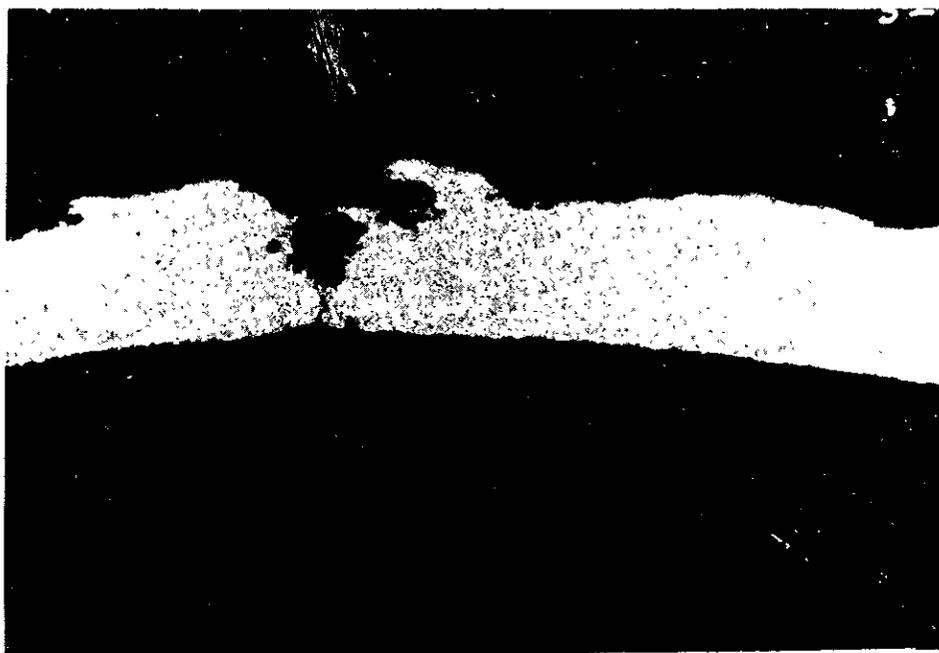
Cross-section of
aluminum. Non-
perforated section.

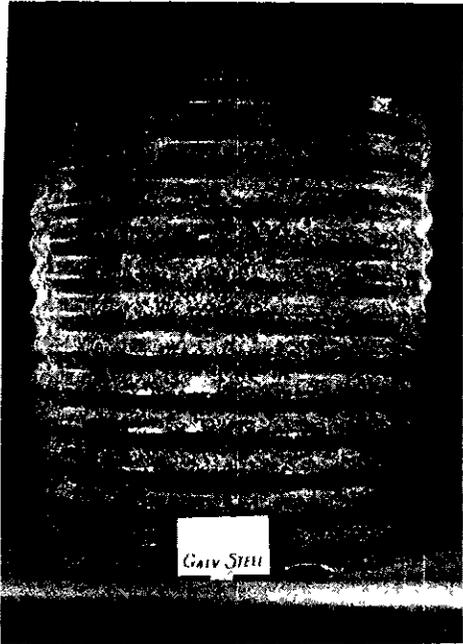
Appearance of cleaned galvanized steel
samples after 2.4 years of test.

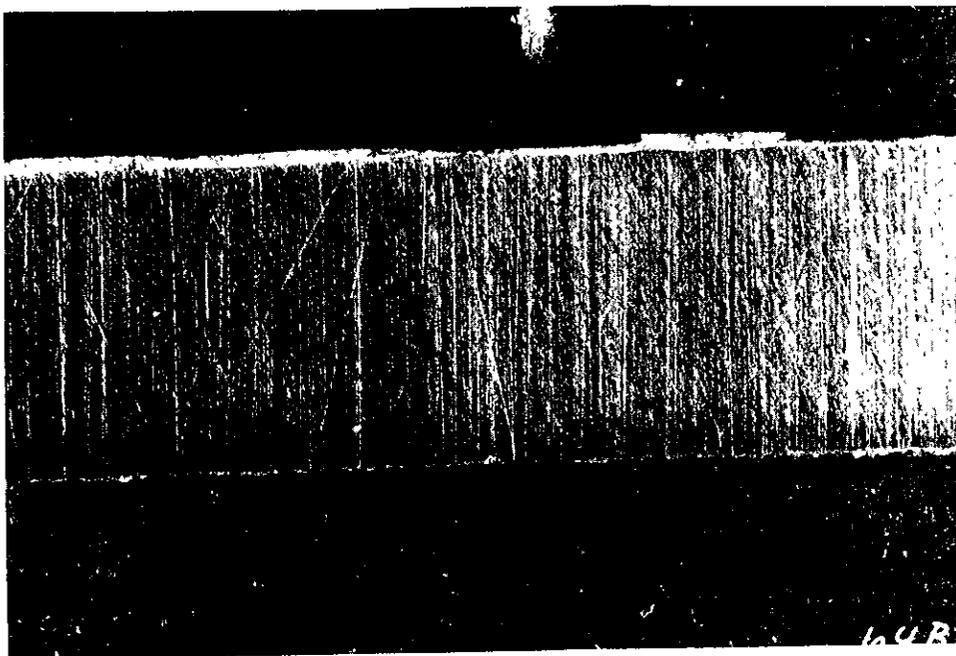
Cross-section of steel.

Note partial loss of galvanizing on both sides.

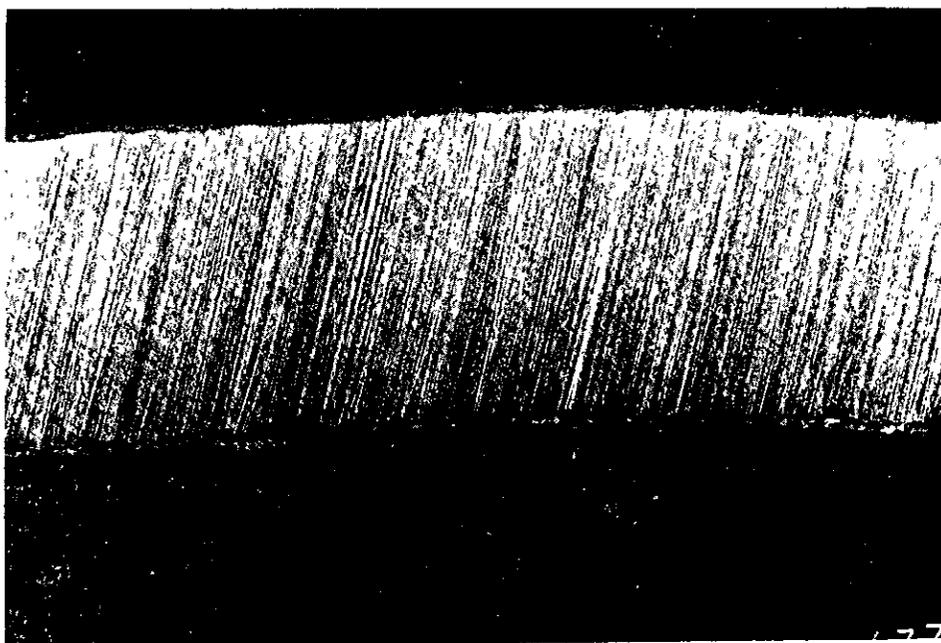
Galvanizing penetrated at localized spots. (Top surface of photo.)

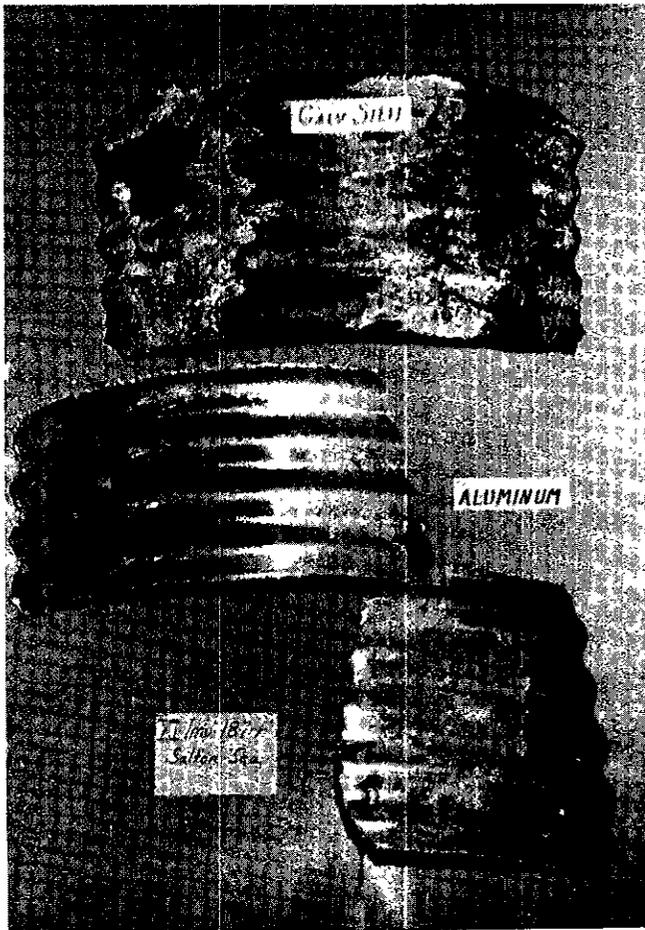
Backfill side of cul-
vert samples. Approxi-
mately 1.7 years of
exposure. Dark areas
on steel and light areas
on aluminum are locations
of corrosion.

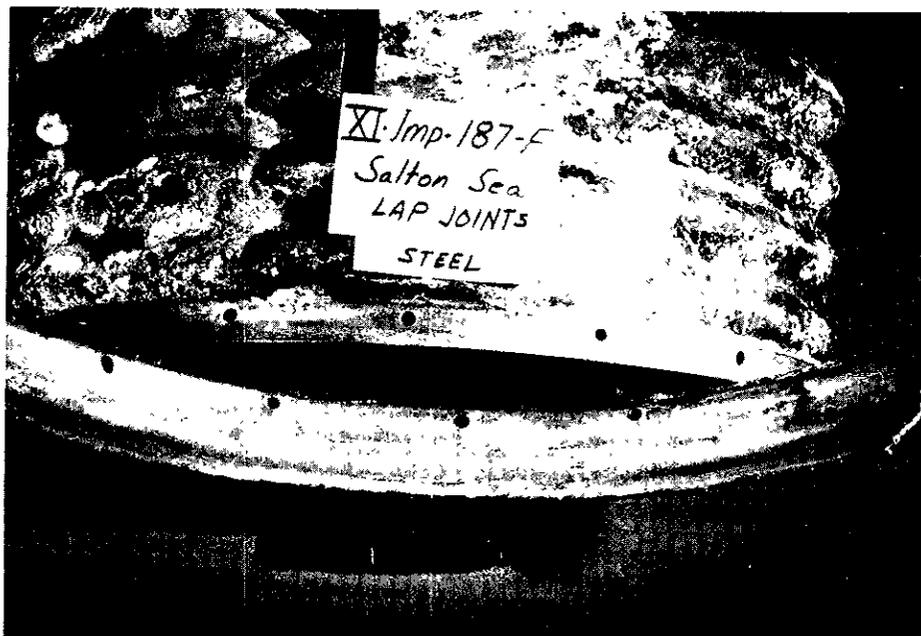
Appearance of galvanized steel joint after cleaning. Dark areas are rust.

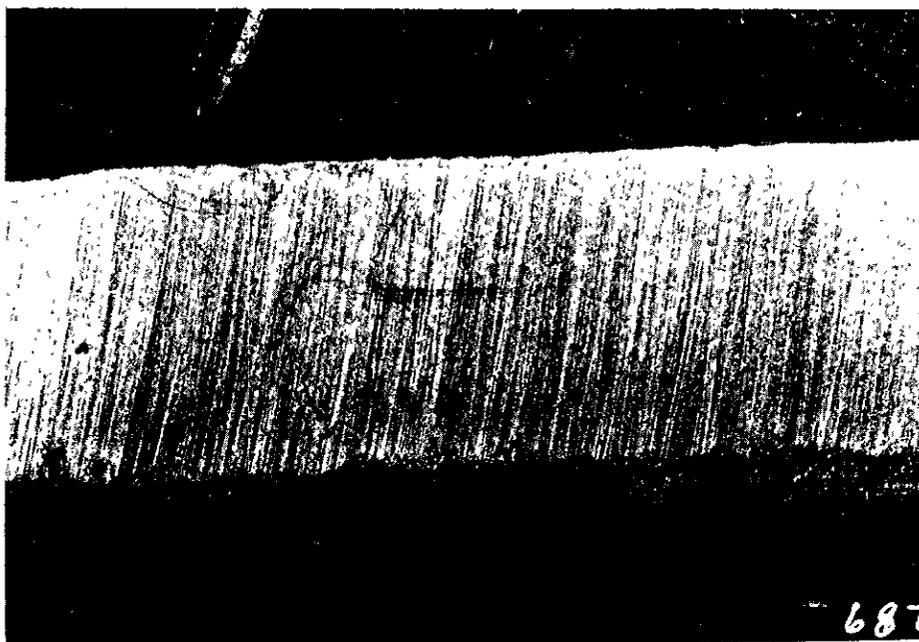
Section through steel. Note loss of galvanizing and penetration at localized areas.

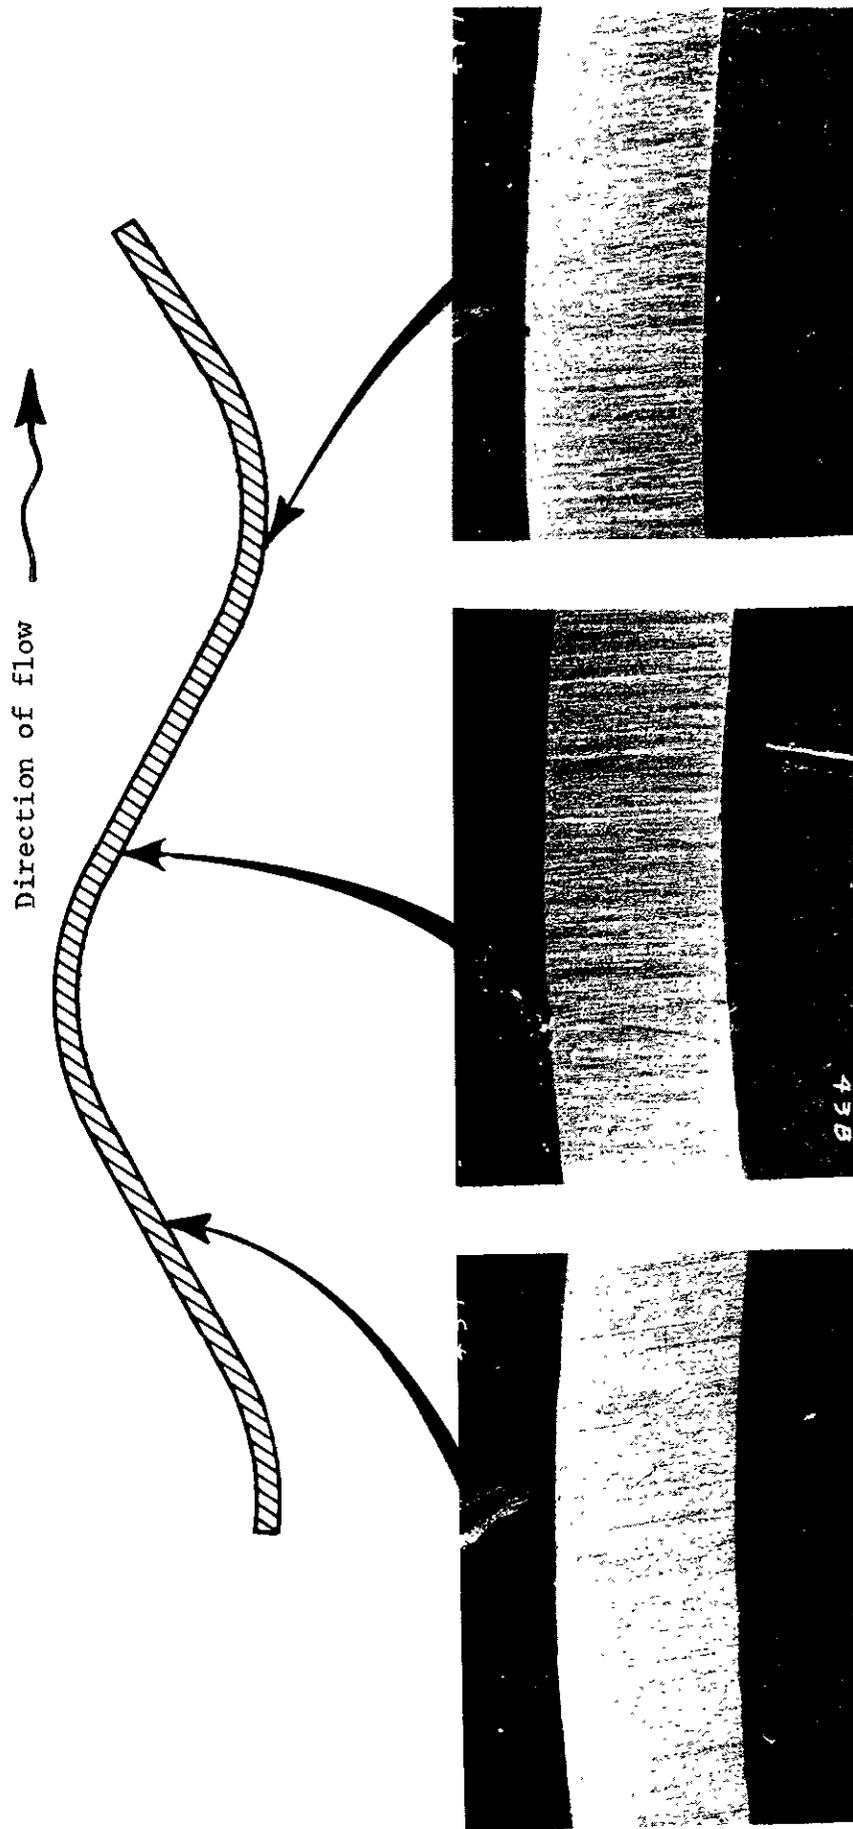
Cross-sections of plain steel test sample after approximately 8 days of testing. Note the minor abrasion loss of metal as shown on the left photo, which was caused by Ottawa sand and a specimen velocity of approximately 5 fps. Note lack of corrosion in this test.

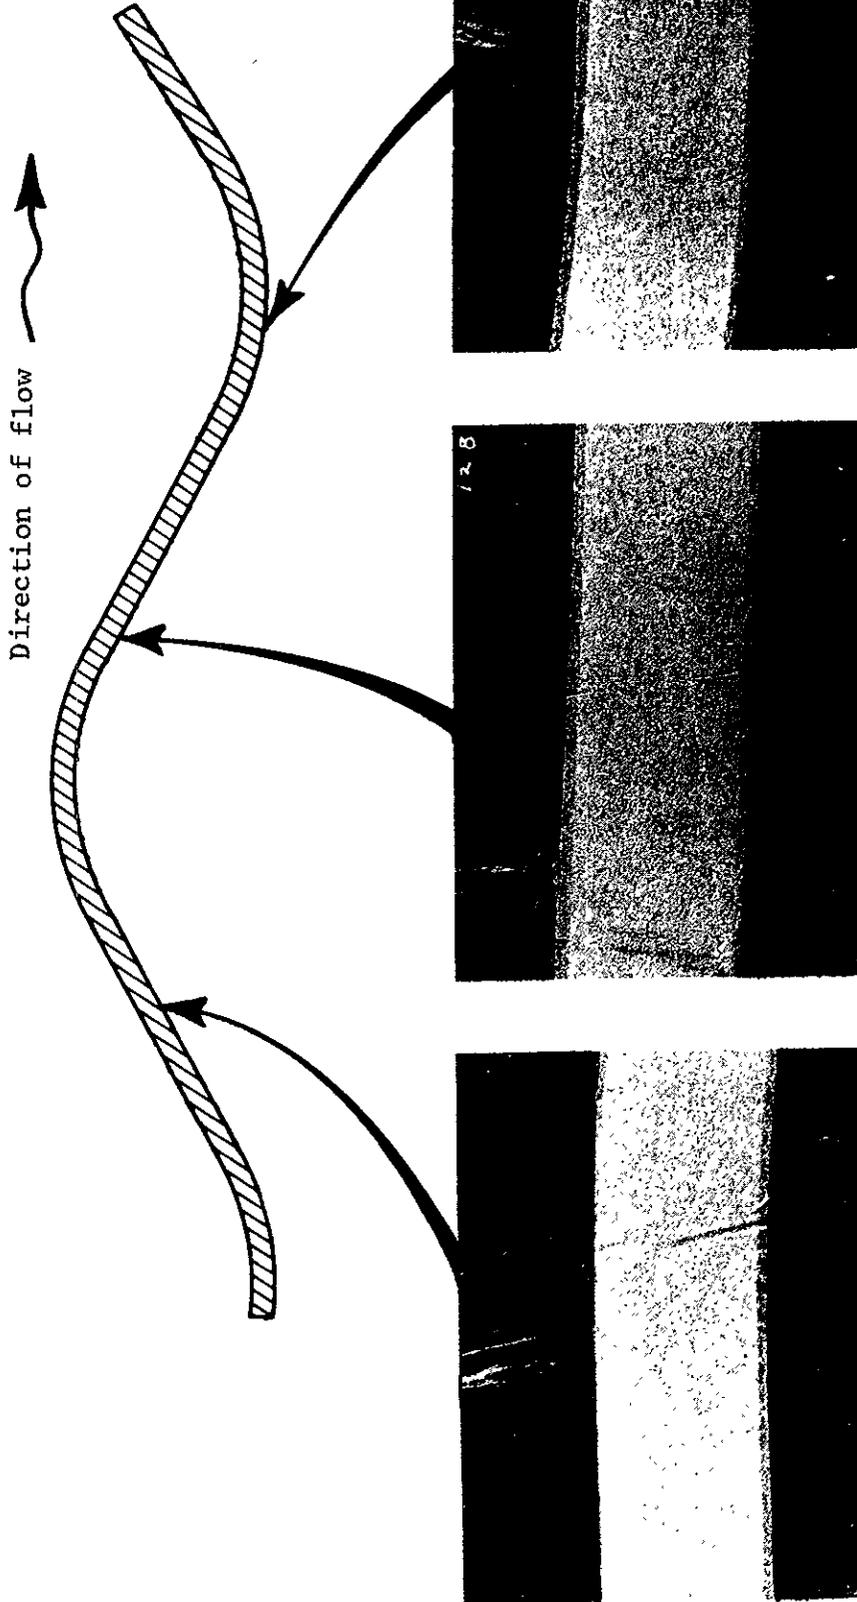
Figure 31

Cross-sections of aluminum test sample after approximately 8 days of testing. Note the typical loss of cladding as shown on the left photo which was caused by Ottawa sand and a specimen velocity of approximately 5 fps. Note lack of corrosion in this test.

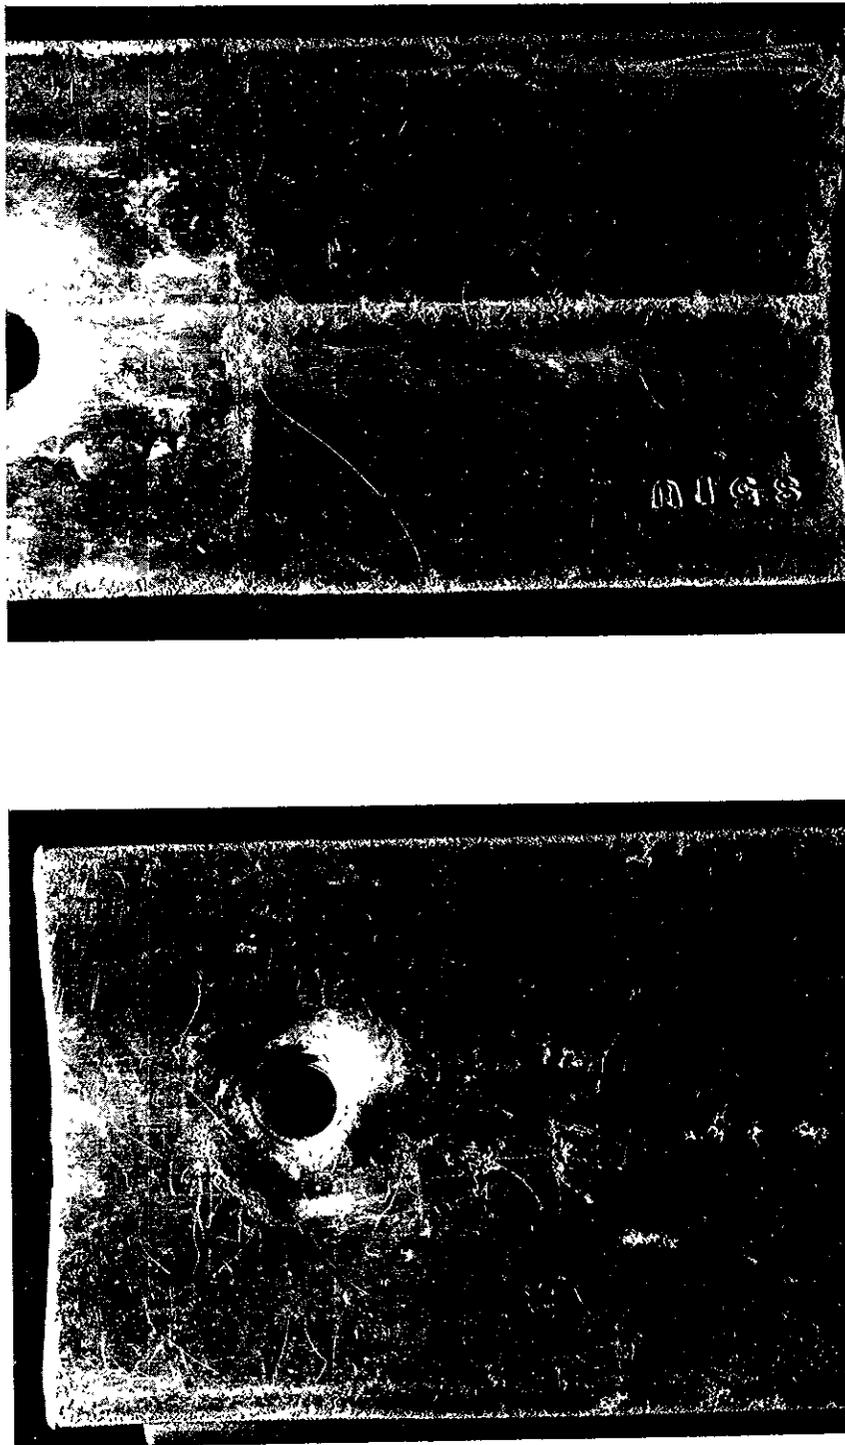
Solution pH = 4.3, resistivity = 1000 ohm cm.

Note corrosion at edges near rivet hole, roll marks and where the two pieces of aluminum over lapped (right photo).

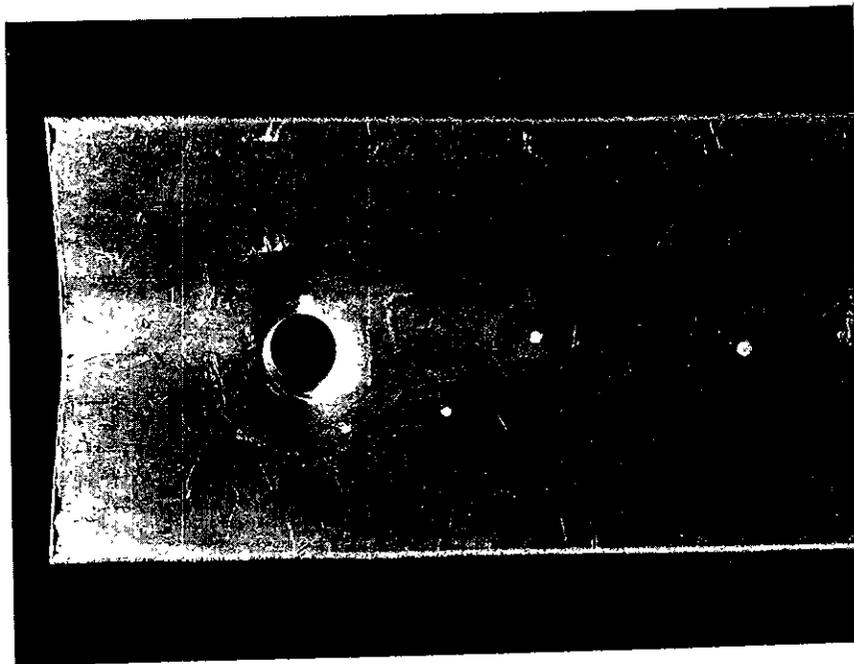
Figure 34

Solution pH 7.5, resistivity = 1000 ohm cm.

Note corrosion at edges near rivet hole and where the two pieces of aluminum overlapped (right photo).

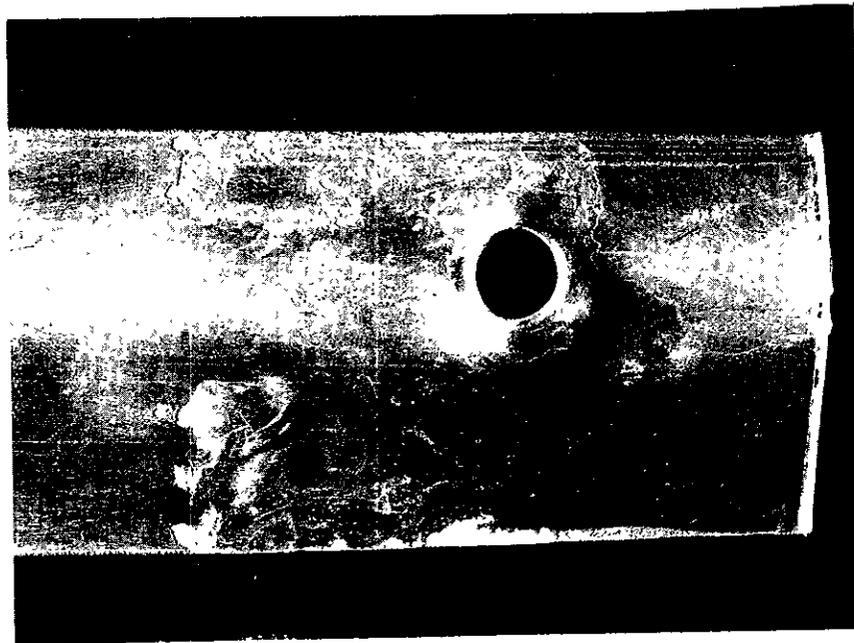
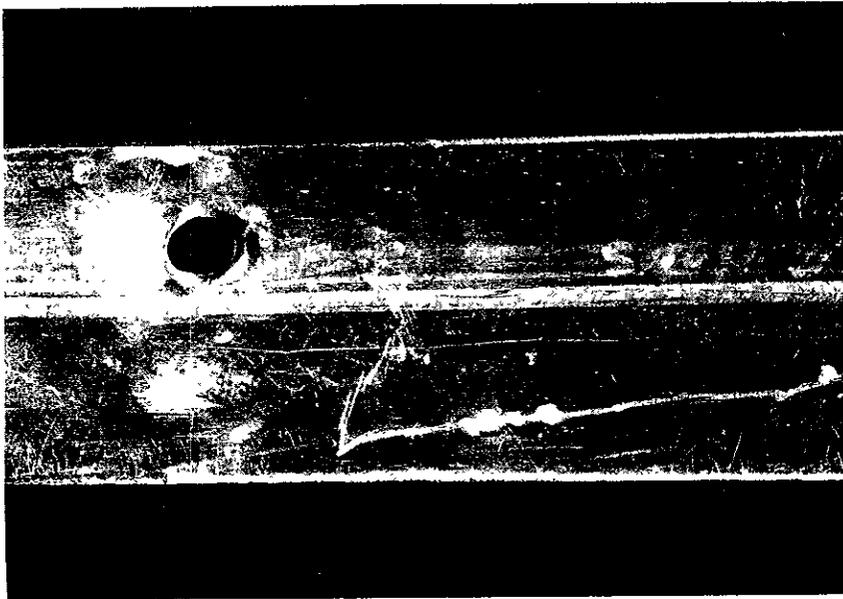
Solution pH 9.0, resistivity = 1000 ohm cm.
Note corrosion at edges near rivet holes where the two pieces of aluminum overlapped (left photo), and corrosion in the long scratch (right photo).
