CA-HY-MR-5116-8-72-41

Corrosion Autopsy Of A Structurally Unsound Bridge Deck

7. AUTHOR(S)

Materials and Research Department
California Division of Highways
Sacramento, CA 95819

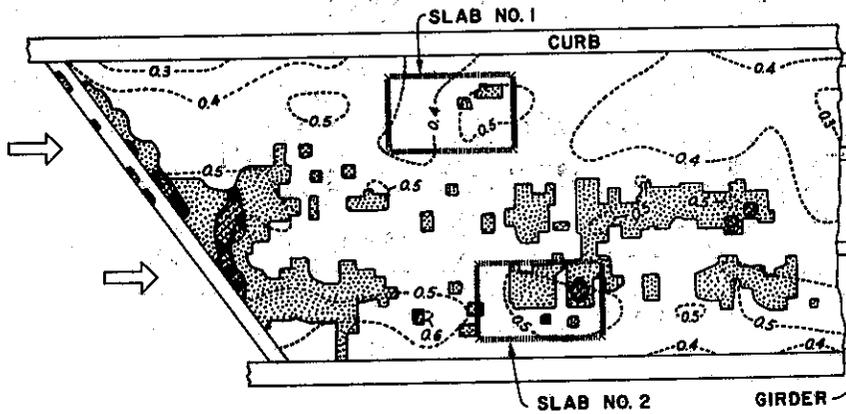
Figure 1. Part of Span 1

Figures 1 and 2, show that the high potential measurements on nearly the whole deck surface indicated a massive area of active corrosion of the steel. Although not shown on Figures 1 and 2, visual observations of the steel during the concrete removal show significant areas of rusting steel even though the concrete in these areas showed no indication of spalling or delamination.

For the entire bridge deck about 94% of all of the halfcell potentials of the steel were in the active or corroding range. In contrast, approximately 20% of the deck area was found to be delaminated or to have undersurface concrete fractures at the top layer of the steel.

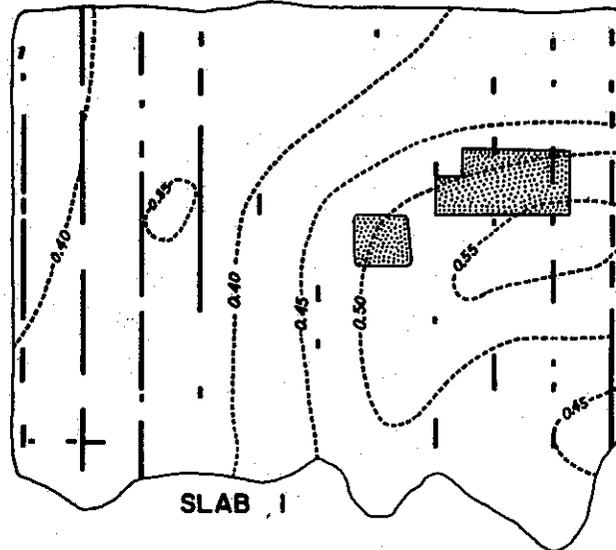
Figure 3. Slab showing little delamination.

Figure 3, shows the electrical potentials and concrete delamination that was measured on the relatively good slab. All of the halfcell potentials are in the active range of -0.35 to -0.55 volts and denote the likelihood of significant corrosion of the steel. On Figures 3, 4, and 5 the locations of steel that had visible rust was plotted as solid lines. If the top mat of reinforcing had no rust, it was not shown.

Shown on Figure 3 is an undersurface delamination that apparently is in a location of unrusted steel. Because this area of concrete still had the epoxy-aggregate membrane on the surface, it is believed that the hollow sound that caused a recording of a concrete delamination might have been the result of disbonding between the epoxy membrane and the underlying concrete surface.

As shown by Figures 3, 4, and 5, the relationship between rusted steel and concrete delaminations can be poor. This is not to say that the corroding steel does not cause delaminations, but

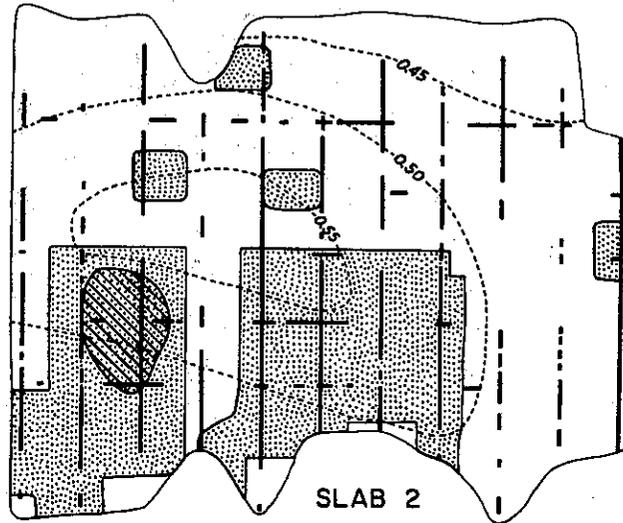
Figure 4. Slab showing severe cracking of soffit and epoxy patches.

it does indicate that the amount of rust that forms on steel causing a spall can be highly variable. It is obvious that the sounding of concrete only relates to the condition of the concrete and not necessarily to the condition of the steel.

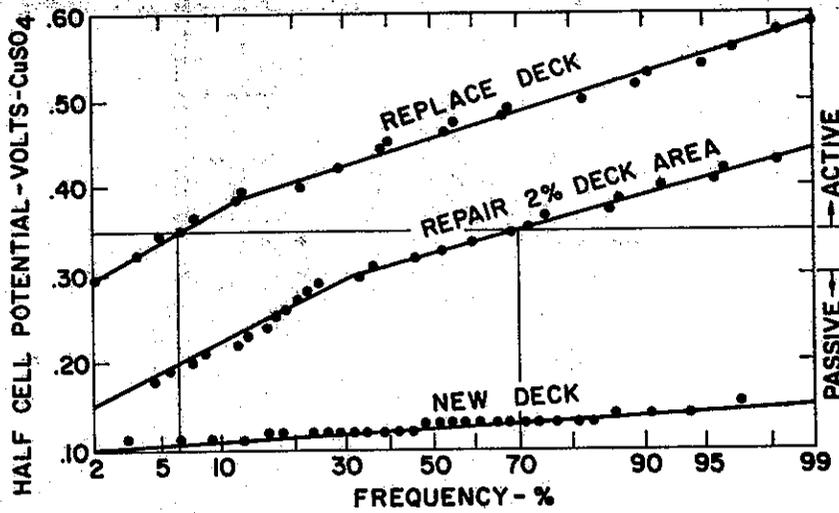
Figure 6. Distribution of halfcell potentials.

To relate the halfcell potential measurements to the observed condition of the bridge, Figure 6, shows the cumulative frequency distribution on three bridges. The distribution curve "Replace Deck" is for the bridge under investigation, while the distribution curve for another bridge is titled "Repair 2% Deck Area". For the bridge deck that required replacement, about 94% of all of the potential measurements made showed that the steel was active (more negative than -0.35 volts, $\text{Cu} \cdot \text{CuSO}_4$) or corroding. For the deck that was repaired, only 30% of the measurements showed active halfcell potentials, and the new deck had no measured active potentials.

The data shown on Figure 6 may reflect a means for "logging" the condition of a bridge according to the percentage of active or passive potentials. However the distribution curve can have a "break", therefore one must exercise caution in mathematically calculating a mean or standard deviation for the halfcell potentials.
