Fiberglass Roving for Erosion Control
Ponderosa Road and Highway 50 Interchange

HIGHWAY STUDY REPORT

FINAL REPORT

TRANSPORTATION LABORATORY
RESEARCH REPORT
CA-DOT-TL-7158-1-74-19
19-954130

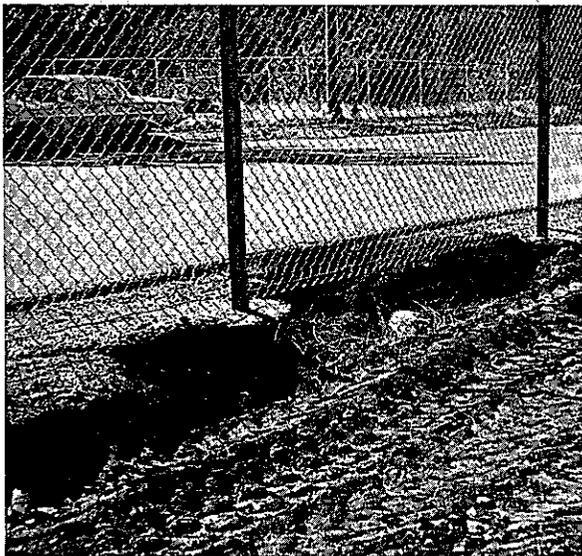
Erosion at this location has been a problem since construction of the road. Plate 2 illustrates the safety hazard caused by erosion undermining the frontage road at Location 1. Plates 3 and 4 illustrate the severe and hazardous erosion adjacent to an on-ramp at Location 2. Plate 5 indicates the deterioration of an A.C. lined ditch at Location 3. Plates 6 and 7 illustrate moderate

Plate 2
Frontage Road Undermined
by Erosion at Location 1

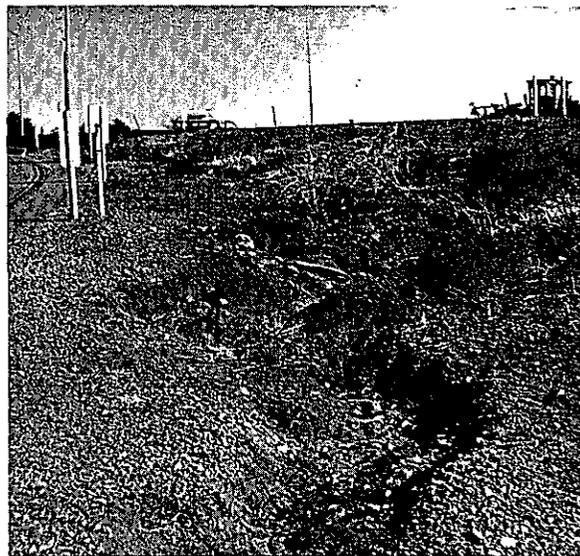
Plate 3
Hazardous Condition
at Location 2

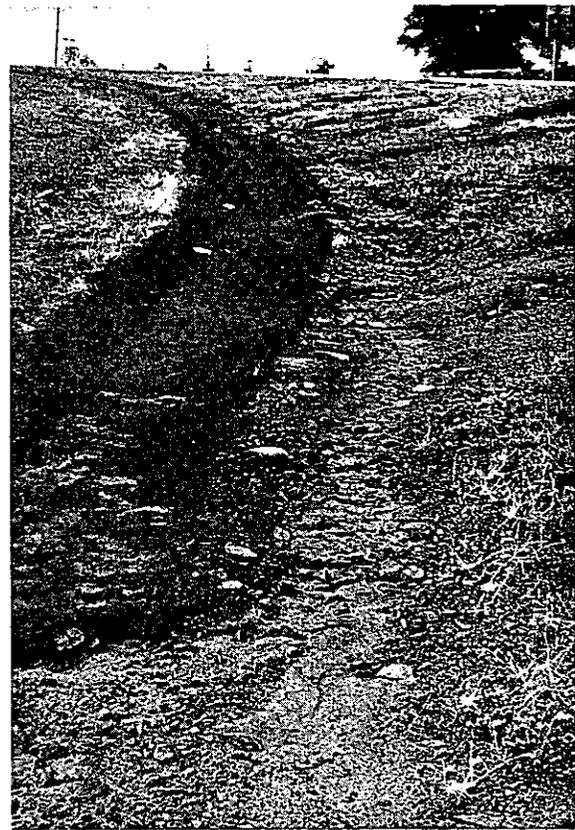
Plate 7
Moderate Erosion
At Location 4

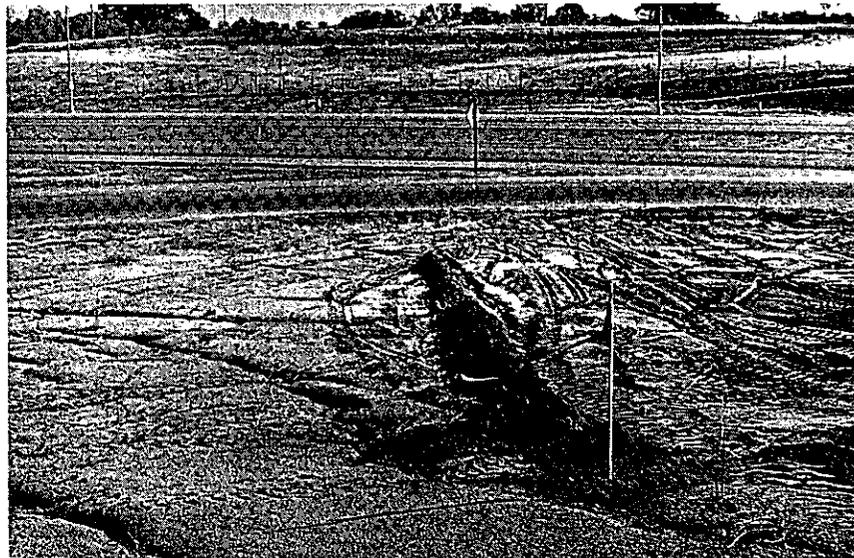
Plate 8
Severe Erosion at Location 5

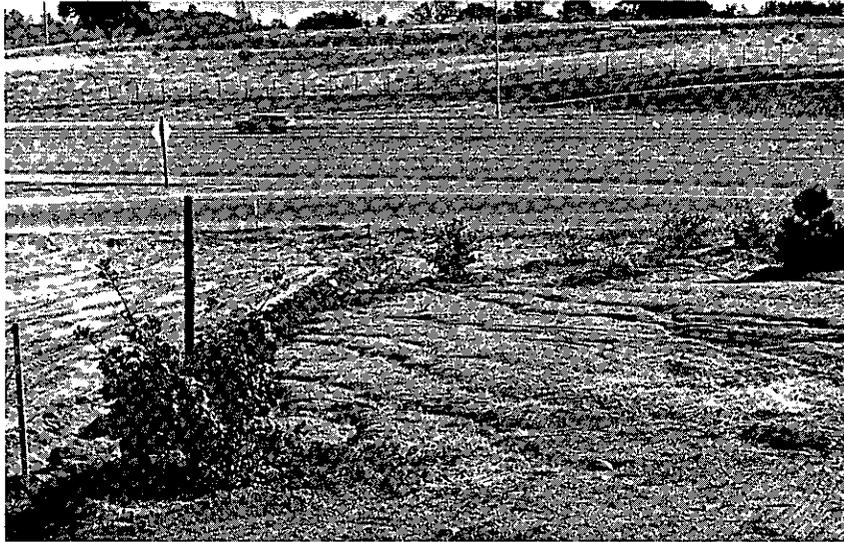
Plate 9
Severe Erosion at Location 5

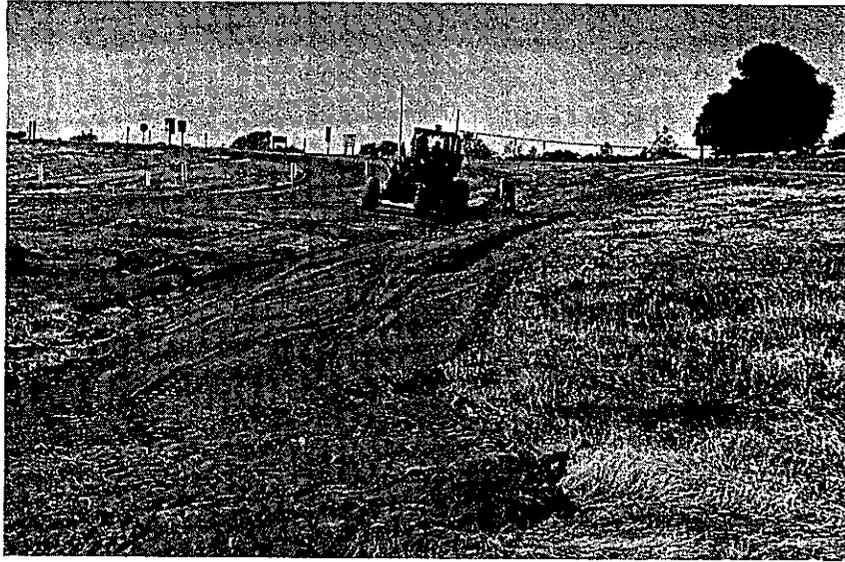
Plate 10
Regrading Ditch at Location 4

Preparatory work at Locations 1, 2, 3 and 4 consisted of regrading the eroded ditches and reshaping the ditch into flat bottomed sections with flat slopes. (See typical sections on page 10) A rectangular section of slope at Location 5 was regraded to a smooth section. One-half foot deep lateral trenches were constructed at Locations 3, 4 and 5 to allow for burial of the fiberglass mat to eliminate undermining by lateral inflow. A one-foot deep trench was cut along the upgrade end at all five locations to allow for burial of the mat and to prevent undermining.

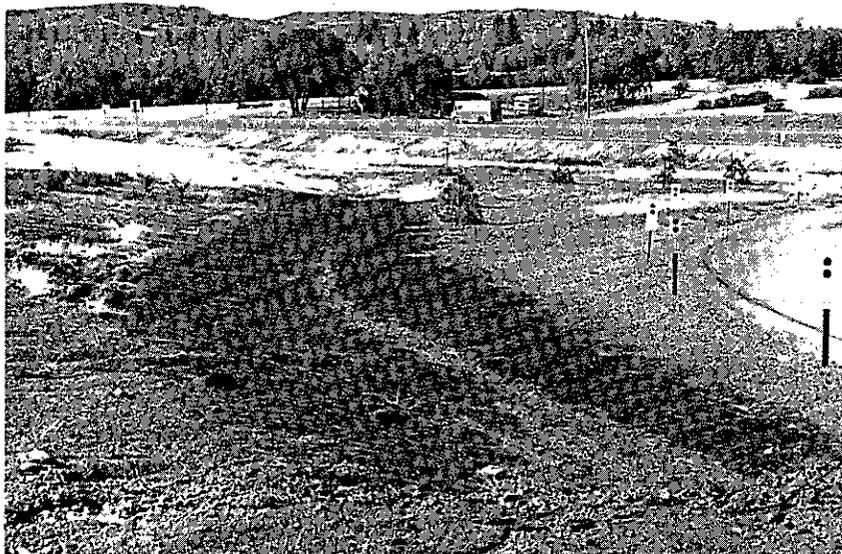
There was considerable lateral inflow at Location 2 as illustrated by Plates 17 and 18. However, the sides of the treated area were not undermined in spite of the omission of lateral trenches. This indicates that the use of lateral trenches to bury the sides of the mat is not necessary for conditions experienced during the test period.

Plate 17
Lateral Inflow at Location 2

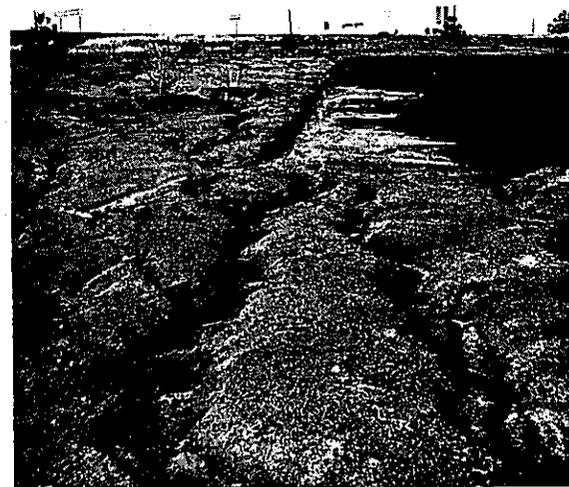
Plates 19 and 20 illustrate the progressive severity of the erosion along the sides of the mat at Location 5. This concentrated

Plate 20
Progressive Erosion at Untreated Adjacent Areas

erosion was caused by the lateral trenches which were constructed to bury the sides of the mat and indicates that installing the trenches may have created an adverse effect.

In the preparation of sites prior to the application of fiberglass roving, it is recommended that lateral trenches for the burial of the sides of the mat should not be constructed. However, the upper and lower end of the mat should be buried in a one-foot deep trench to prevent undermining at these locations. It is recommended that asphalt be applied at a rate of 0.25 to 0.35 gals./square yard.

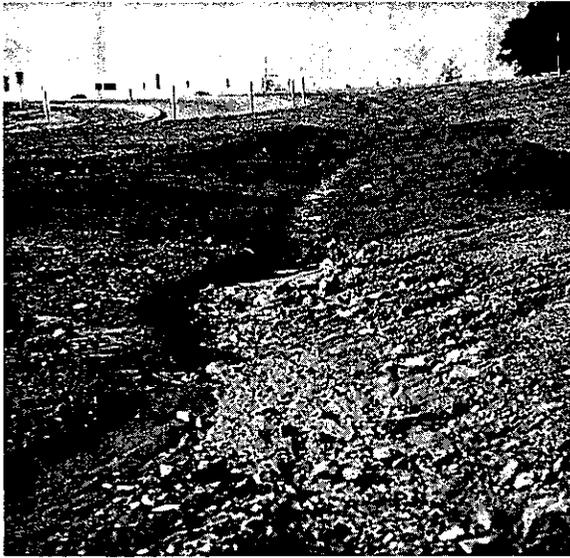
There were a few small spots at Locations 3, 4 and 5 where over-application of asphalt sealed the mat and appeared to hinder vegetal growth. However, most of the grasses managed to emerge through the asphalt. The rather poor grass growth at the south half of Location 4 (see Plates 21 and 22) was possibly due to a lack of or low application of fertilizer.

Lower Rate of Grass
Growth at Location 4
