FHWA-CA-TL-78-4

Control of Slope Erosion Using Fiberglass Roving with Vegetation

October 1978

Office of Transportation Laboratory
California Department of Transportation
Sacramento, California 95819

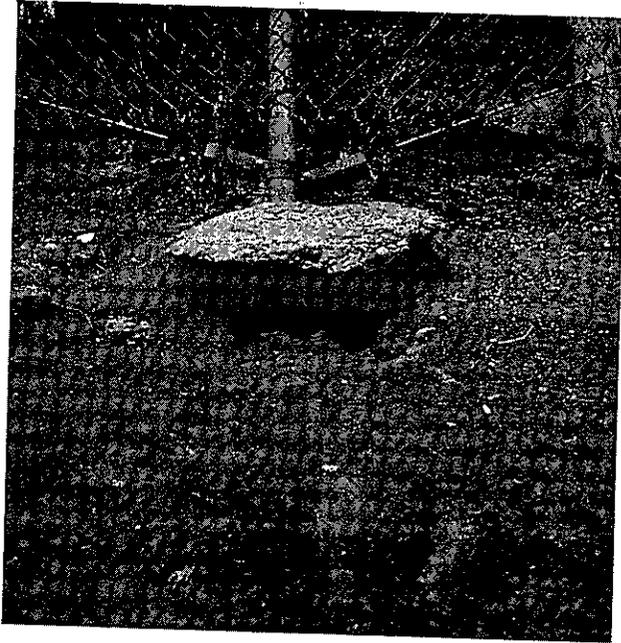
The first slope treated under this research project is located on Route 50 near Camino in El Dorado County (03-ED-50, PM 23.8) about 6 miles east of Placerville. The soil at this location consists of a red silty clay. The slope faces south and was constructed in 1963 on a 2:1 angle. The site is situated about 3,000 feet above mean sea level (MSL) in the foothills of the Sierra Nevada Mountains (Figure 3). The climate is typically mediterrean with an average annual rainfall of nearly 45 inches, with occurs mainly during the period from October to May. Sheet erosion on this slope is severe as evidenced by the removal of soil from around the concrete at the base of some fence posts located near the upper portion of the slope (Plate 4).

Plate 4. Erosion at base of fence post (Camino, Route 50).

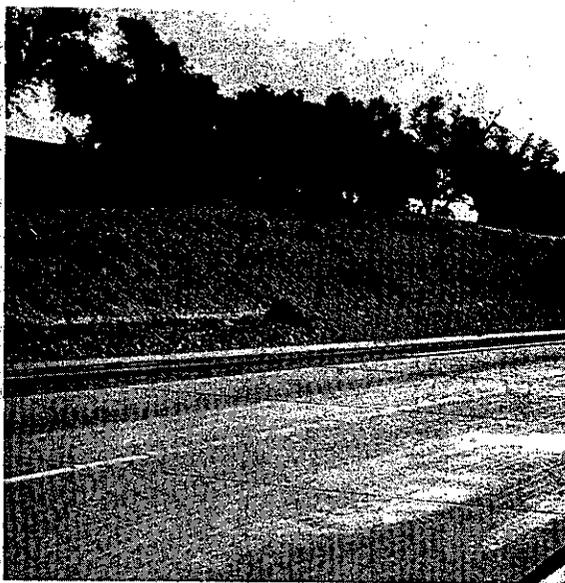
Plate 21 Cut Slope Before Treatment
January 10, 1978

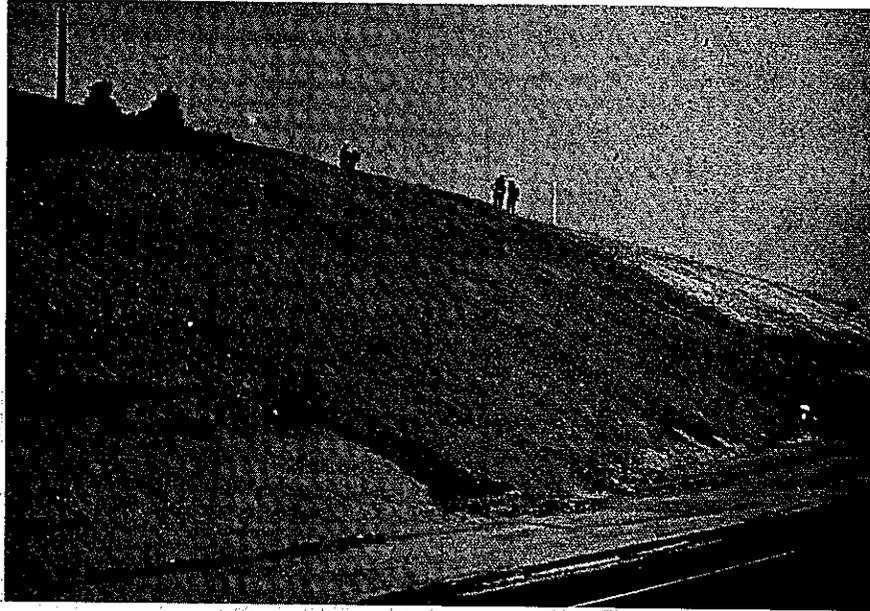
Plate 33 Cut Slope Before Treatment
October 18, 1976.

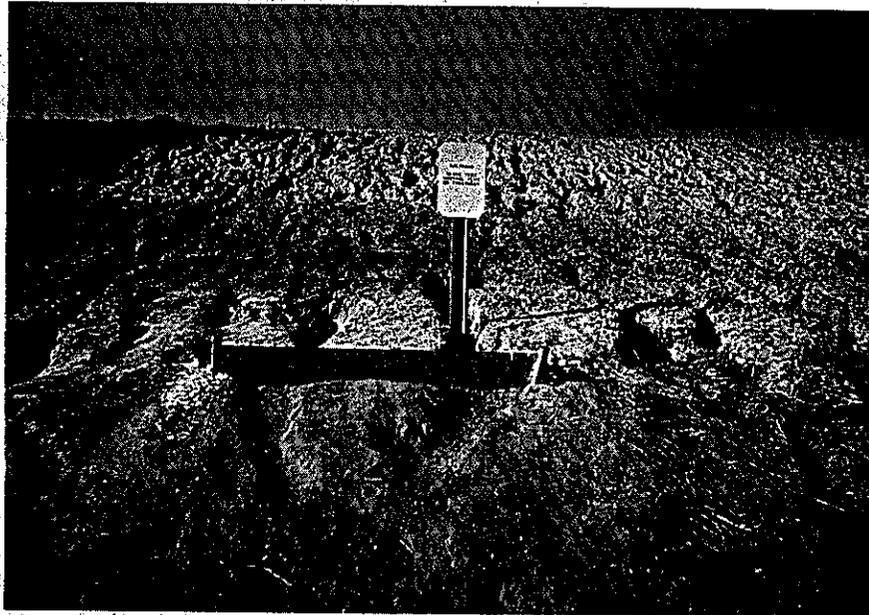
Plate 34 Cut Slope Surface Showing Rills
Before Treatment October 18, 1976

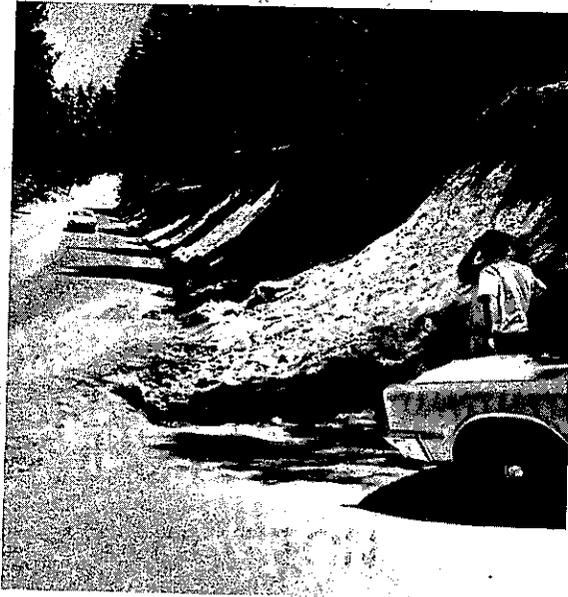
Plate 38 Cut Slope Before Redressing
