Investigation of Corrosion at 14 Mechanically Stabilized Embankment Sites

November 1987

Office of Transportation Laboratory  
California Department of Transportation  
Sacramento, California

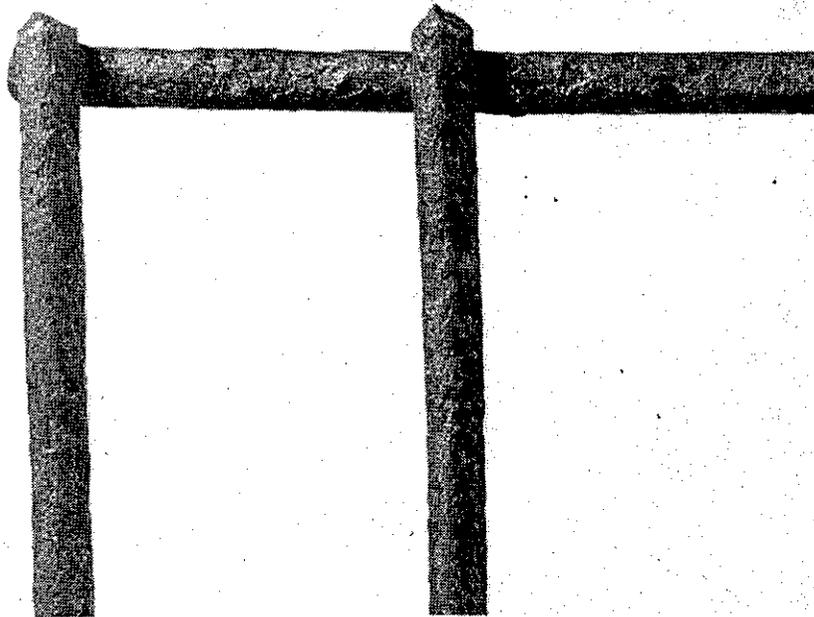
Soil reinforcement sections taken from the same site but from within three feet of the surface corroded in a more or less uniform fashion with corrosion equivalent to 25% of the design value. Backfill surrounding these elements classified as a well-graded clayey gravel.

Photo 4 - Section of bar-mat removed from top of MSE wall near Mariposa, California

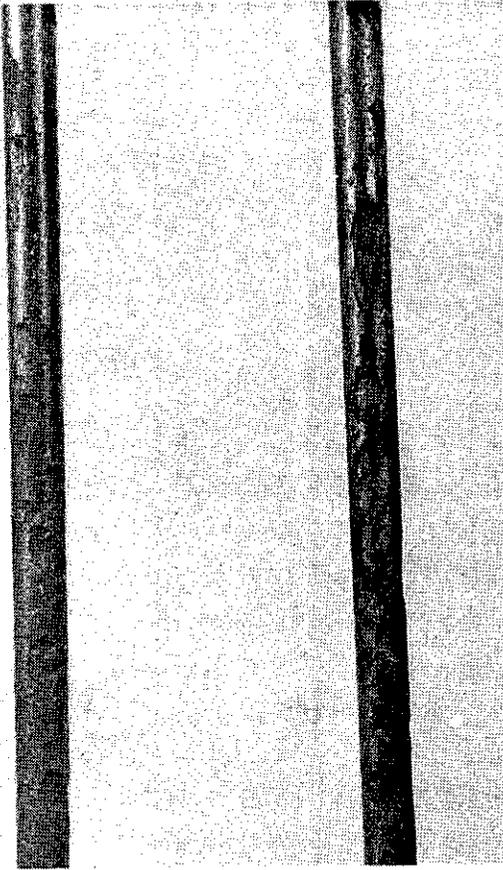
Interestingly, the inspection rods at one of these sites (Baxter) exhibited more corrosion on that portion of the inspection rod located within three feet of the wall face than the corrosion found on the steel farther back. Very little difference in moisture content, soil gradation or salt content was measured at selected locations at this site. Density measurements were not taken of the frontal three feet but it was apparent from material extraction resistances of the backfill that this zone was much looser than the material farther back.

Photo 5 - Photo of two inspection wires removed from the MSE wall near Baxter, California.

Note transition area between corroded lower section and non corroded upper section; age 3 years.

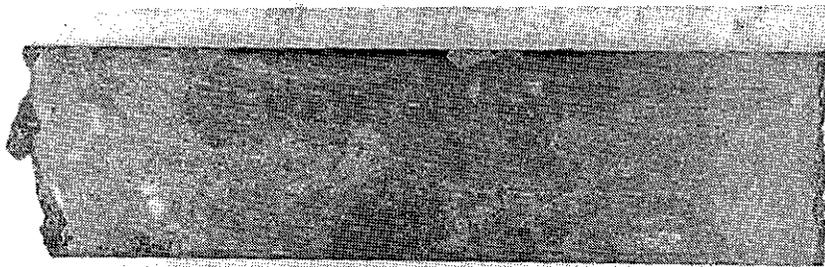
Photo 13 - Reinforcing strap removed near the base of the RE wall in the San Gabriel Mountains on Rt 39 near Los Angeles. Strap is in excellent condition after 13 years.
