FHWA/CA/TL-88/07

Vehicle Impact Testing of Lightweight Lighting Standards

October 1988

Office of Transportation Laboratory  
California Department of Transportation  
Sacramento, California 95819

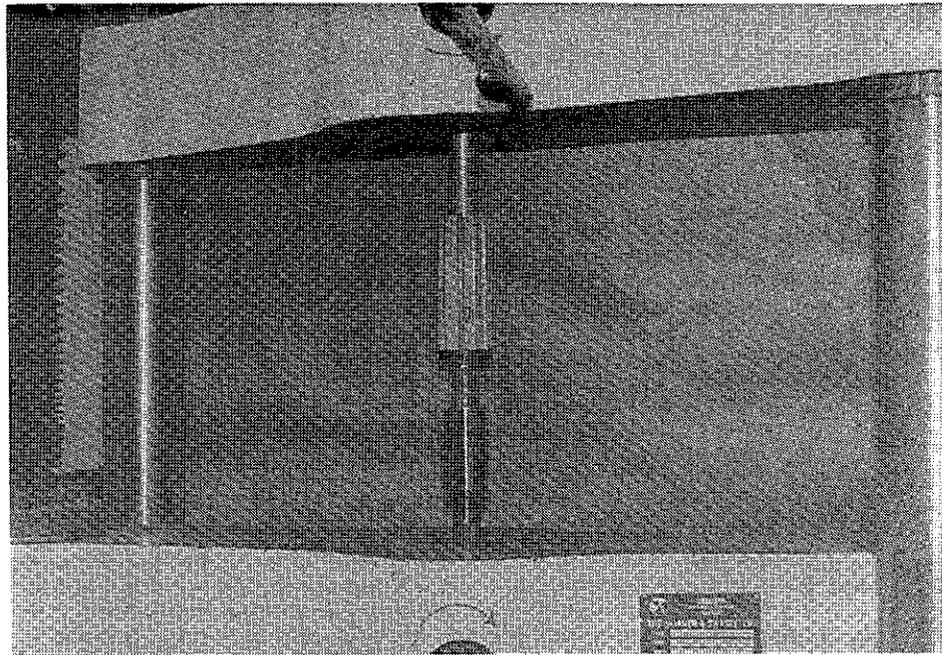
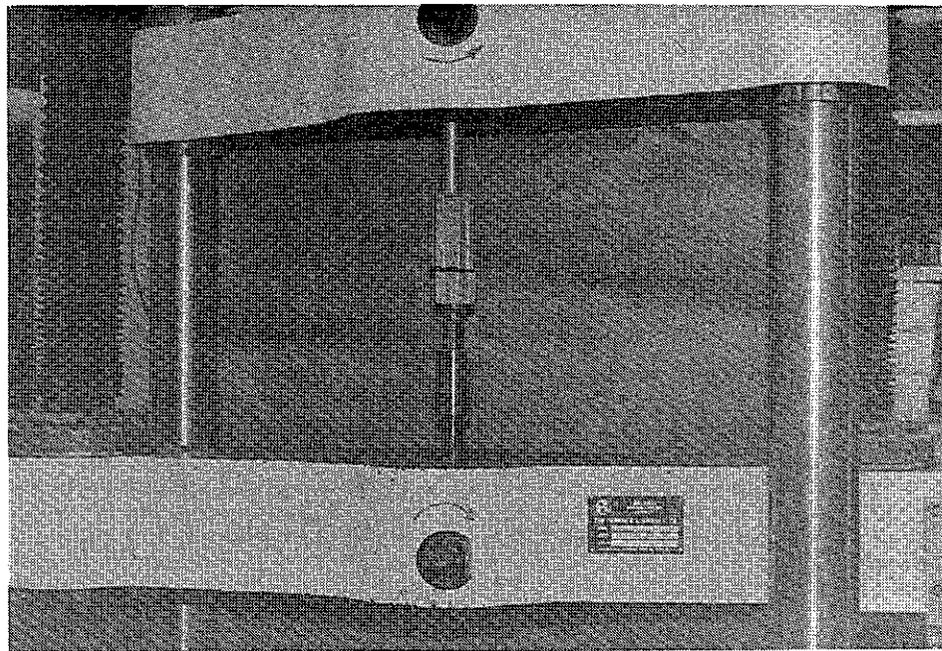
Figure 16. Tensile Test Setup and Typical Failure Mode of Transpo Die-Cast Aluminum Couplings

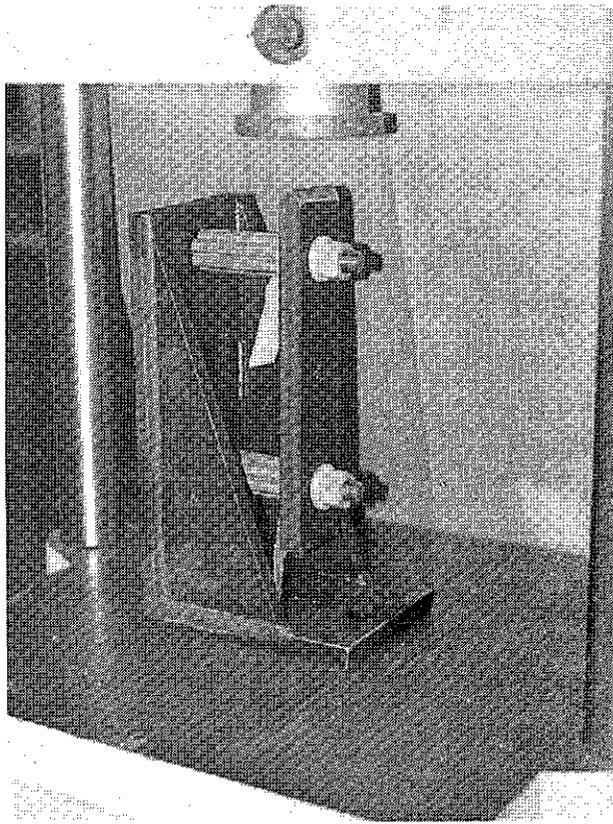
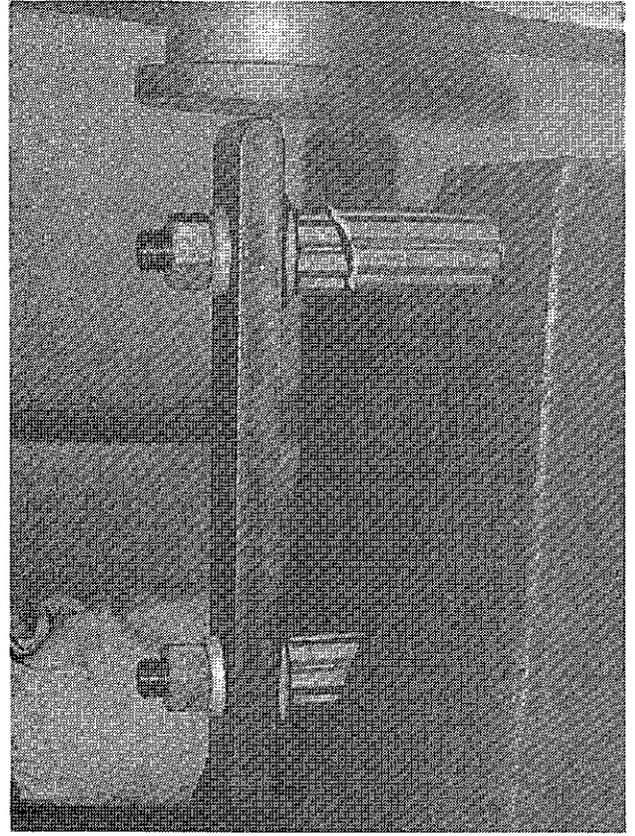
Figure 18. Restrained Shear Test Setup and Typical Failure Mode of Transpo Die-Cast Aluminum Couplings

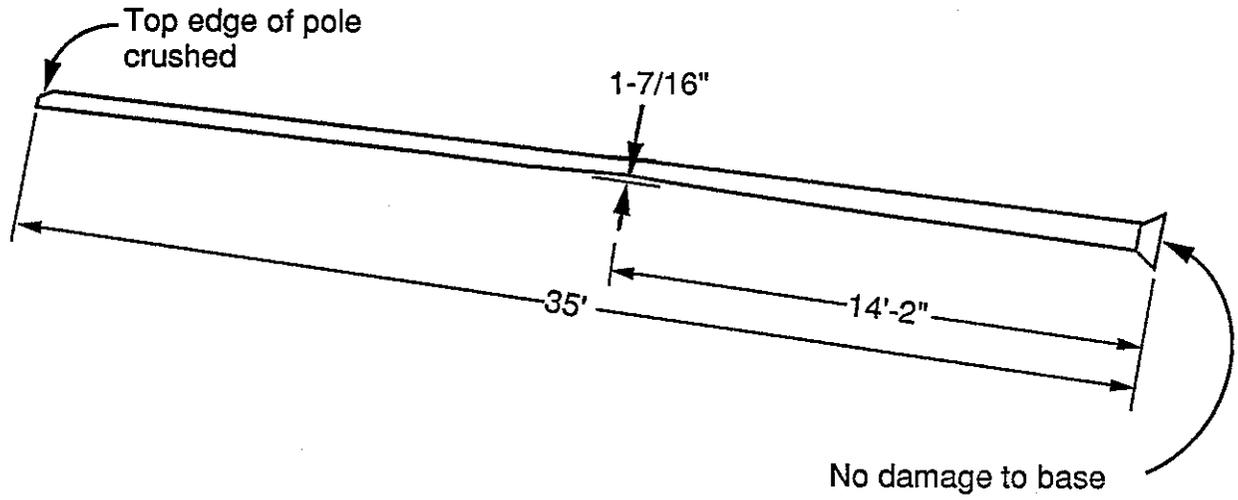
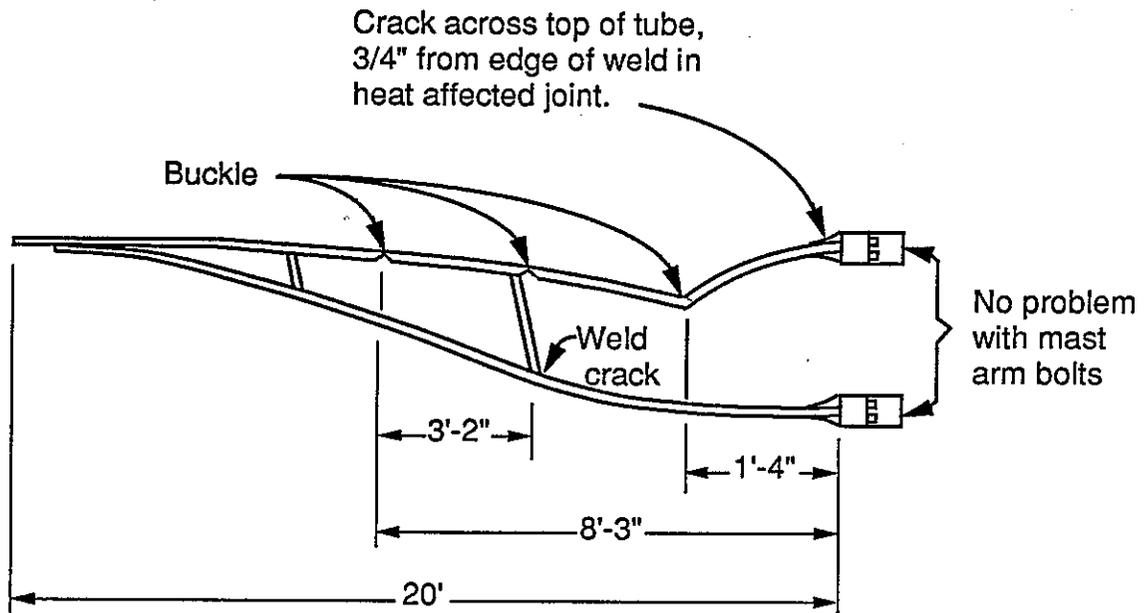
Figure 27. Damage To The Pole And The Mast Arm - Test 401

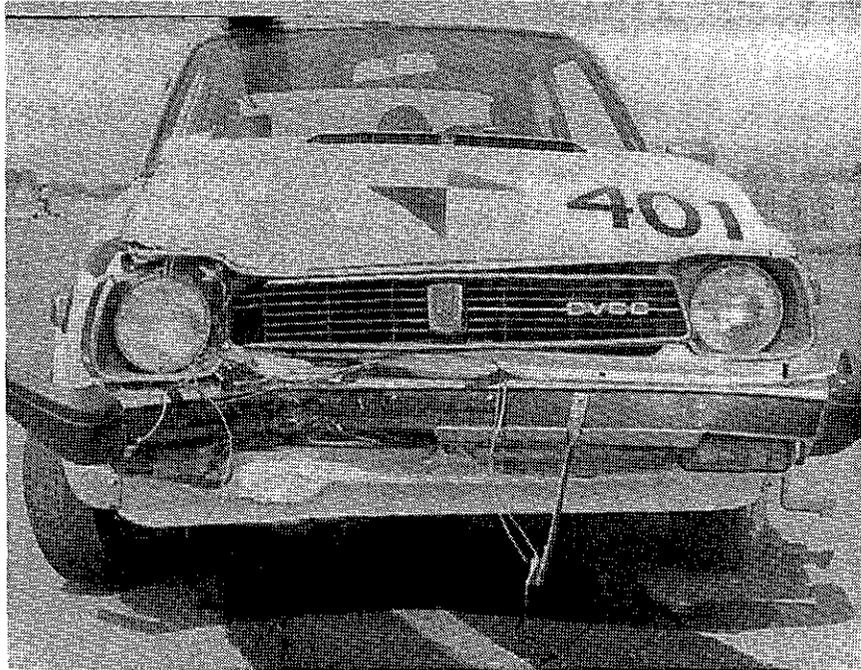
Figure 28. Test Vehicle After Impact - Test 401

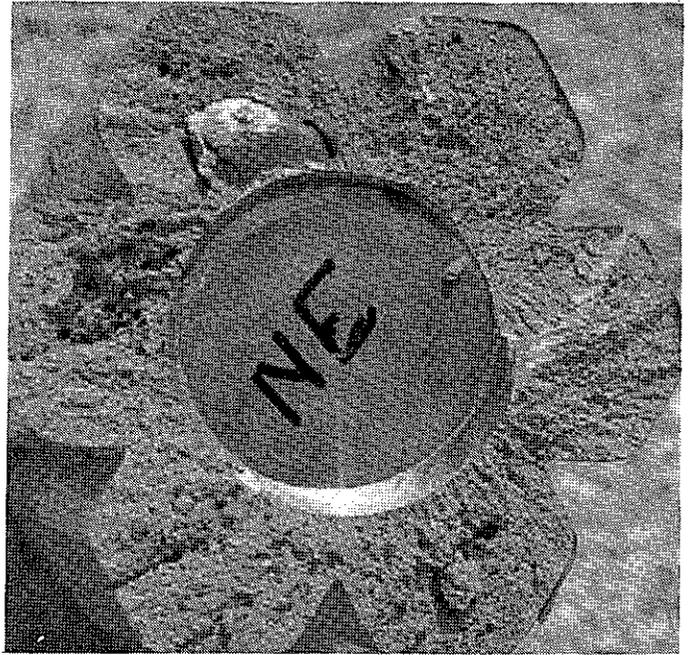
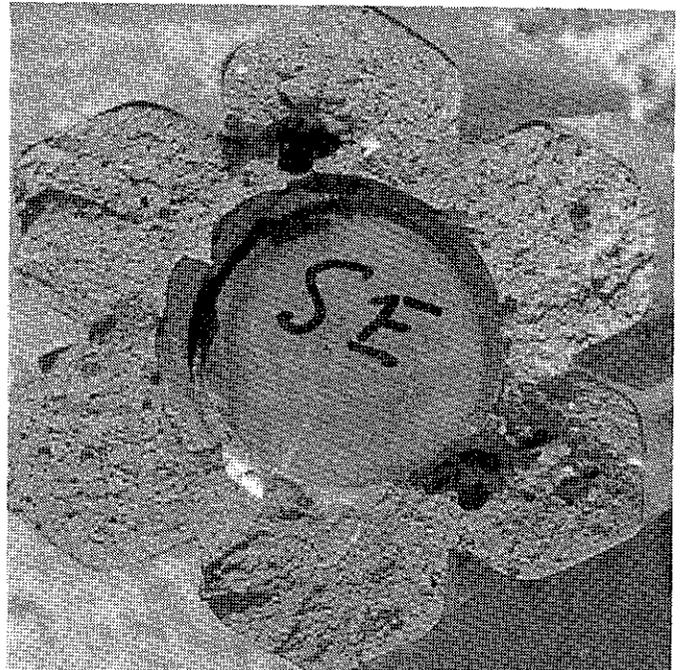
Figure 35. Fractured Surfaces of Die-Cast Aluminum Couplings - Test 402

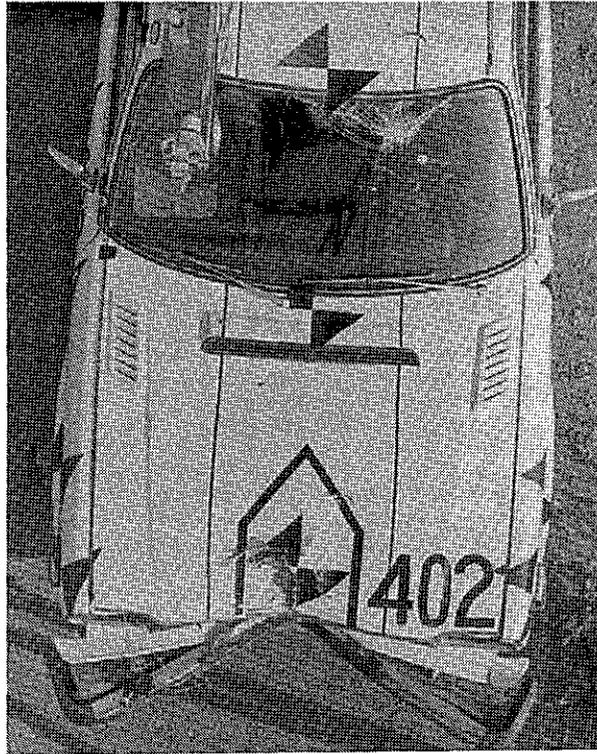
Figure 37. Test Vehicle After Impact - Test 402

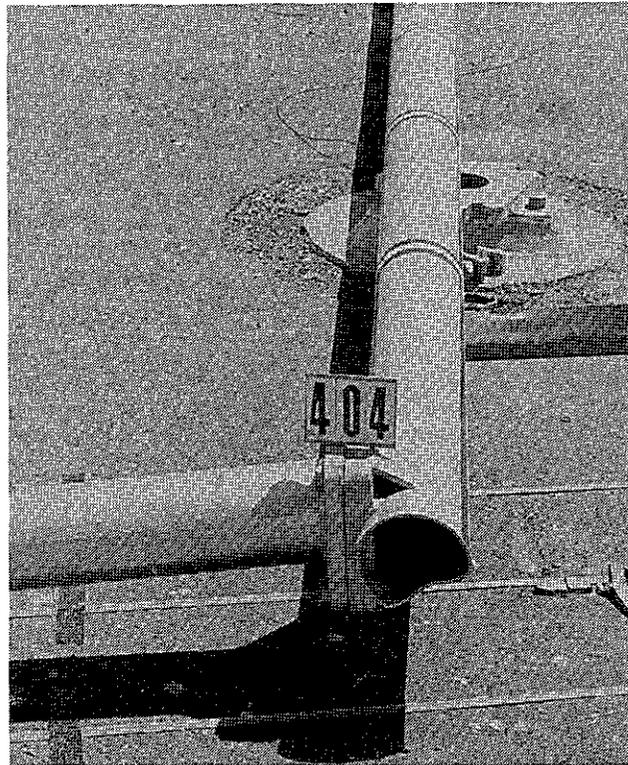
Figure 47. Lighting Standard Damage - Test 404

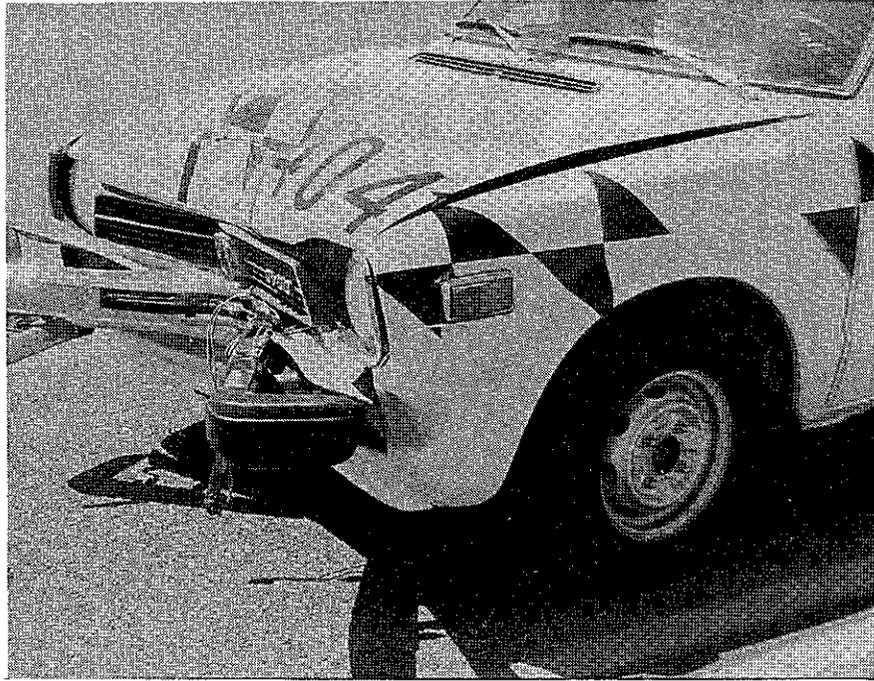
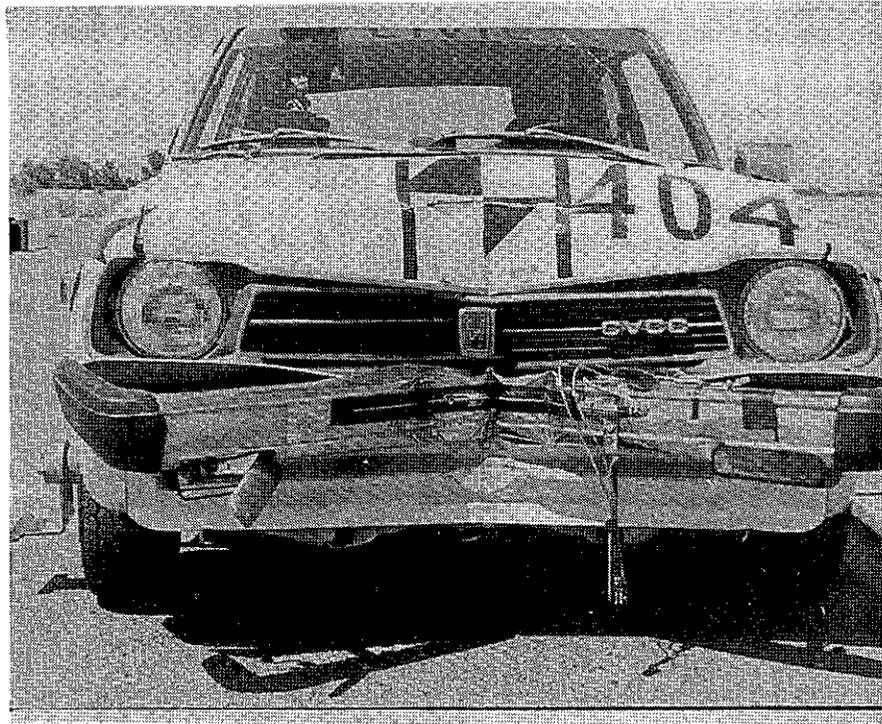
Figure 48. Test Vehicle After Impact - Test 404

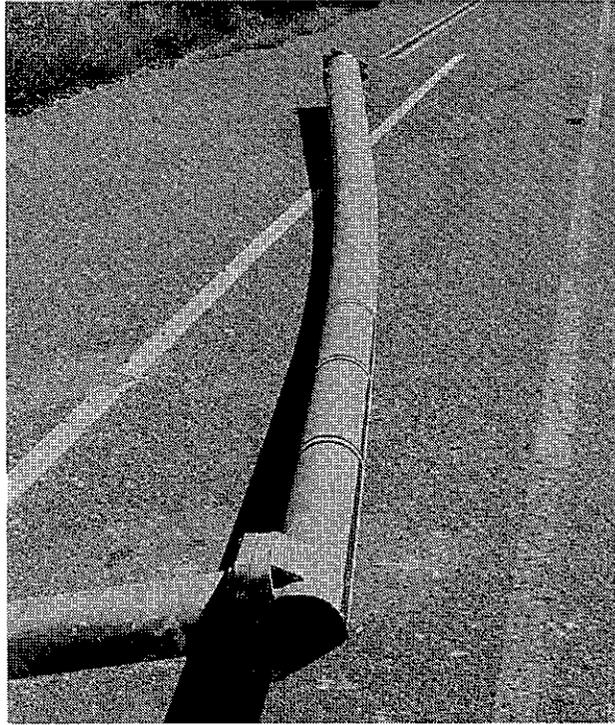
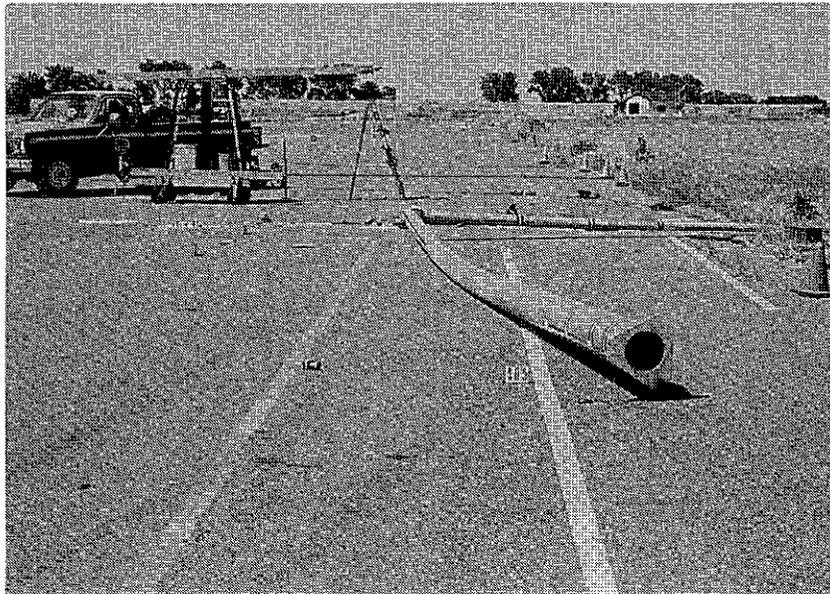
Figure 52. Lighting Standard Damage - Test 405

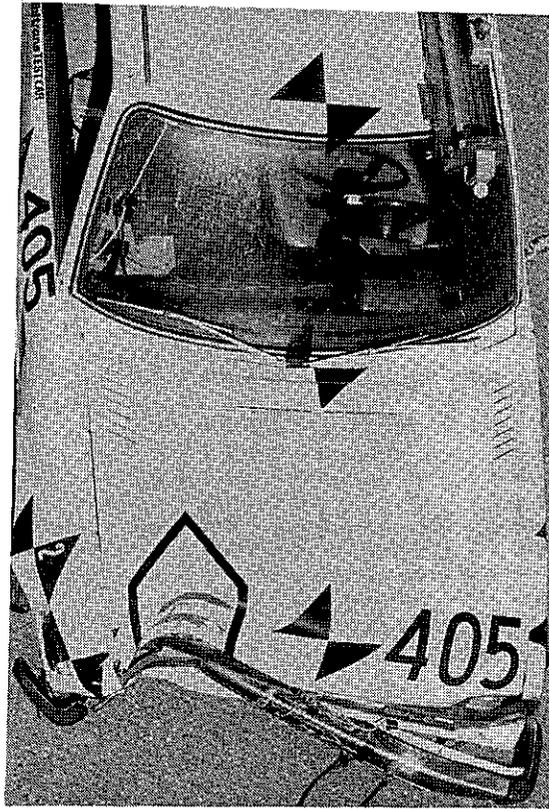
Figure 53. Test Vehicle After Impact - Test 405

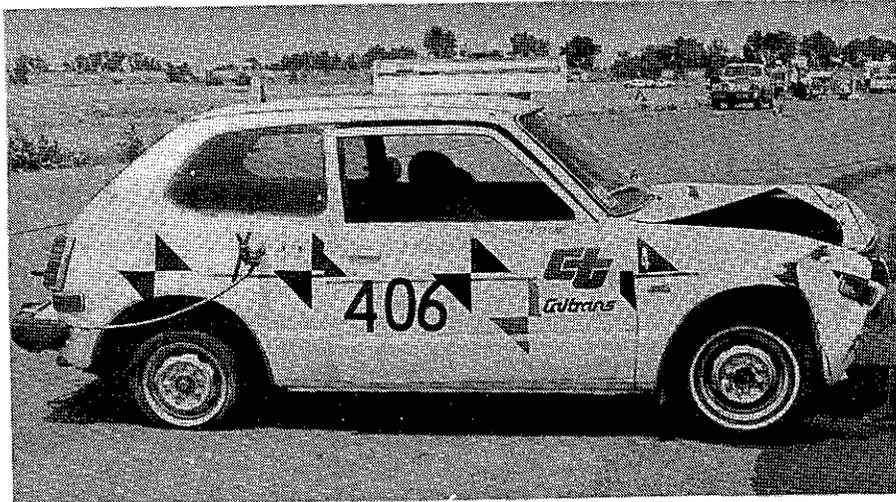
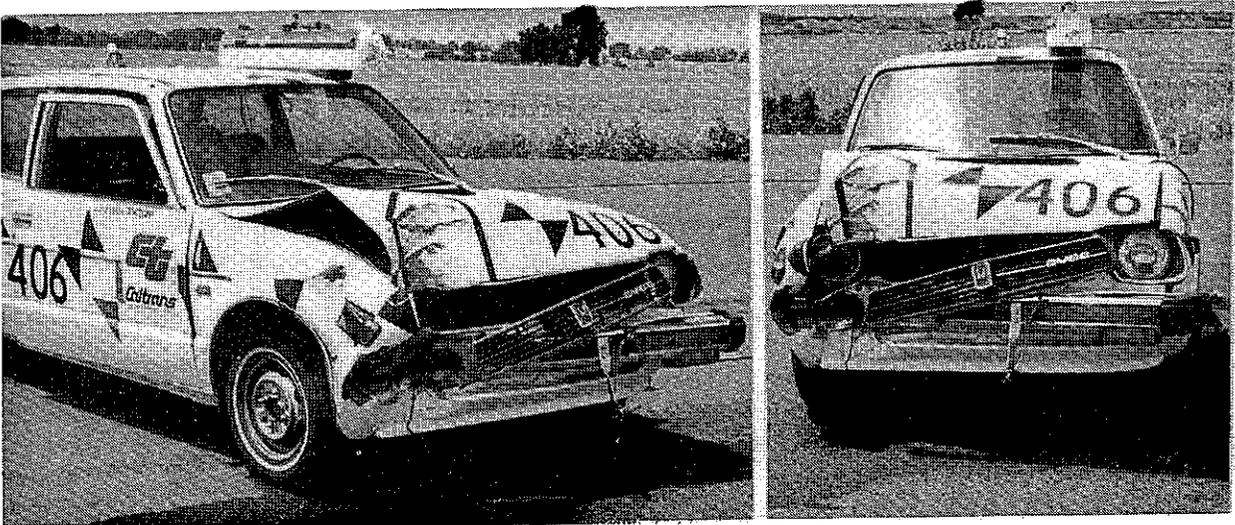
Figure 58. Test Vehicle After Impact - Test 406

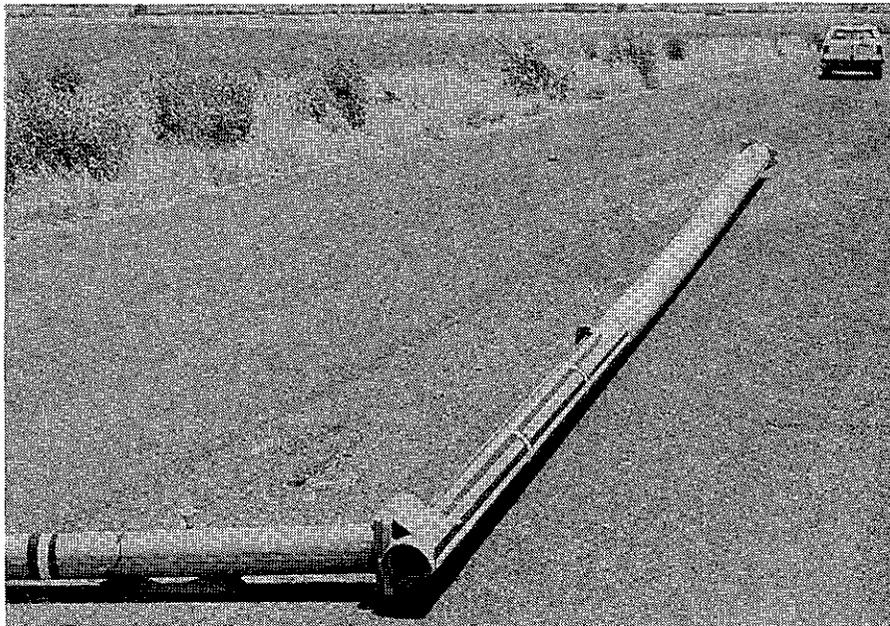
Figure 63. Lighting Standard Damage - Test 407

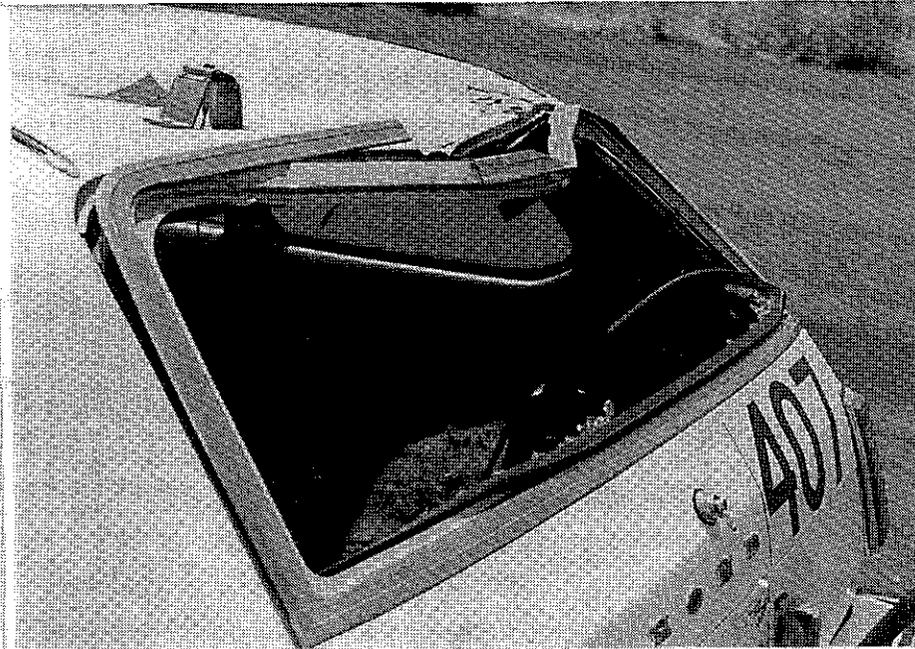
Figure 64. Test Vehicle After Impact - Test 407
