CONSTRUCTION EVALUATED  
RESEARCH REPORT:

CATHODIC PROTECTION SYSTEMS  
INSTALLED ON SUBSTRUCTURE SURFACES

CA-92-02  
03-NEV-80 PM 59.44  
03-377601  
Yuba Pass Overhead and Separation  
Bridge No. 17-23L/R

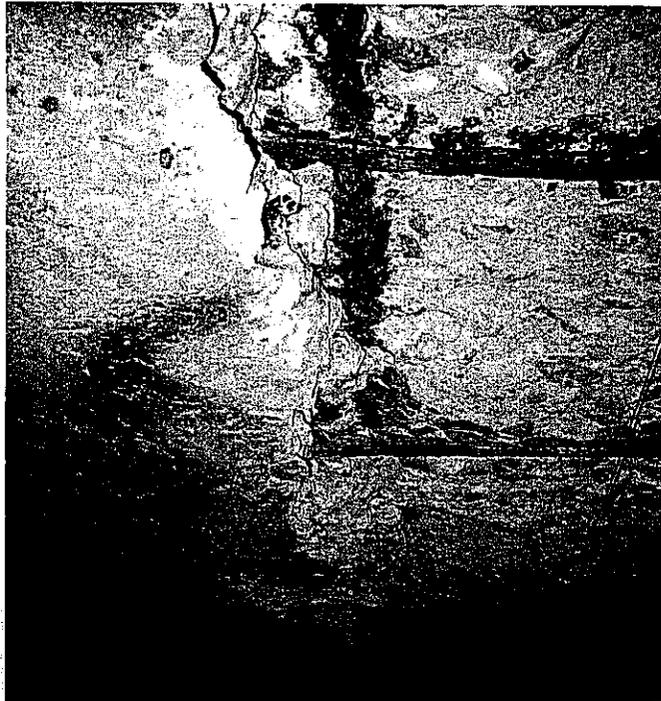
Severely corroded confinement reinforcing steel (No. 4 rebar) was found at some locations (Figures 6, 7 and 8) after unsound concrete was removed. In some cases, there were losses of cross-section greater than 75% for the confinement steel due to corrosion. A contract change order was issued to replace confinement reinforcing steel at all locations where corrosion had removed more than 25% of the original reinforcing steel cross-sectional area.

Figure 6. View of Bent 4R showing corrosion damage to the No. 4 confinement reinforcing steel and No. 11 vertical reinforcing steel. Corrosion resulted in a loss of nearly 75% of the cross-sectional area of some No. 4 rebars. Although some of the vertical No. 11 rebars experienced corrosion, there was virtually no loss of rebar cross-section.

The confinement reinforcing steel was replaced by either replacing an entire segment (hoop), or by cutting out the corroded section and lap-splicing replacement reinforcing steel of appropriate length to the remaining portion of reinforcing steel. Lap splices were welded with a minimum 300 mm (12 inch) splice overlap. All welding was performed by certified welders in accordance with Sections 4-103, 4-1103D, and 9-1.03 of the Caltrans Standard Specifications. The replacement reinforcing steel was tied onto the vertical column steel to maintain the original 300 mm (12 inch) confinement steel spacing.

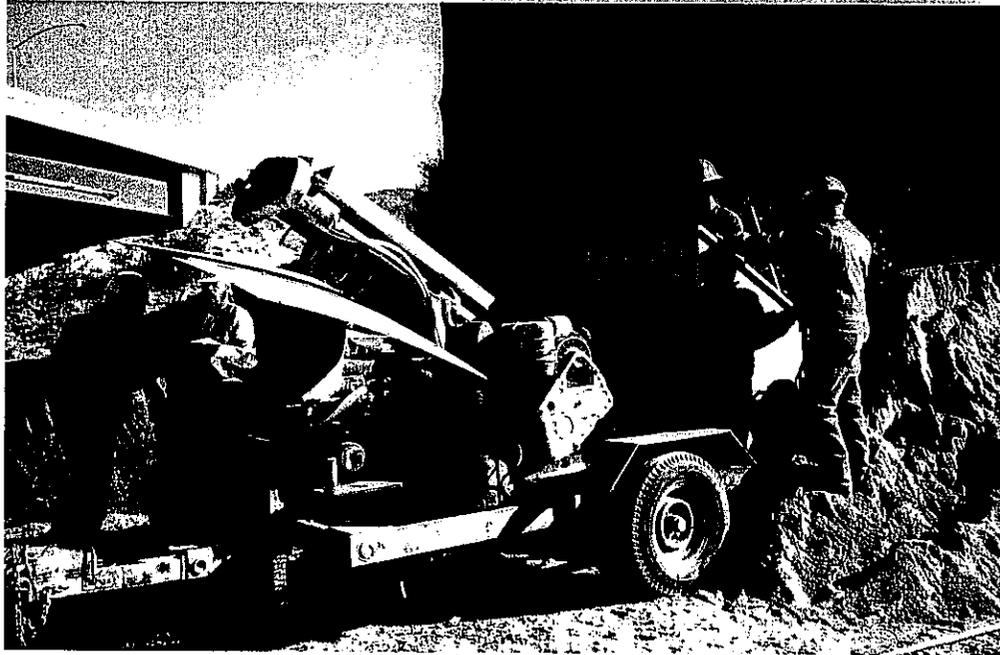
Figure 9. View of the shotcrete pump. Sand and cement were added to separate hoppers in pre-determined proportions. They were mixed with a spiral mixing blade and pumped dry under through the 80 mm (3 inch) diameter hose. Water was added at the nozzle and the shotcrete was propelled out of the nozzle at high velocity.

Chipped concrete areas were repaired with shotcrete. The shotcrete was applied using a dry mix shotcrete pump (Figures 9 and 10). Sand and cement were added to a mixing hopper and pumped dry through the delivery hose to the shotcrete nozzle where water was added through a pressure ring. The amount of water added to the mix was controlled by the nozzle operator. The shotcrete mix design was in accordance with Section 53 of the Caltrans Standard Specifications.

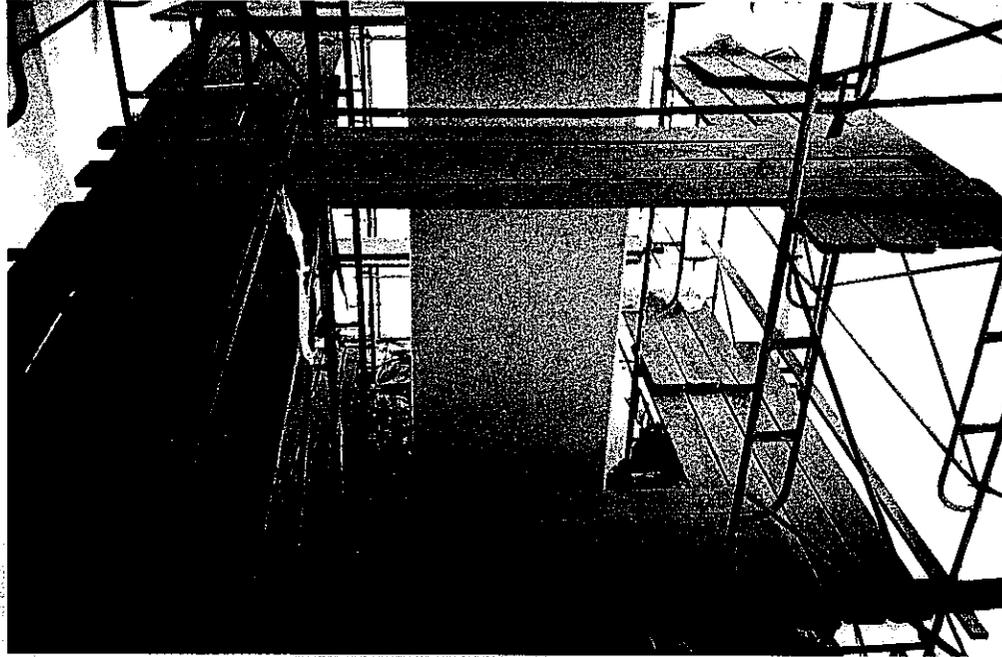
Figure 13. Photograph showing the metallized concrete surface. The sprayed zinc in contact with the brass anode pads (shown in Figures 14 and 15) distributes the protective CP current uniformly to the concrete and reinforcing steel.

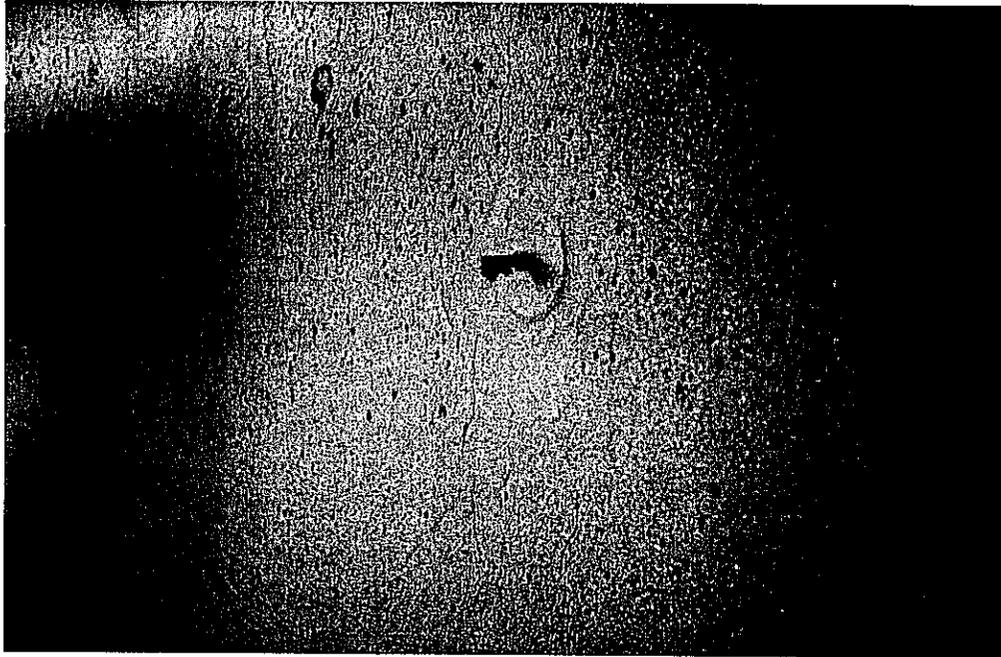
Figure 15. Close-up view of the brass anode pad after the zinc metallizing operation. The zinc has been metallized over the brass pad.

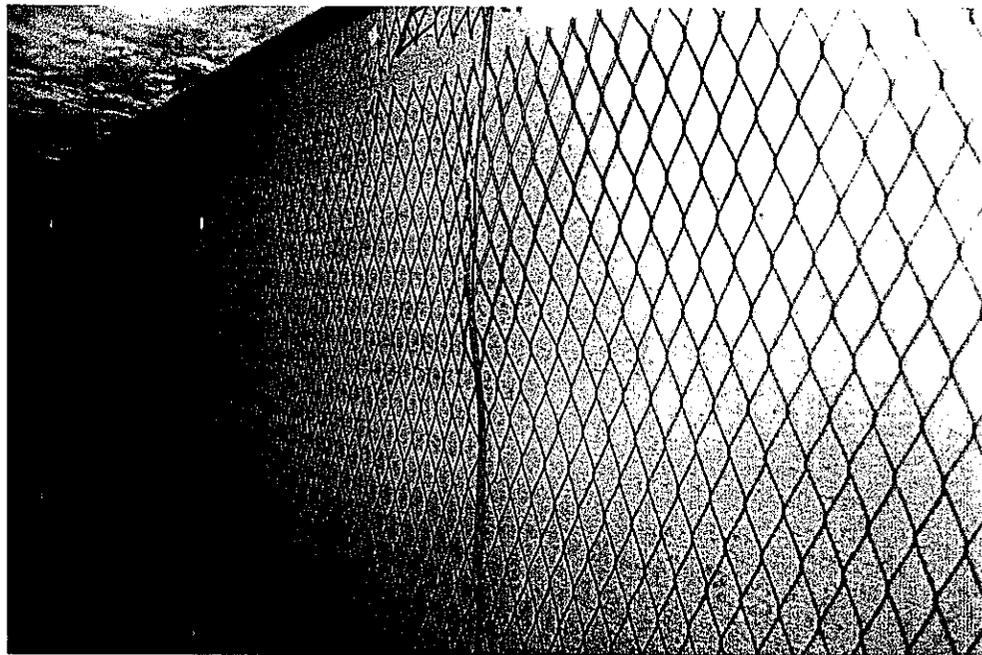
Figure 16. Photograph showing the Elgard mesh placed against the patched concrete surface at Bent 4L. The mesh is held in-place with plastic anchors.

The titanium mesh was attached to the concrete surface with plastic anchors placed into 25 mm deep holes drilled into the concrete at the manufacturers recommended spacing of approximately 600 mm (2 feet). The mesh was placed in sections. A portable voltmeter (connected to the reinforcing steel and titanium mesh) was used to monitor for electrical shorts. Each section of mesh was resistance welded to the titanium alloy strips. No electrical shorts were detected during placement of the mesh.

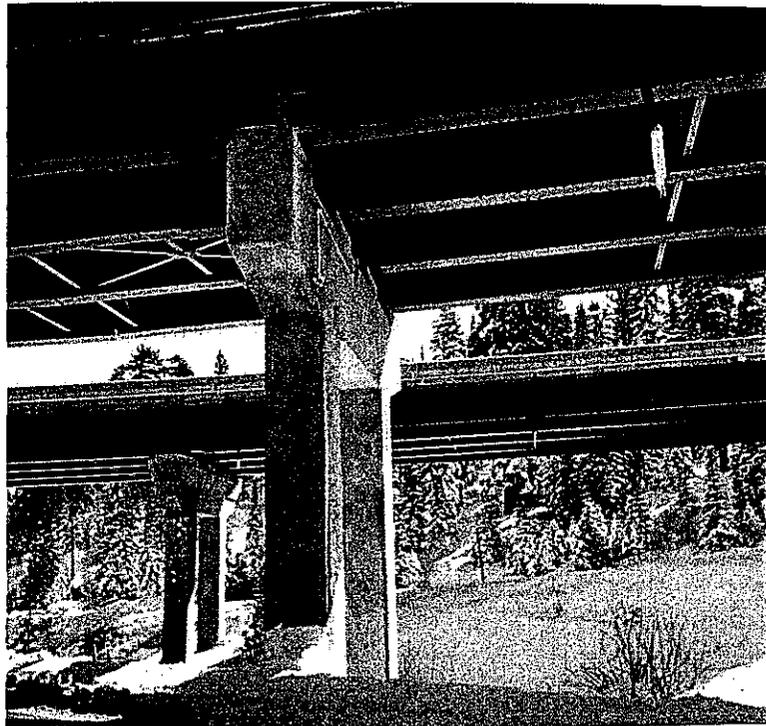
Figure 26. View of Bent 4L (Elgard Mesh CP system) showing the finished shotcrete surface over the Elgard mesh.

- **CCO No. 7** provided a lump sum increase of \$1000 to the contractor to mobilize equipment at Bent 4L for placing 1.5 cm of additional shotcrete prior to placement of the Elgard mesh. Applicable materials and labor costs were paid for with available contract funds for placement shotcrete at the contract price of \$1589 per cubic meter. **Reasoning:** Additional shotcrete was needed at Bent 4L prior to placing the Elgard mesh to eliminate the possibility of contact between the mesh and the large amount of surface metal that was found.

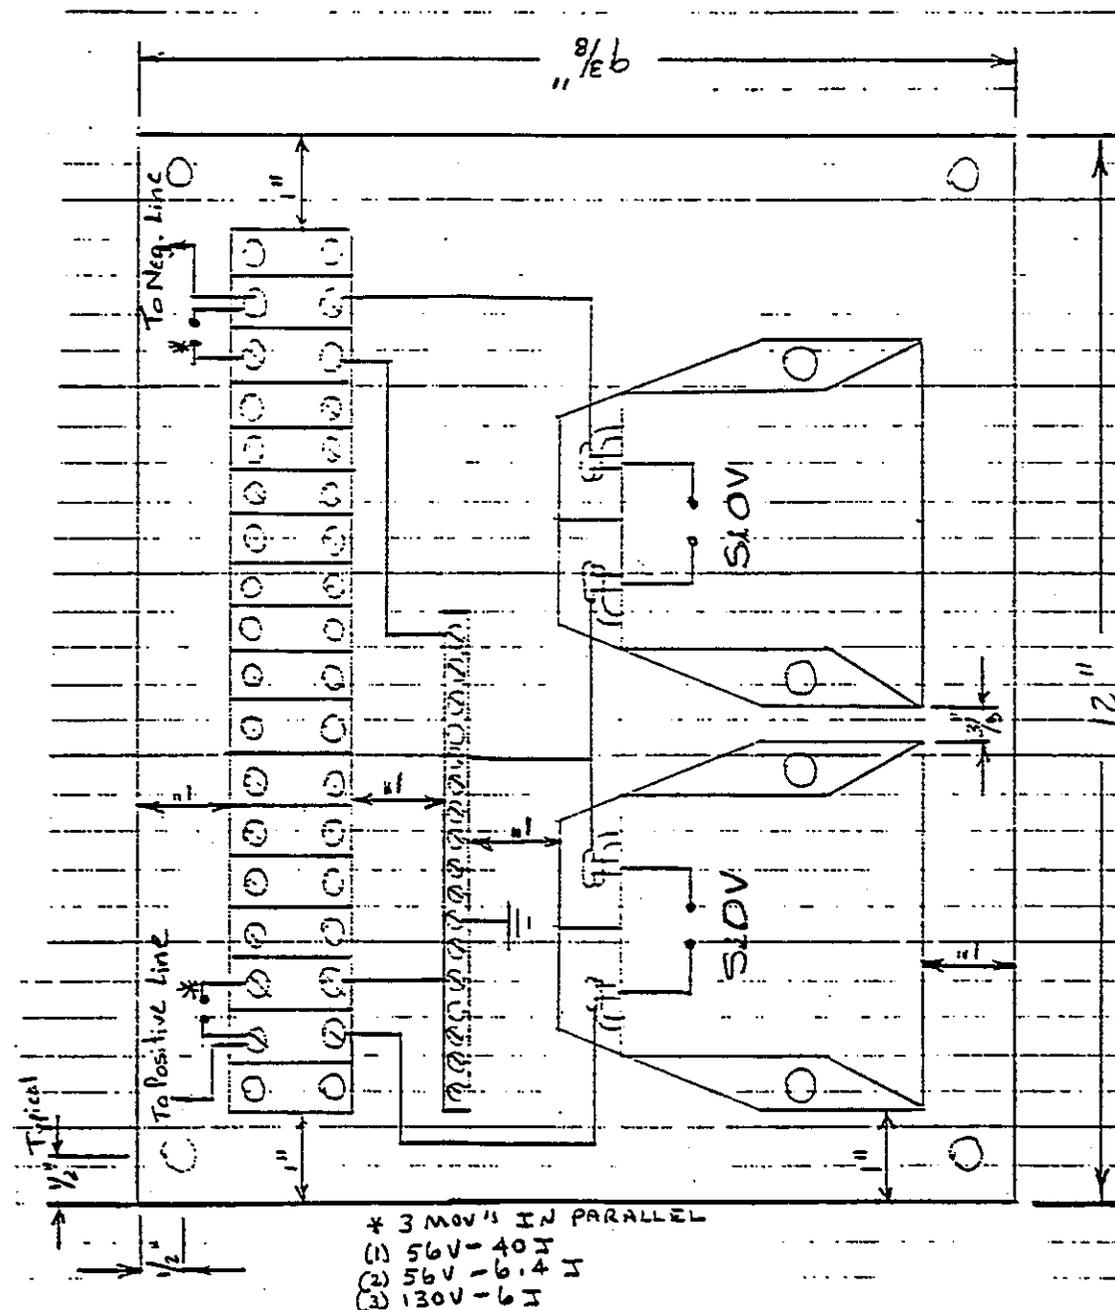
On March 10, 1994 lightning damaged the Campbell datalogger and the Metallized Zinc CP rectifier. The CP rectifiers had DC lightning protection devices across the positive and negative rectifier output leads and an AC lightning protection device across the AC power input lines to the CP system. The electrical ground for the CP systems as originally connected was provided through a third wire ground lead connection (from the AC power input lines) to an existing ground rod for the nearby Caltrans fuel and maintenance work building located approximately 90 meters (300 feet) from the rectifier location.

Figure 28. Schematic diagram of metal oxide varistor (MOV) board used for lightning protection of the power supply leads to Bent 4R (Metallized Zinc CP system). The MOV's provide a shunt to ground if large spikes or surges occur in the wiring due to electrical storms. Three MOV's with different energy level ratings were used in parallel to protect against a wide range of electrical spiking and/or surges. The board was mounted in a pull box at Abutment 5R. This location provided the shortest path to ground if electric charge is collected on the metallized zinc surface during an electrical storm event.

Repairs were made to the damaged components and additional lightning protection devices were added after reviewing the latest available literature regarding lightning protection for electrical components and consulting with members of the Caltrans Electrical and Commodities Testing Section. Metal oxide varistors (MOV's) were added to all input and output lines of the Elgard and Metallized Zinc CP systems for additional lightning protection. These devices provide a shunt to ground if large transient spikes or surges occur in the CP system wiring and components during storm events. MOV's with different energy ratings were stacked in parallel on input and output lines of the CP systems to provide lightning protection against a wide range of transient responses. Figures 27 through 29 are schematic diagrams that show the added MOV's.

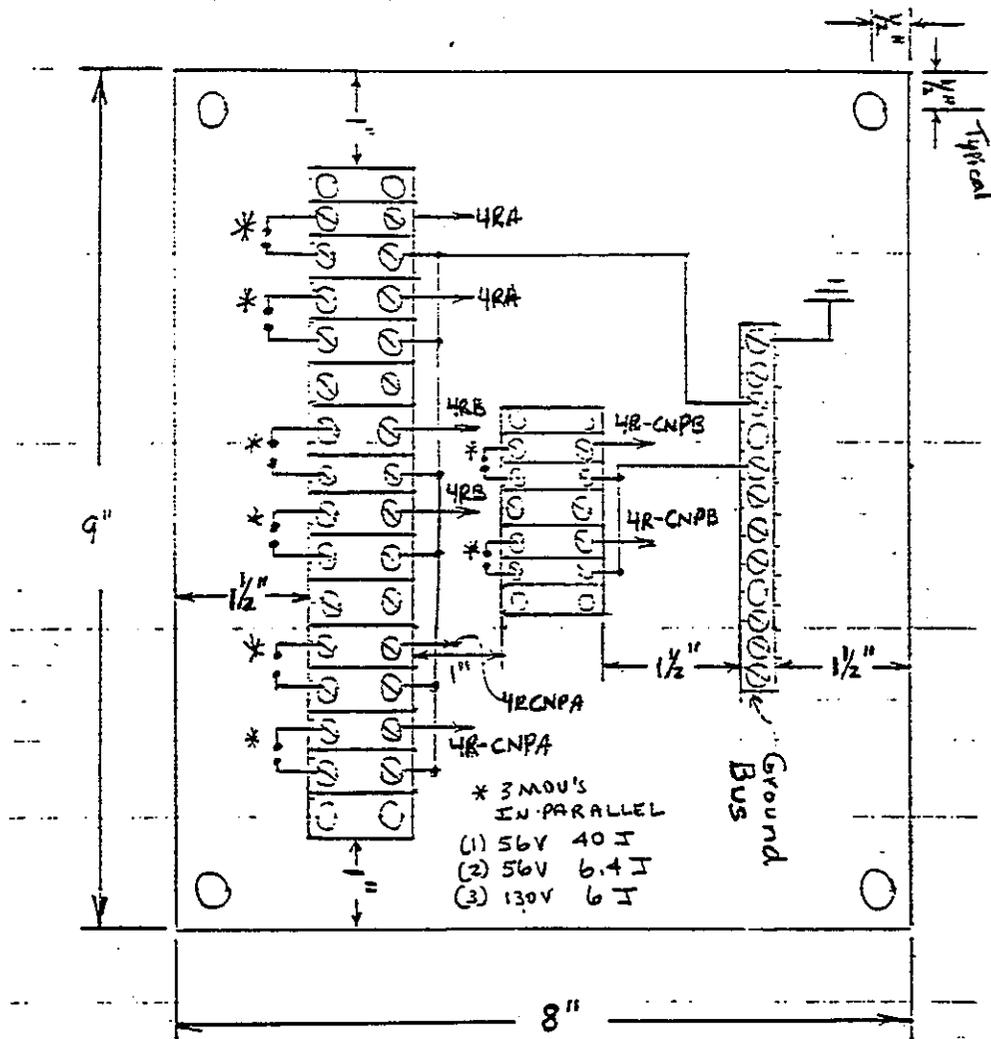
Figure 29. Schematic diagram of metal oxide varistor (MOV) board used for lightning protection of the reference cell leads and corrosion null probe leads to Bent 4R (Metallized Zinc CP system). The MOV's provide a shunt to ground if large spikes or surges occur due to electrical storms. Three MOV's with different energy level ratings were used in parallel to protect against a wide range of electrical spiking and/or surges. The board was mounted in a pull box at Abutment 5R. This location provided the shortest path to ground if electric charge collected on the metallized zinc surface during an electrical storm event.
