FHWA/CA/TL-93/09

Effects of Corrosion on the Bare Weathering Steel in the Antioch Bridge

June 1992

Division of New Technology
Materials and Research
California Department of Transportation
Sacramento, CA 95819

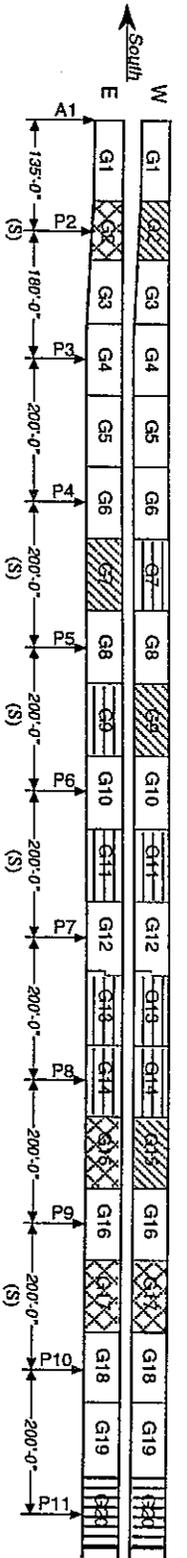
Rust on Antioch Bridge Evaluated
by Translab - January 24, 1983

- Severe
 - Bad
 - Moderate
 - Slight
 - Satisfactory
 (S) - Loose Rust

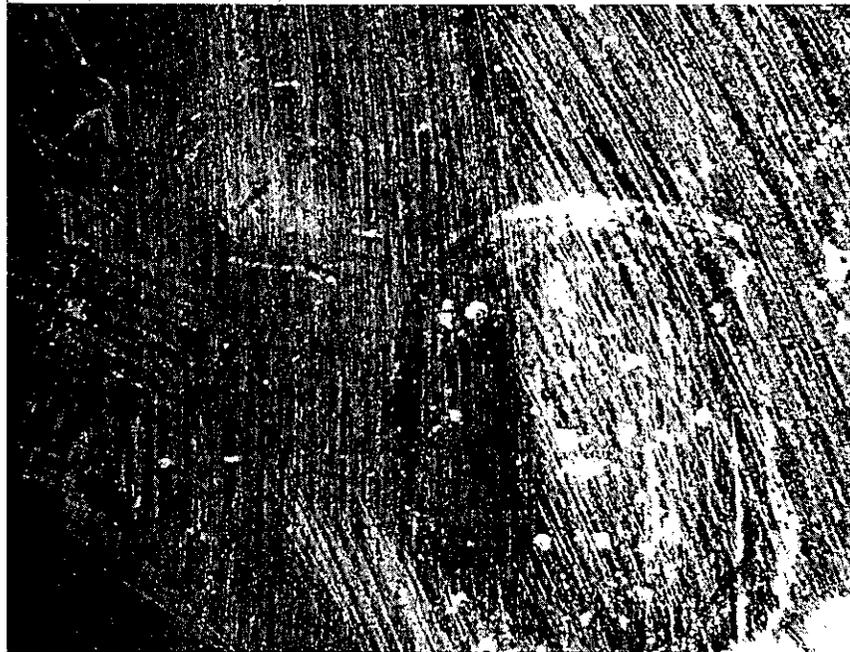
Figure 4 is the surface of GL 35-3-3 after grinding off approximately 4 mils. The light areas are pits remaining. It required grinding off 7 mils before all of the pits were ground out indicating a maximum pit depth of 7 mils.

GL 35-3-3 Shows pits Remaining After Removing 4 mils By Grinding

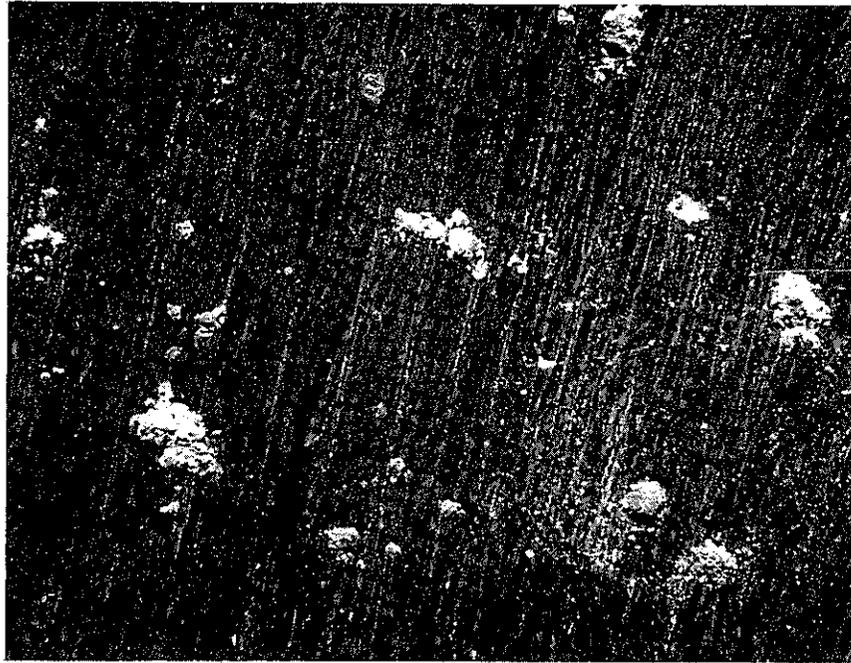
Figure 5 is a photo of the surface of plaque GL 39-2-7 after grinding off 7 mils. The light areas show remaining pits.

GL 39-2-7 Pits remaining After Grinding Off 7 Mills

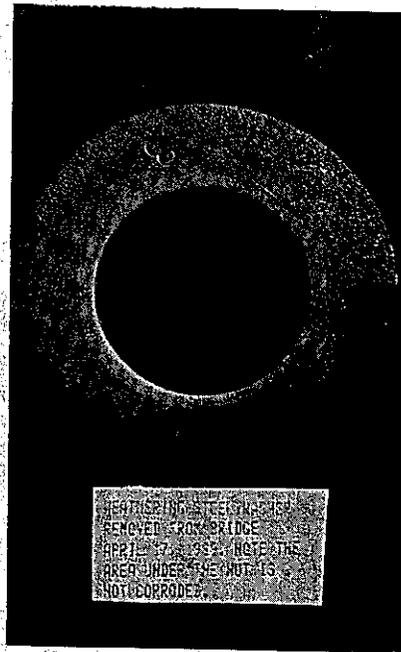
Figure 6

The washer shown in figure 6 is pitted around the outer edge and shows little pitting in the area that was under the nut. The average pit depth in the pitted area is 0.0027 inch. This would be approximately 0.22 mils/year.

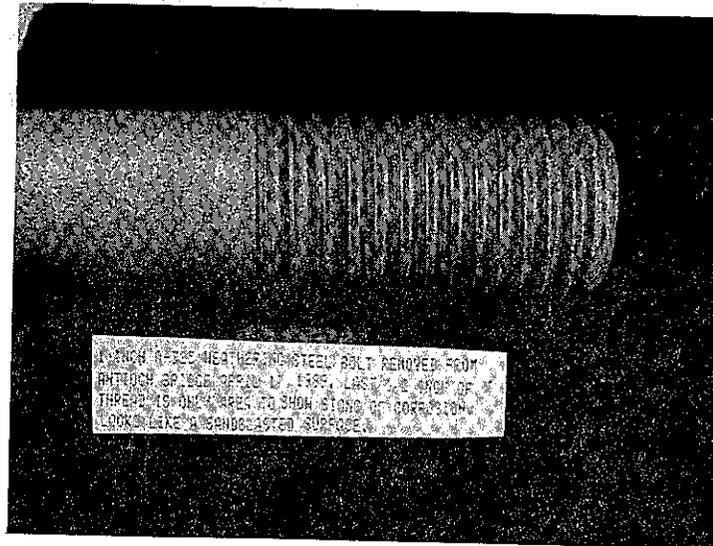
Figure 7

The bolt shown in figure 7 is pitted on the exposed threaded end and had an average pit depth of 0.0033 inch in the pitted area for an average of 0.28 mils/year.

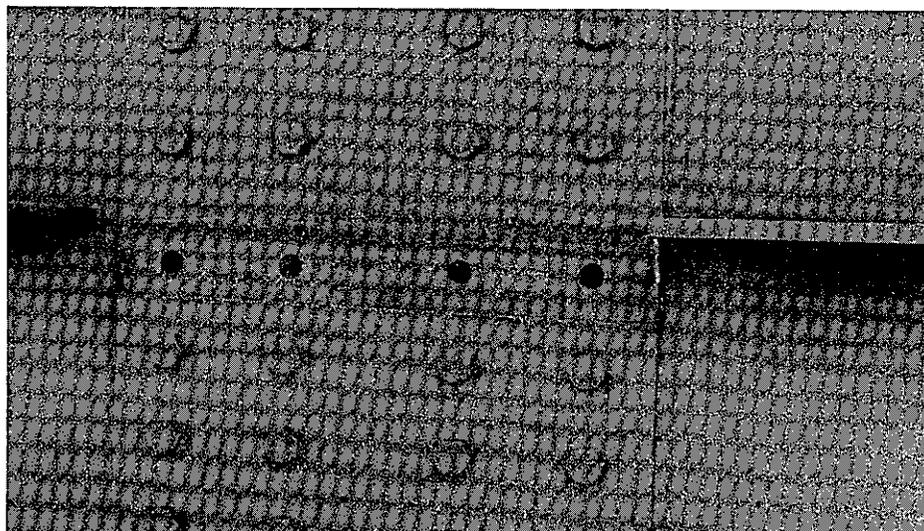
The area where the bent stiffener splice plate and the girder splice plate come together shows active corrosion on both the girder splice plate and the stiffener splice plate. The bent plate provides a receptacle for debris of all kinds which tends to hold moisture. Figure 8 is a view of the girder splice plate with the stiffener splice plate removed.
