COMPLIANCE CRASH TESTING OF THE
TYPE 60K CONCRETE BARRIER USED IN
SEMI-PERMANENT INSTALLATIONS
FINAL REPORT # **FHWA/CA/TL-2001/08**
CALTRANS STUDY # F99TL36

STATE OF CALIFORNIA
DEPARTMENT OF TRANSPORTATION
DIVISION OF NEW TECHNOLOGY,
MATERIALS AND RESEARCH

**COMPLIANCE CRASH TESTING
OF THE TYPE 60K CONCRETE
BARRIER USED IN SEMI-
PERMANENT INSTALLATIONS**

1. REPORT NO.	2. GOVERNMENT ACCESSION NO.	3. RECIPIENT'S CATALOG NO.	
4. TITLE AND SUBTITLE COMPLIANCE CRASH TESTING OF THE TYPE 60K CONCRETE BARRIER USED IN SEMI-PERMANENT INSTALLATIONS		5. REPORT DATE August 9, 2001

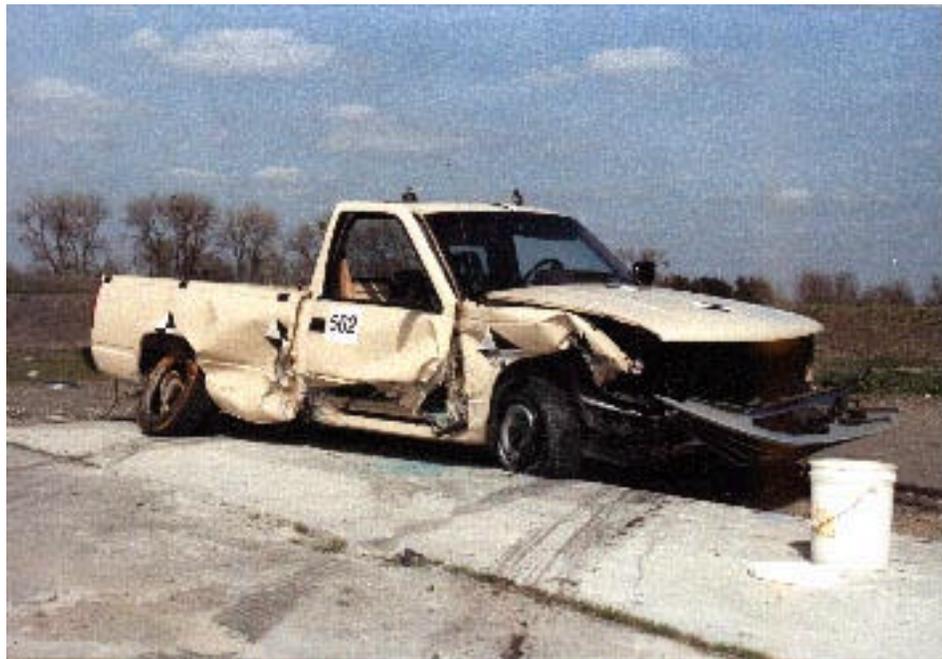
Most of the damage to the vehicle was on the front half of the right side (Figure 2-1). The right third of the bumper was pushed back into the front right wheel well. The front tire was

The back half of the vehicle also received some damage. The portion of the bed separating the rear tire and the cab was crushed and rippled. The rear right tire was blown and the rim was bent. The wheel did not sustain any permanent longitudinal displacement.

The floor deformation at the center of the front passenger side of the vehicle was about 115 mm. At the firewall, the maximum floor deformation was 135 mm.

Figure 2-1 – Test 562. Overall damage to the vehicle

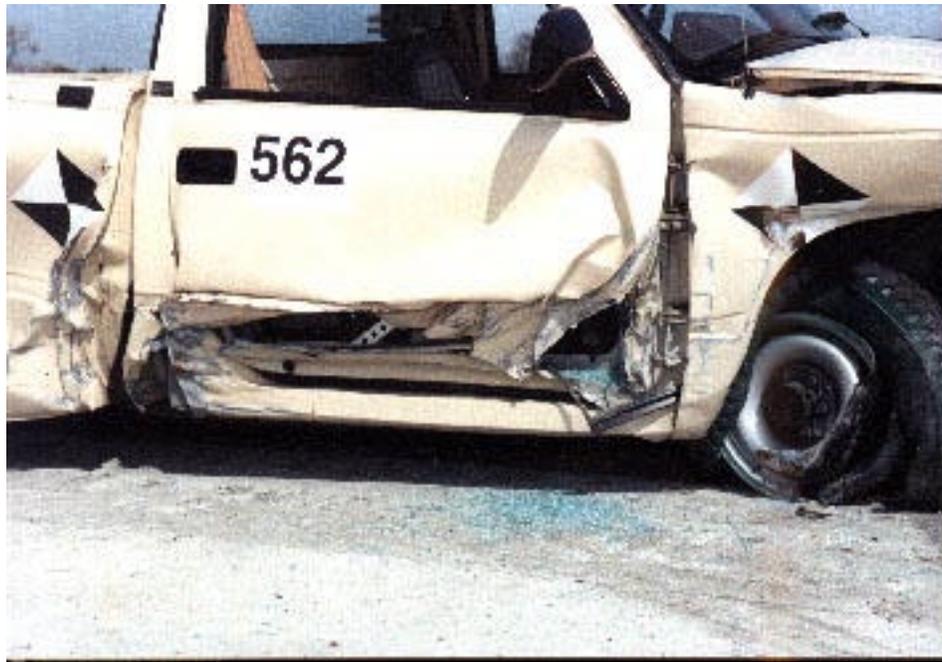
Figure 2-2 – Test 562. Damage to the vehicle door

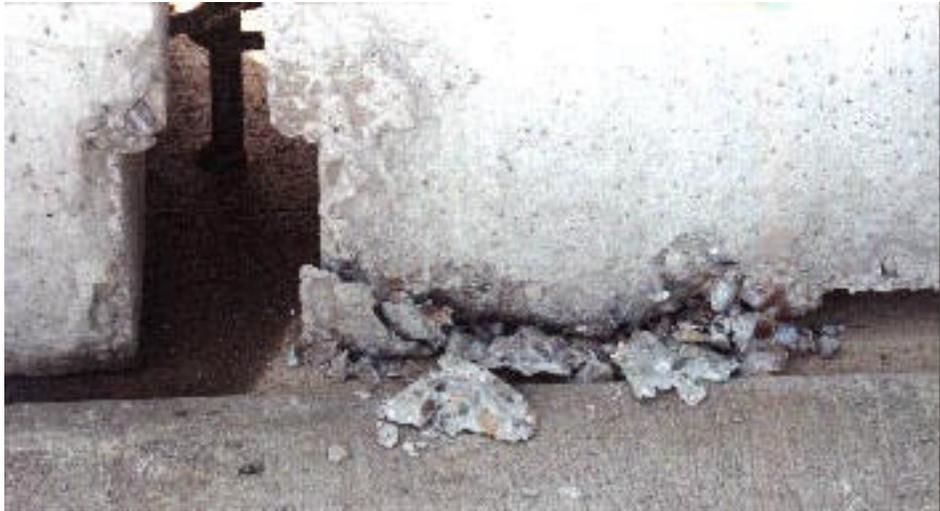
The barrier did not have any significant permanent deflection and appeared, at first glance, to be in good condition after the impact. After closer examination, however, it was noted that the backside of each of the segments that shifted was spalled along the bottom edge. The steel angle that lined the sides of the trough was littered with concrete that had been cut by the angle. The leading edges of two of the segments sustained minor spalling. Two of the connecting pins were bent enough that they had to be cut before the barrier could be disassembled.

Figure 2-3 shows the spalled concrete at the base of segment 8, one joint upstream of impact. The steel angle lining the sides of the trough acted to cut the barrier along the backside of the segments that were laterally deflected.

Figure 2-3 – Test 562. Segment 8 at Joint 7-8

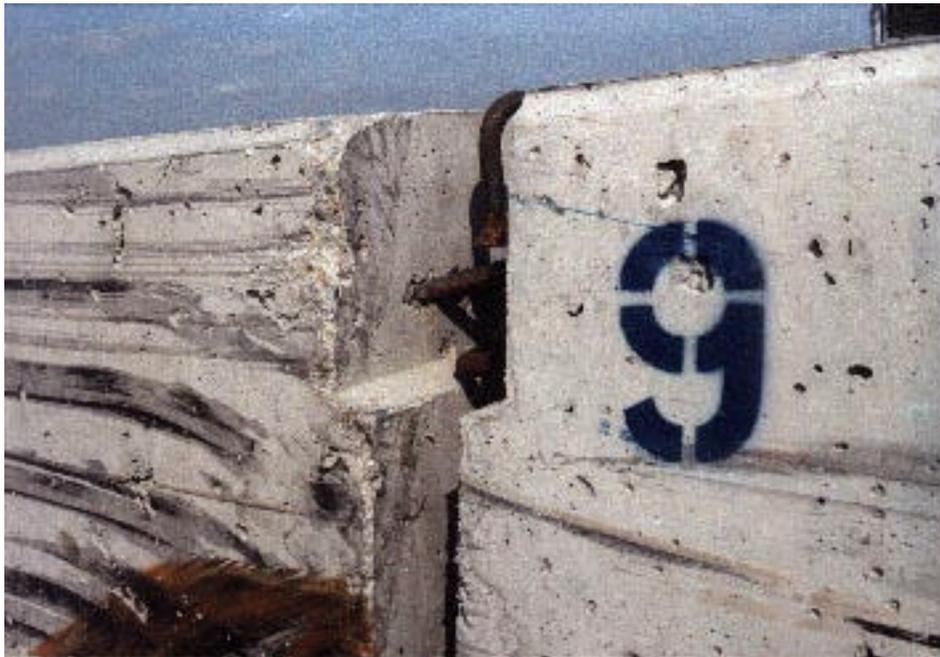
Illustrating the snagging potential of the Type 60K-v1, Figure 2-4 shows the scuff marks on the end face of segment 10 where the vehicle penetrated the barrier face.

Figure 2-4 - Test 562. Segments 9 and 10

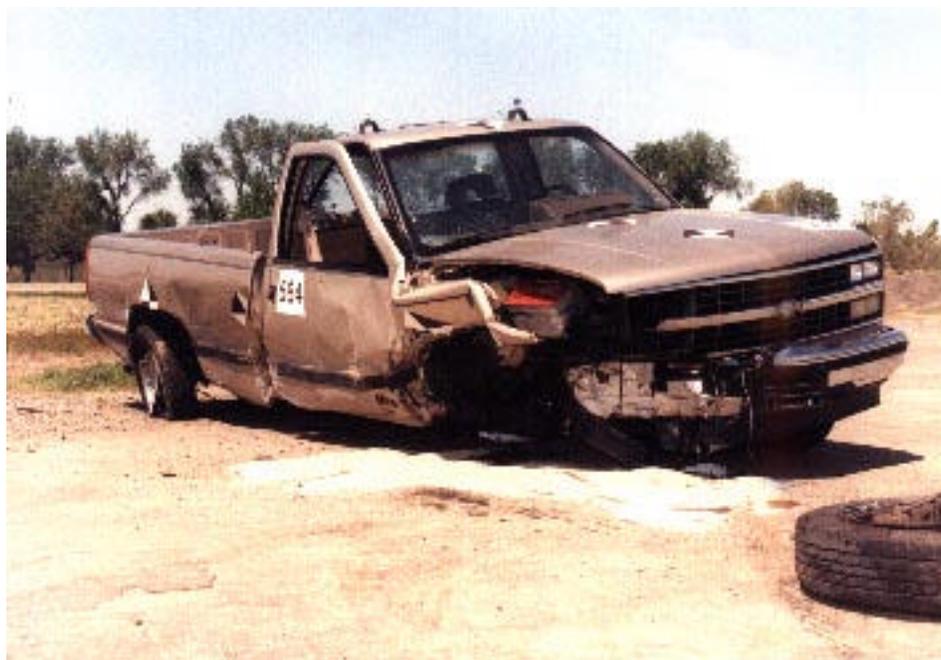
Vehicle damage was extensive. The right front wheel, hub and spindle assemblies were sheared from the suspension. The right A-arm was bent back and twisted. The right side of the front bumper was pushed back approximately 510 mm (see Figure 2-6). The right front fender and inner fender were pushed in and back against the engine. The right frame rail was bent into the engine and the engine was tilted up on the right side. The radiator, transmission cooler, battery box and battery received extensive damage.

Transmission oil, coolant and battery acid leaked out of the vehicle. The right side of the hood received minor damage and the windshield was fractured on the right side. The right door was pushed back into its frame. The right door buckled outward approximately 140 mm, jamming the door closed and breaking the door glass.

Figure 2-6 – Test 564. Damage to the front of the vehicle

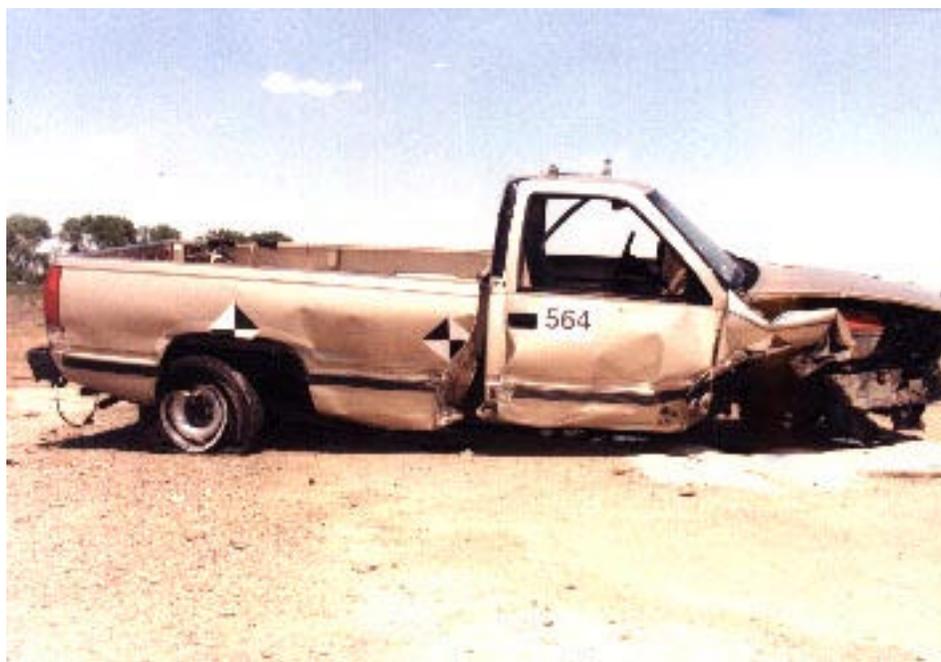
The right rear of the vehicle also received extensive damage (see Figure 2-7). The right side of the bed was dented the full length and the whole bed was shifted to the left on the frame. The rear axle broke loose from the suspension, and was pushed back approximately 600 mm. The axle housing bent and the differential housing broke. Both of the right side tires were flat and ruptured with extensive damage to both wheels.

Figure 2-7 – Test 564. Damage to the side of the vehicle

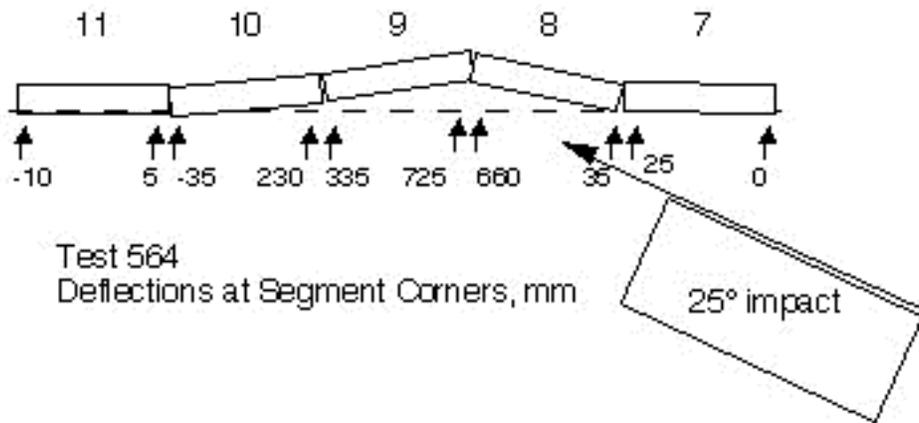
Figure 2-8 – Test 564. Barrier deflections

Damage to the barrier was limited to barrier deflection, two of the connection pins being pulled out of the pavement, and some minor concrete spalling. The maximum, permanent barrier deflection was 725 mm at the joint between segments 8 and 9 (see Figure 2-8). The barrier deflections led to the pins at joints 8-9 and 9-10 being pulled out of the pavement. Concrete spalling was limited to the leading edges of segments 8 and 10 where the vehicle snagged the barrier. All of the barrier segments were reusable.

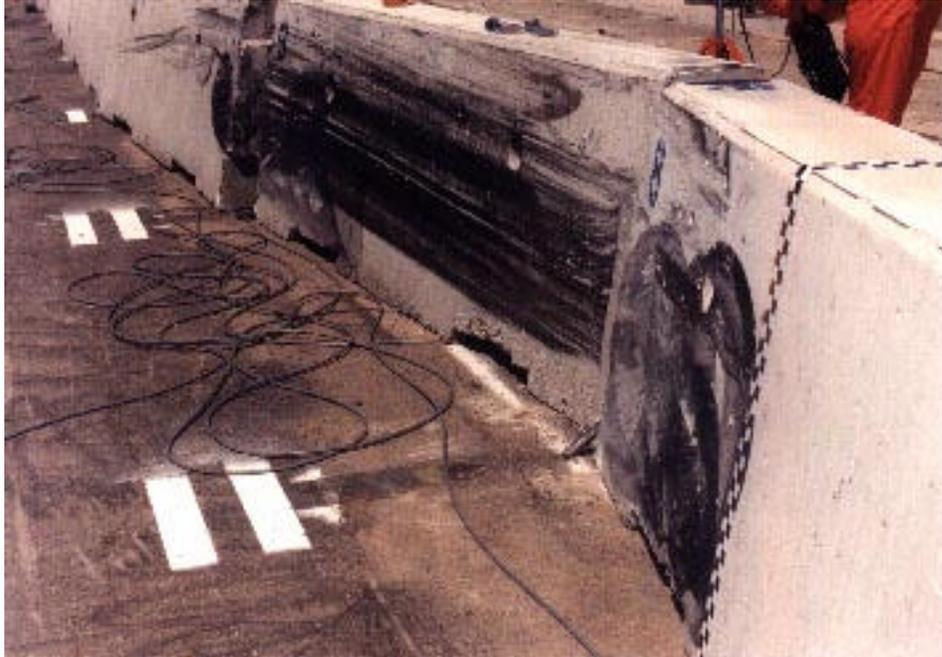
Figure 2-9 – Test 564. Deflection and tire marks

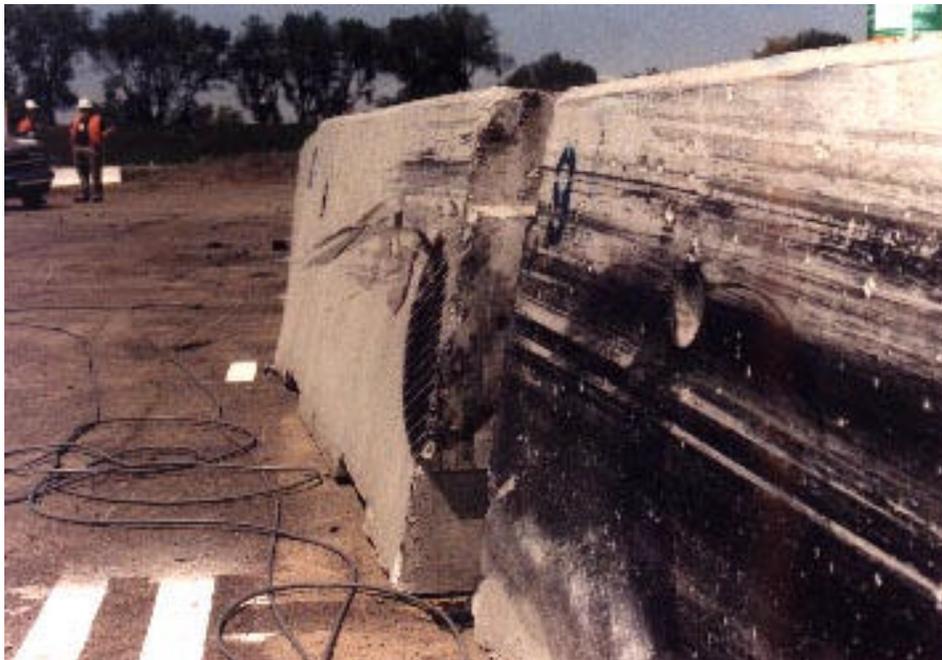
Figure 2-10 – Test 564. Snag at joint 9-10

60K-v2: The structural adequacy of the 60K-v2 was also unacceptable. Test 564 showed that the differential rotation of the barrier segments and consequential vehicle snagging at the barrier joints was even more pronounced than in the test of 60K-v1. During the time of contact between the test vehicles and the barriers there were minor amounts of scraping and spalling.

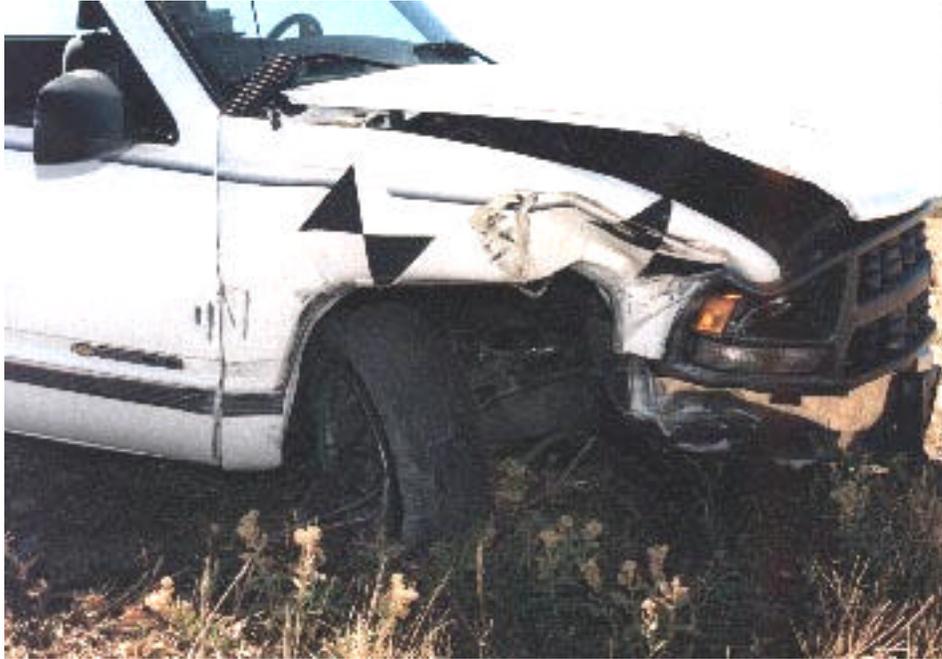
Most of the damage to the vehicle was confined to the front right corner, with additional damage along the impacting side of the vehicle (see Figure 2-12 and Figure 2-13). The front right tire was torn, but still on the vehicle. The corner panel and the far right side of the bumper were crushed. The tie-rod was severely bent. The hood was partly raised, but still latched. There were scuffmarks along the rear right side of the vehicle. The right rear wheel separated at the seam, allowing the tire and rim to detach from the vehicle. The engine was still functional.

Figure 2-12 – Test 565. Impacted corner of vehicle

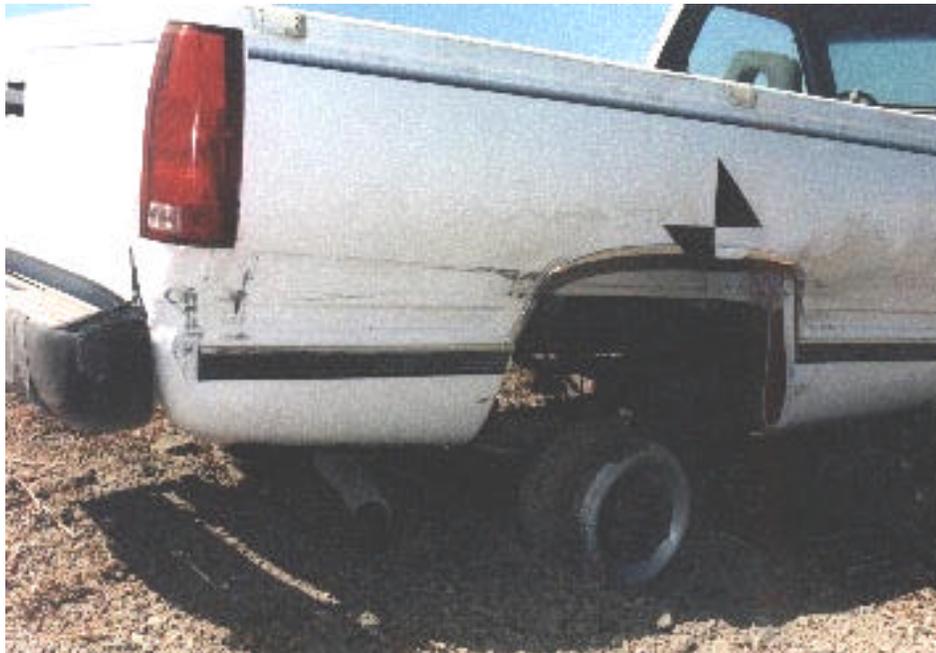
Figure 2-13 – Test 565. Damage to the back right of the vehicle

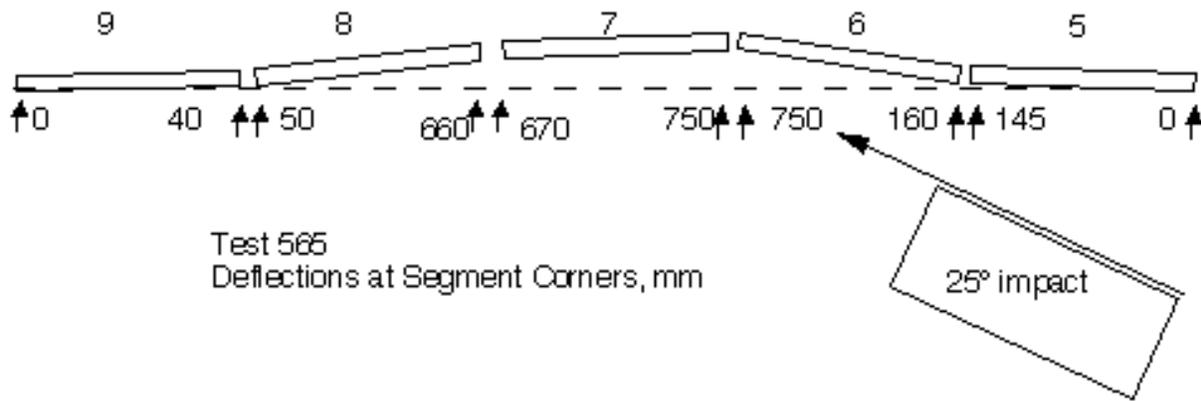
The barrier shifted a maximum of 750 mm at the impacted joint during impact.

Figure 2-14 – Test 565. Barrier deflections

Damage to the barrier was limited to shifted segments, minor concrete spalling, bent connecting pins, and scuffing of the concrete face. Out of the 12 segments making up this barrier, only segments 1, 2, and 12 did not move. Segments 5,6,7,8, and 9 had measurable lateral deflections. The spalling concrete occurred at joint 6-7 where the concrete is the thinnest. The connecting pins nearest the impact were bent, six of which had to be cut. All of the barrier segments were reusable.

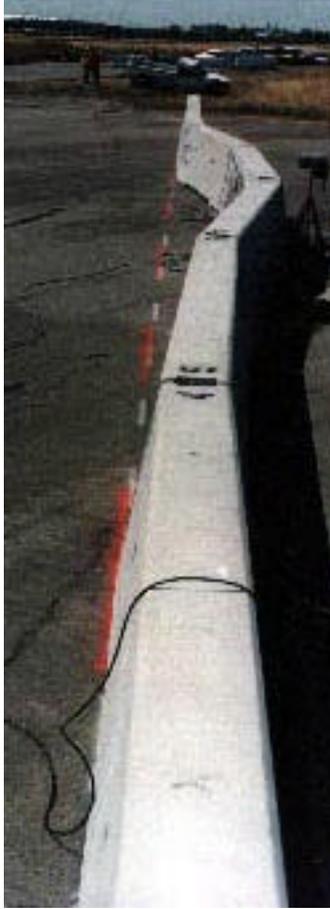
Figure 2-15 – Test 565. Lateral deflections

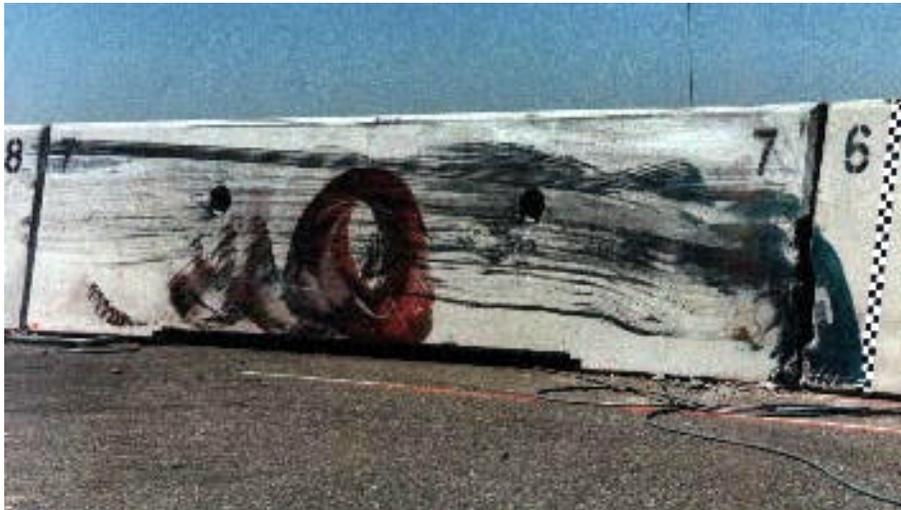
Figure 2-16 – Test 565. Tire marks

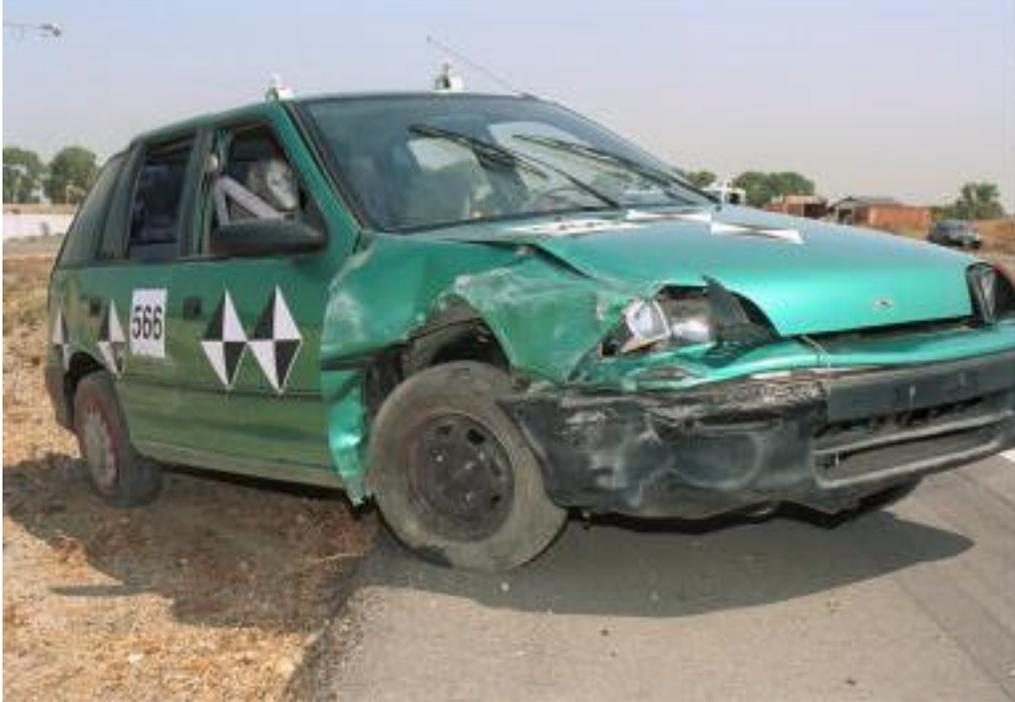
Most of the vehicle damage was limited to the front right corner of the vehicle. The corner panel was crushed and the hood had been buckled. The front right wheel was turned inward. The steering mechanism was damaged but the steering wheel could still turn the wheels. The tire was still inflated. The hubcap was missing from the front right wheel.

Figure 2-18 – Test 566. Vehicle damage to the impacted corner

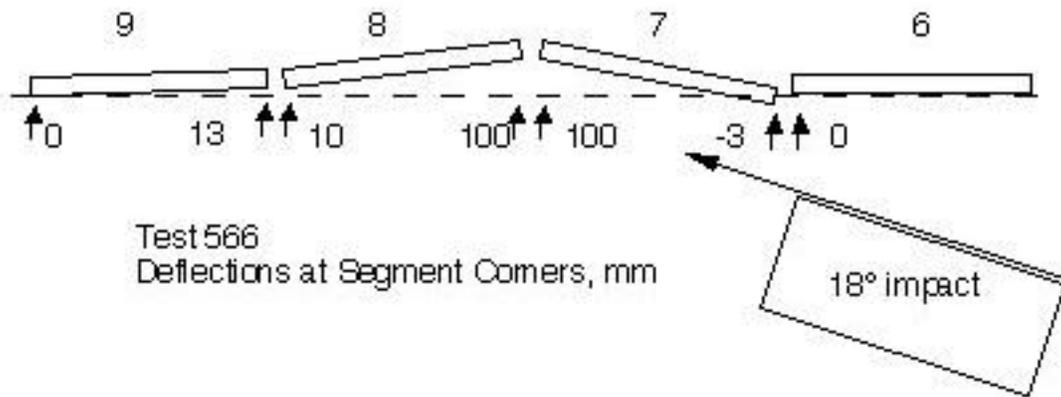
The barrier shifted a maximum of 100 mm during impact.

Figure 2-19 – Test 566. Barrier deflections

Impact occurred on segment 8, 535 mm downstream from joint 7-8. Damage was limited to scuffing on the face of segment 8 only. Although the connecting pins were slightly snug, they could be pulled out using a pry bar.

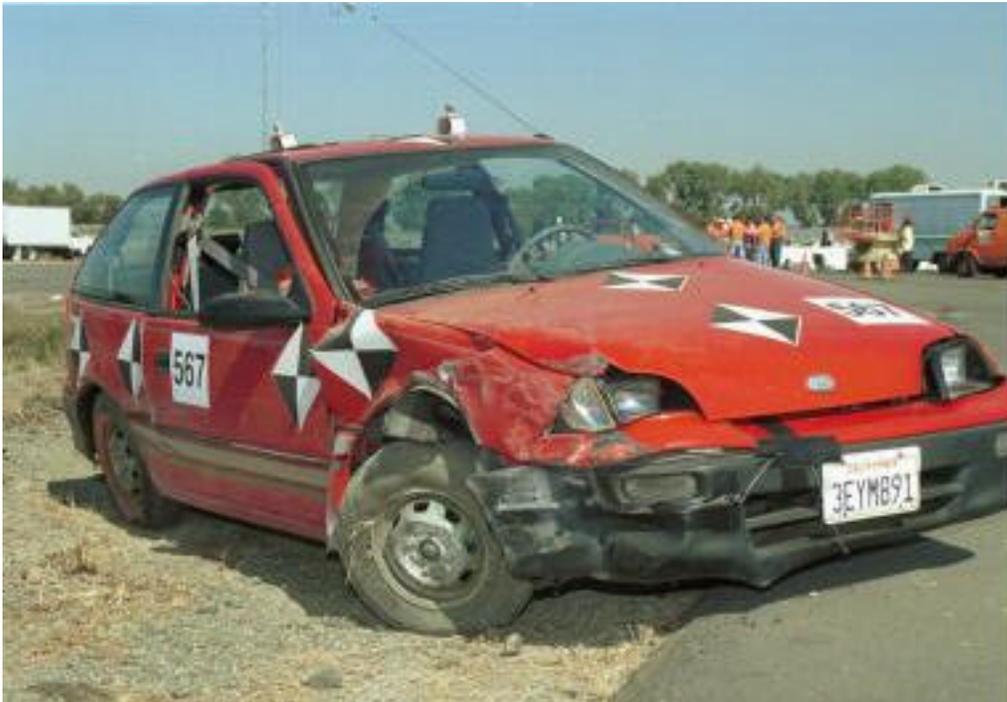
The damage to the test vehicle was similar to the vehicle damage in test 566. Most of the damage was limited to the front right corner of the vehicle. The corner panel was crushed and the hood had a small dent. The right 300 mm of the front bumper was pushed back 150 mm into the wheel well. The front right wheel was turned inward more severely than in test 566 and the hubcap was lost. The steering mechanism was damaged but the steering wheel could still turn the wheels. The tire was still inflated.

Figure 2-21 - Test 567. Damage to the impacted corner of the vehicle

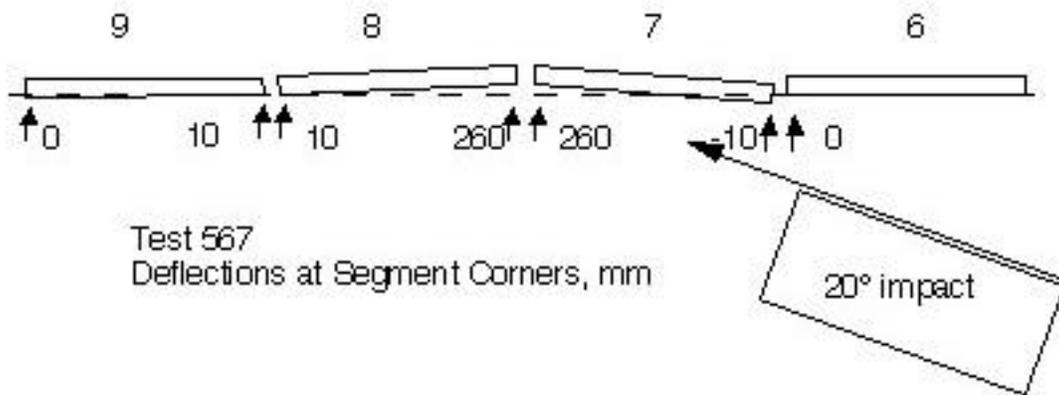
The barrier shifted a maximum of 260 mm during impact.

Figure 2-22 - Test 566. Barrier deflections

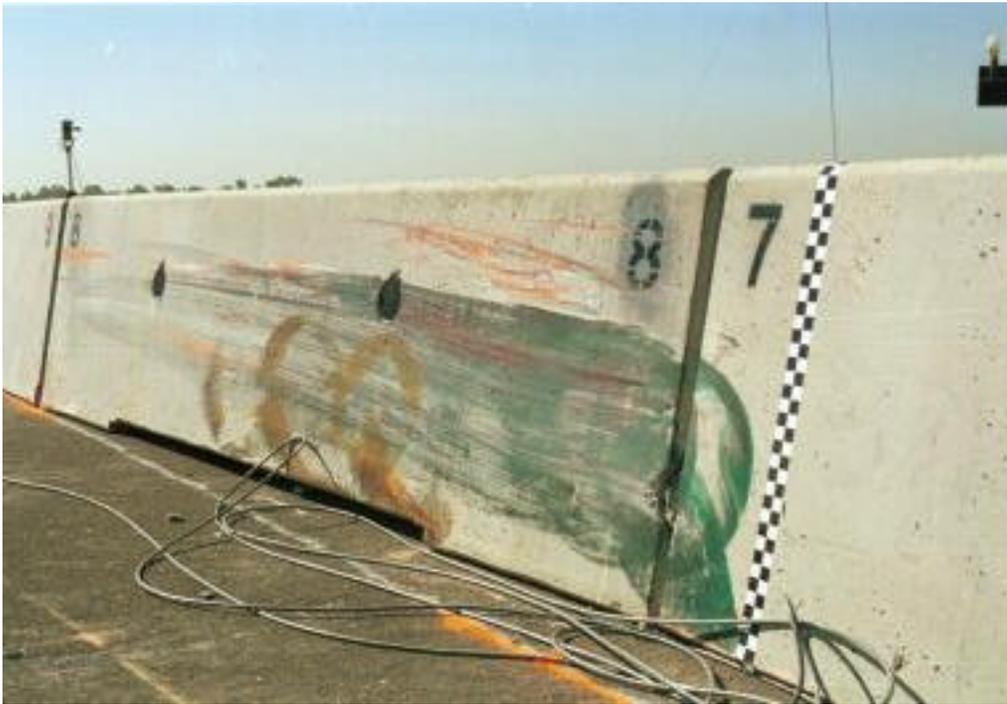
Impact occurred on segment 7, 100 mm upstream from joint 7-8. Segments 7 and 8 received some scuffing during contact with the test vehicle. Segment 8 received some minor spalling at

its leading edge. As in Test 566, the connecting pins were slightly snug, but could be pulled out using a pry bar.

Figure 2-23 – Test 567. Scuffing and lateral deflection of barrier
