Vehicle Crash Tests of the Aesthetic, See-Through Concrete Bridge Rail with Sidewalk, Type 80 SW

August 1998, revised 8/99

Robert Meline, John Jewell, Rich Peter

Materials Engineering and Testing Services  
California Department of Transportation  
5900 Folsom Blvd.  
Sacramento, CA. 95819

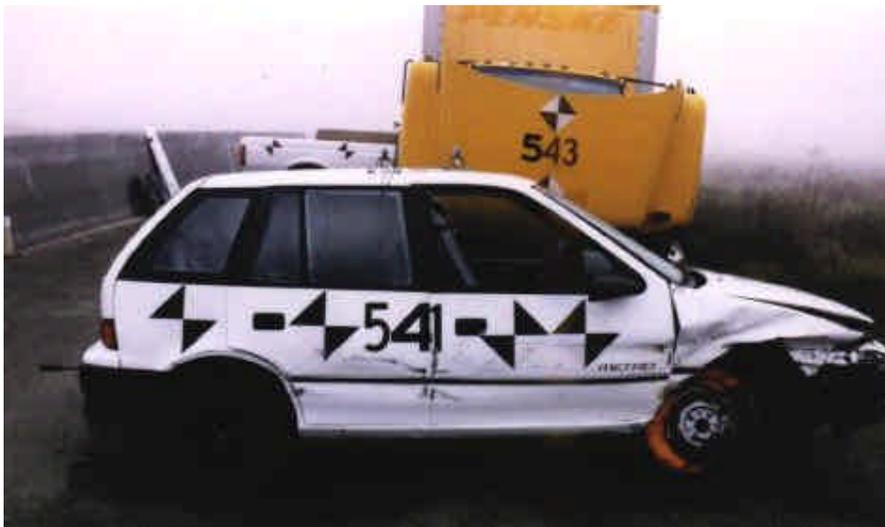
Figure 2-21 -  
Close up of  
Passenger Side  
Front Damage,  
Vehicle 541

The right front section of the vehicle sustained crushing of the bumper and minor unibody frame deformation, damage to the suspension and a flat tire. Initial right front wheel damage occurred on impact with the sidewalk 0.38 m from the beginning of the bridge rail installation. The sidewalk contact caused deformation of the wheel and tire deflation. Other tires experienced minor deformation on impact with the sidewalk but remained inflated. After contacting the bridge rail the right front wheel was pushed back, forcing the wheel well area to deform (Figure 2-21).

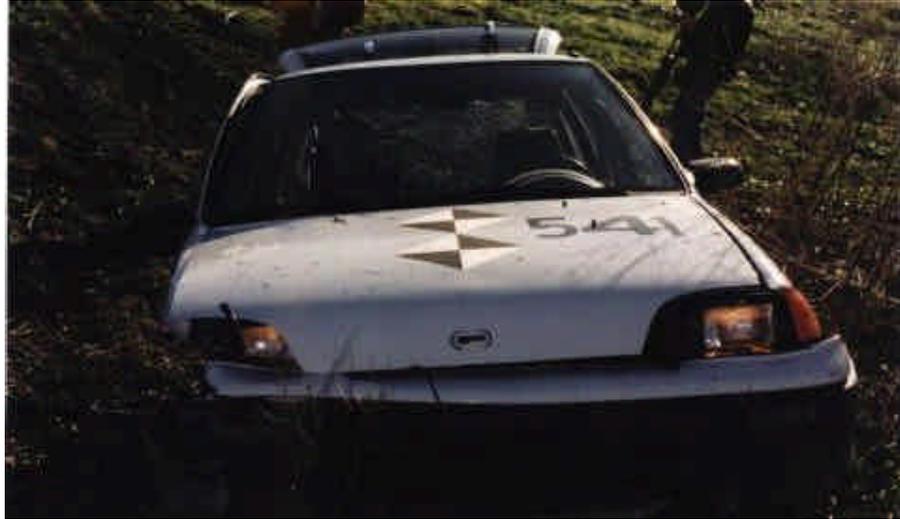
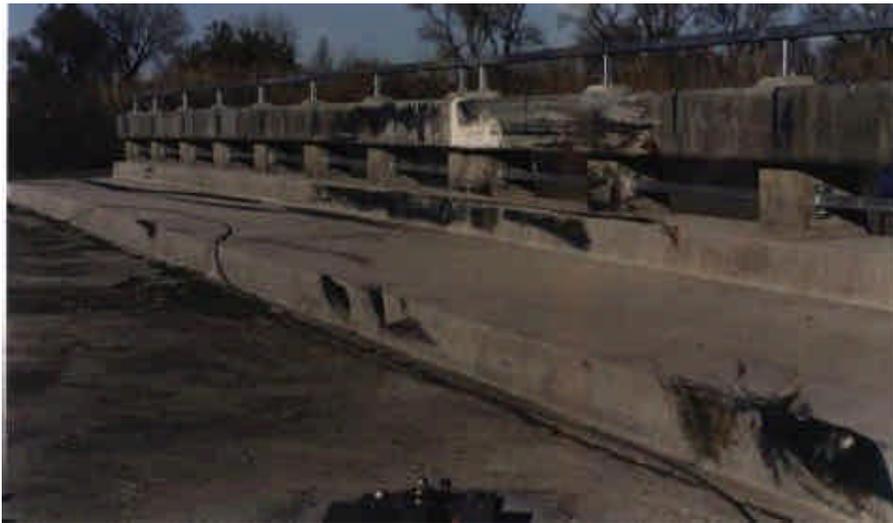
Figure 2-23 -  
Post Impact  
Bridge Rail  
Scuff Marks Test  
541

Barrier damage was cosmetic only, consisting of scrapes and tire marks. Both of the right side tires left marks on the sidewalk curb then on the curb and beam section of the bridge rail. Small amounts of concrete spalled from the face of the barrier where the vehicle's sheet metal and wheels made contact.

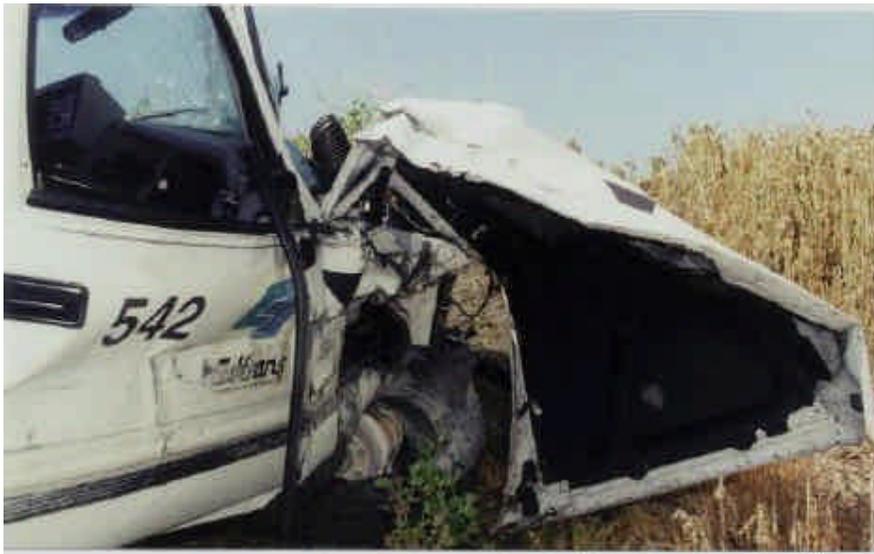
Figure 2-36 -  
Close-up of  
Impacting  
Corner Of  
Tested  
Vehicle 542

The extra speed of the vehicle, 10.2 km/h over target, undoubtedly contributed to higher deformation of the impacting right corner of the vehicle than would have otherwise occurred. Figure 2-36 shows the right front wheel pushed back into the wheel well, caused by impact with the rail curb and beam face. All of the wheels stayed connected to the vehicle throughout the test. The front right shock absorber, stabilizer bar and upper and lower control arms were bent but still attached. The rear and left front suspension components were intact and appeared undamaged. There was minor deformation of the right front frame.

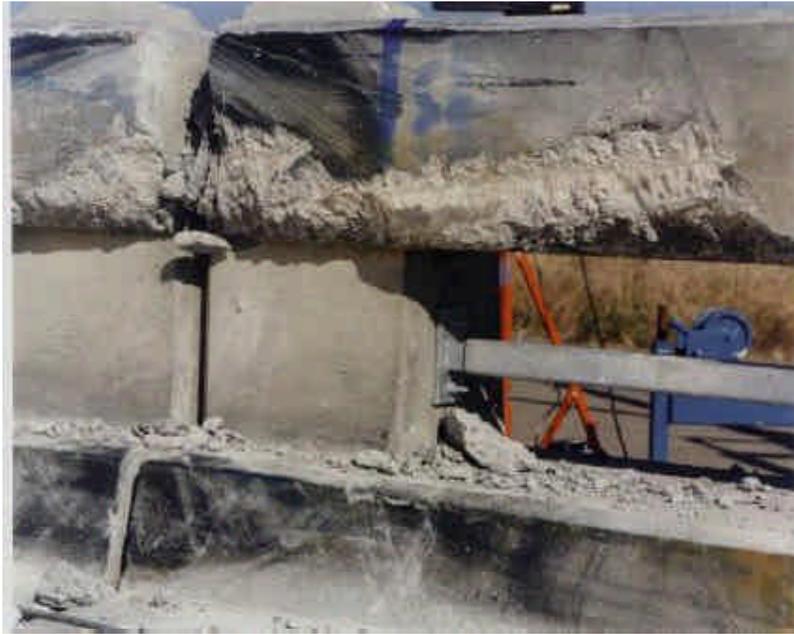
Figure 2-55 -  
Close-up of  
Impact Area for  
Test 543

It appeared that the right front lug nuts scraped along the beam face, causing most of the concrete spalling seen in Figure 2-55. The right wheel well hit the handrail 0.028 s after initial contact with the bridge rail. Beginning 0.177 s after contact with the bridge rail, both the left front and left rear tires rose approximately 1 m off the ground and remained off the ground for 0.480 s and 0.757 s, respectively. The vehicle continued to make contact with the barrier for approximately 4.5 m. A peak roll of the vehicle box section to the right and then left was 17.5° at 0.521 s and 14.5° at 1.099 s, respectively, from the impact with the rail. These peaks were taken before the vehicle exited the end of the test article installation. Higher values may have occurred later after the brakes were applied. The vehicle continued to a point of rest on an earth berm about 43 m from the point of impact. The vehicle remained upright throughout and after the collision.

The barrier was scraped along the face and edges over a 3 m length. There was also spalling on the underside of the beam caused by the downward force of the rotating right front wheel lug nuts. The tire marks along the barrier were only a little longer than the scraping along the face. A concrete spall at the expansion joint was 80 mm to 100 mm deep and extended to the back face of the rail, shown in Figure 2-55 and Figure 2-56. The spall exposed the end of a piece of rebar but no structural damage was evident. The bridge rail withstood the impact from vehicle 543 well with only spall repairs necessary before subsequent tests.

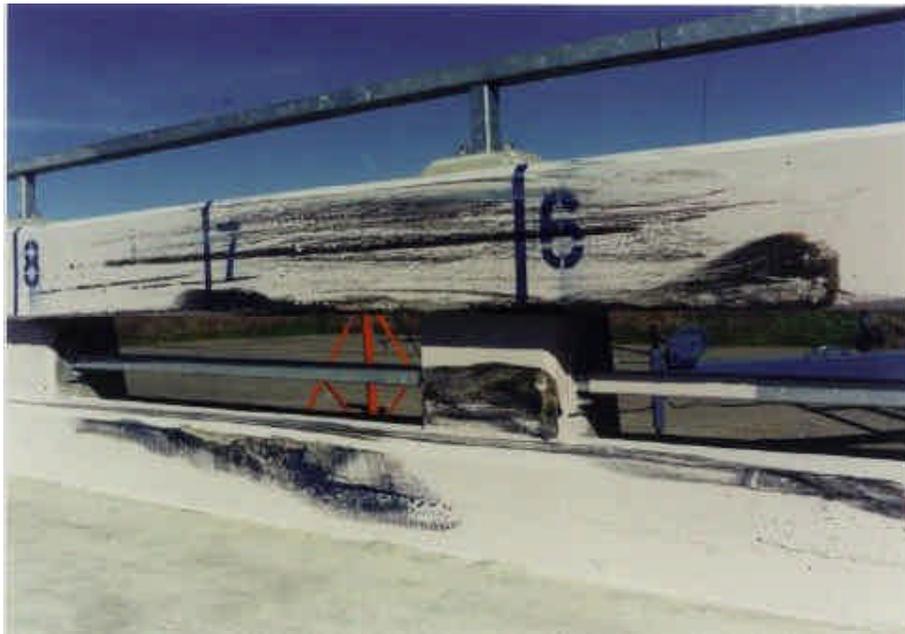
Figure 2-68 - Close-up View of Bridge Rail at Impact Point for Test 548

Since this was a repeat of Test 541, the impact location for Test 548 was set at the same location as Test 541. In order to see clearly the impact marks on the test article, previously damaged or marked areas of the rail had been painted. The impact damage due to Test 548 consisted of only minor scraping and tire scuffing. The total length of impact with the bridge rail was only slightly more than 4 m.
