EVALUATION OF ABRASION RESISTANCE OF PIPE AND PIPE LINING MATERIALS

Final Report

FHWA/CA/TL – CA01-0173

September, 2007

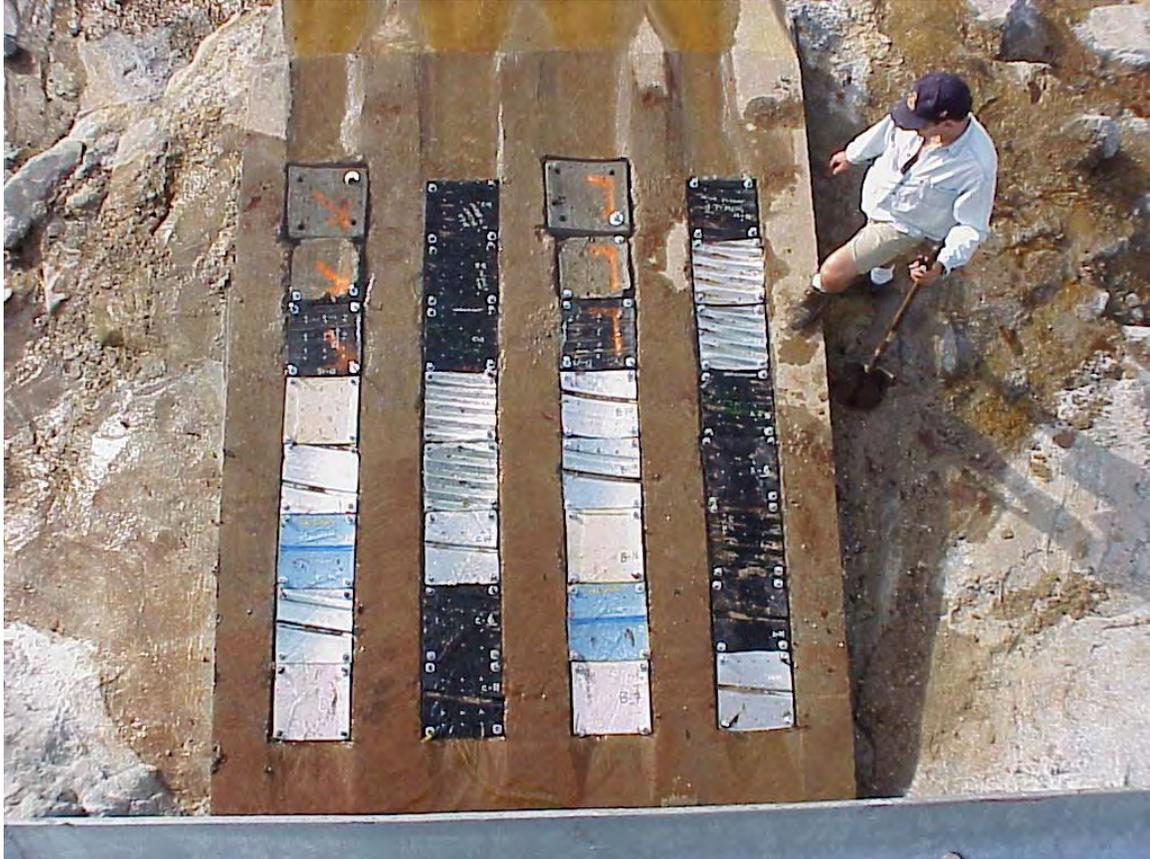
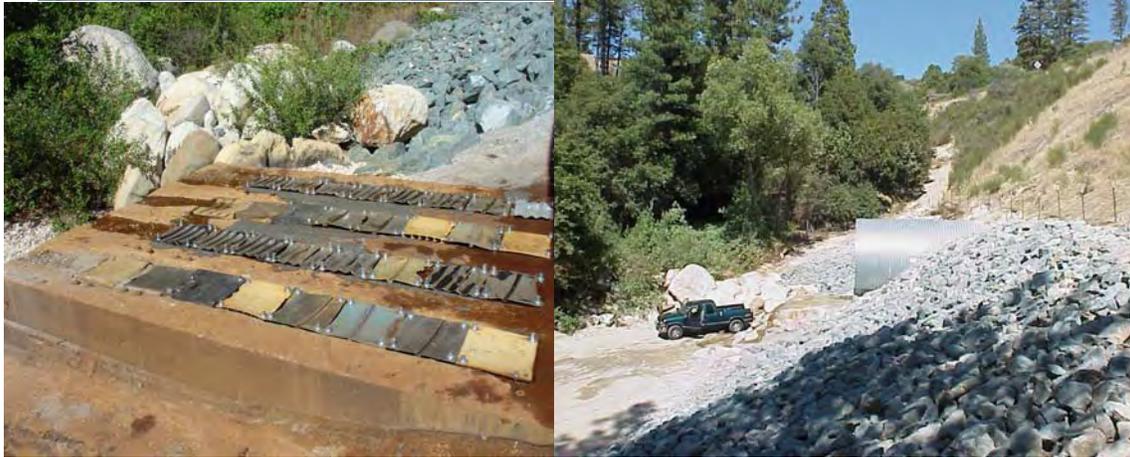
Caltrans abrasion test site at Shady Creek (Highway 49 crossing) photos: September 2001 and 2005

(Cover photo: failed original pipe at outlet)

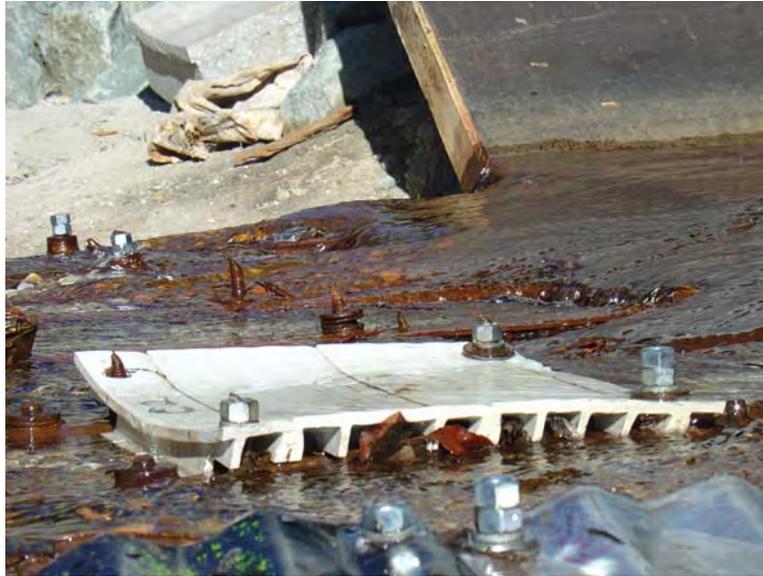
discharge. The bed-load wear stain on the side of the trapezoidal channel near the outlet of the culvert adjacent to the test pad is located entirely within 0.3 ft above the invert in the “unsampled sediment discharge” zone. See picture below:

(Above): Bed-load wear stain on side of steel plate channel

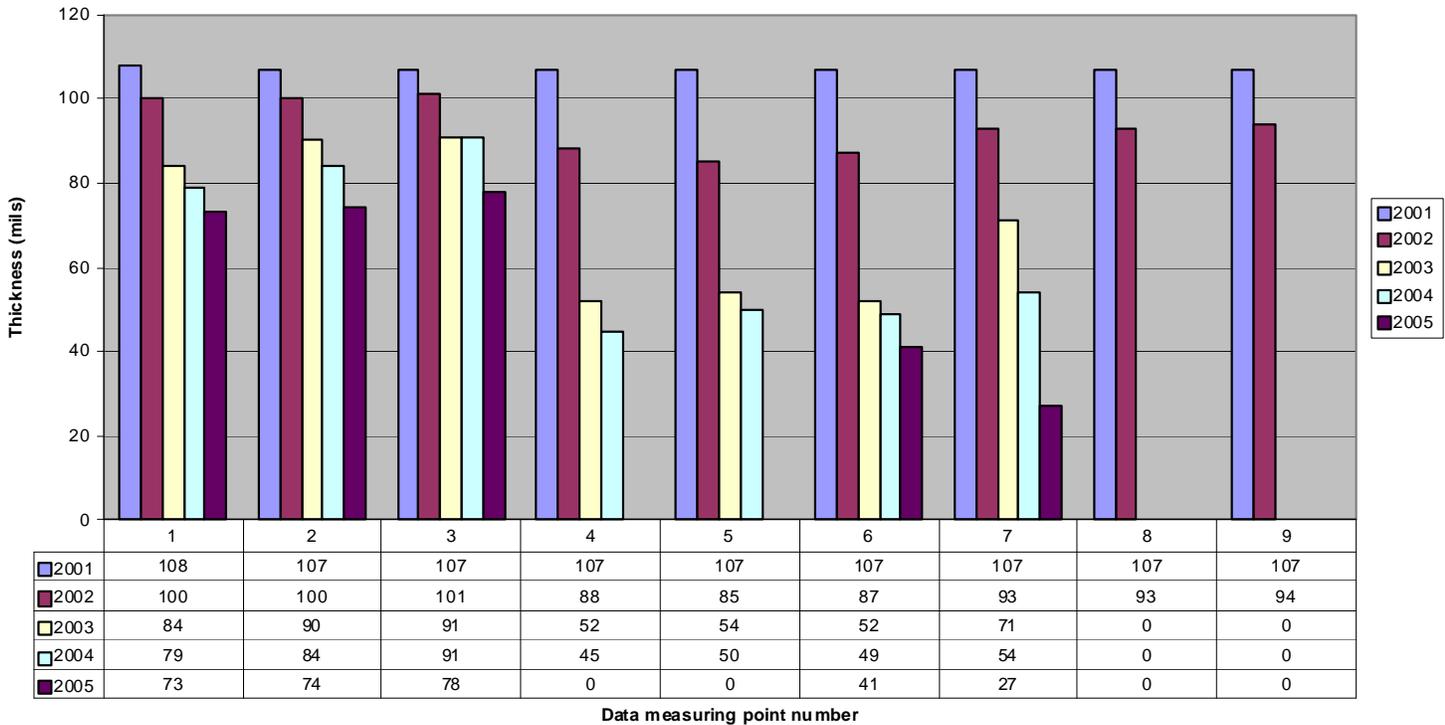
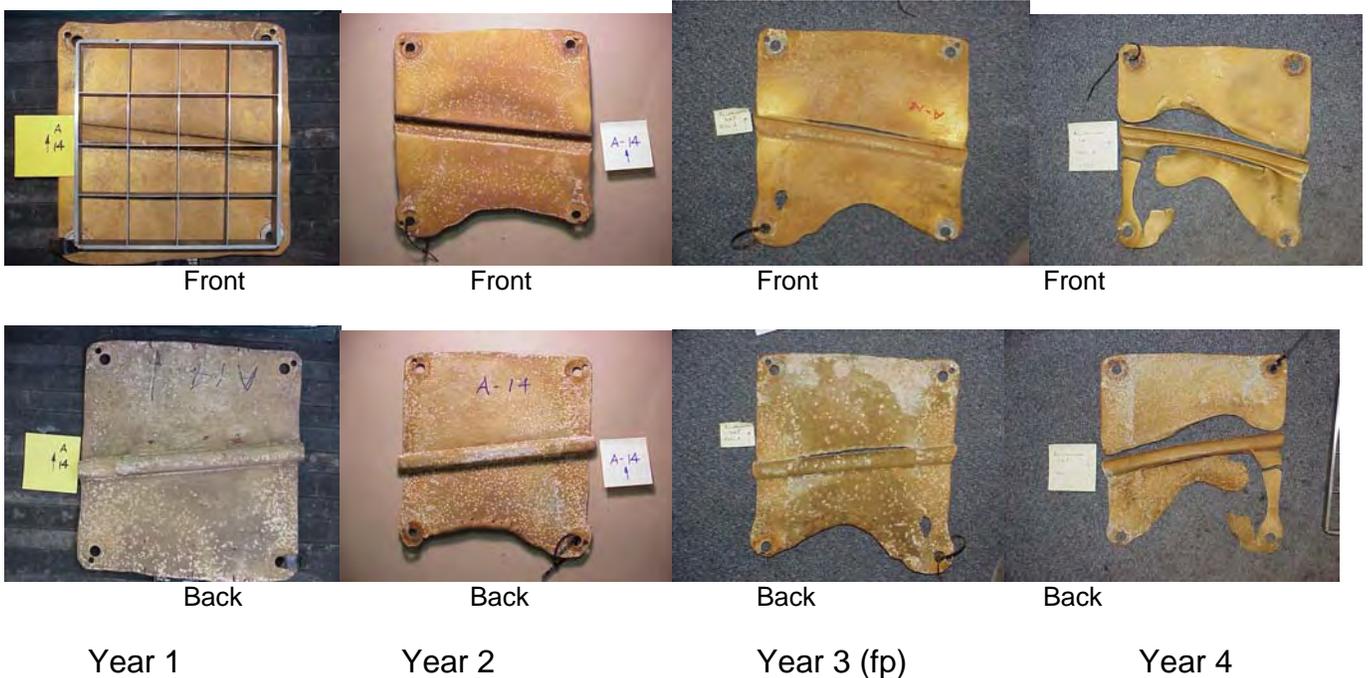
Aluminum SRP Row A

First perforation (fp) to row A panel occurred during year 3. No perforations to row C panel were observed through year 4. Both panels were destroyed during year 5.

Both panels were destroyed during year 5. The averaged wear rates from the data points were very similar during each of the first four years. However, significantly, during year 3 the panel in row A perforated along the leading edge of the rib for several inches in a thin line. The annual wear rate leading up to first perforation was 43 mils/year which was approximately 2.5 times higher than the averaged annual rates of 17 mils/year from the data points in the same panel (assuming first perforation occurred mid way through year 3). There were no perforations observed anywhere on the panel in row C which also experienced slightly lower wear rates than the panel in row A. By year 2, both panels were significantly worn at the leading edge. It is undetermined why the panel in row C seemingly “outperformed” the counterpart in row A. One explanation could be the placement within respective rows; the panel in row A was the very first in the row with the smooth metal plate directly upstream. The panel in row C was third back with a corrugated metal sample directly upstream, which may have deflected some flow offering limited protection. See Appendix A.

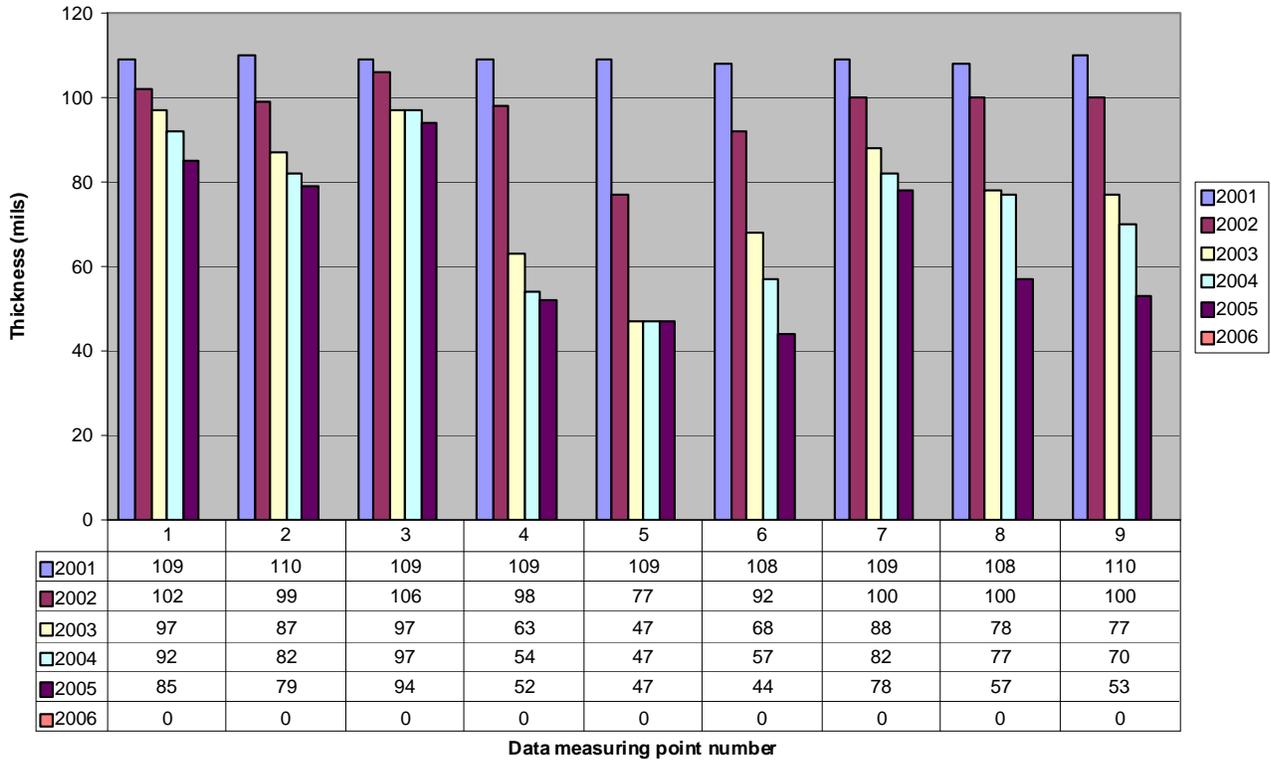
Aluminum SRP Row C

In row C, in a single year, the maximum annual wear rate recorded was 35 mils/year compared with an averaged annual rate of 19 mils/year for the same year (year 2). During the same time period, compared to the uncoated corrugated steel panels in the same rows, the Aluminum panels wore 2-3 times faster in row A, and 1.5-2 times faster in row C. A comparison between the peak annual wear rates for both panels with the uncoated spiral rib steel panels also indicated that under similar conditions Aluminum abrades approximately 2-3 times faster than steel. Caltrans current design guidance in the Highway Design Manual states that under similar conditions Aluminum abrades approximately three times faster than steel.

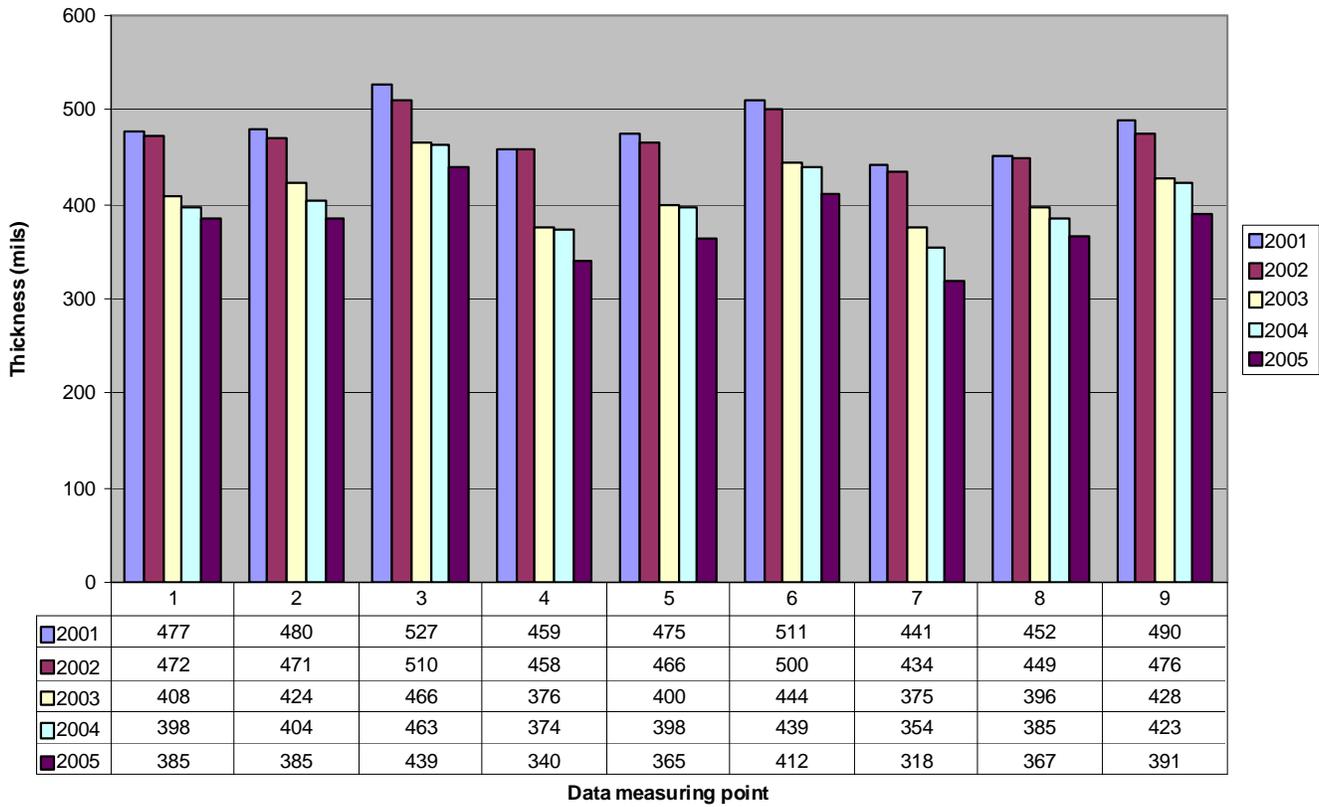
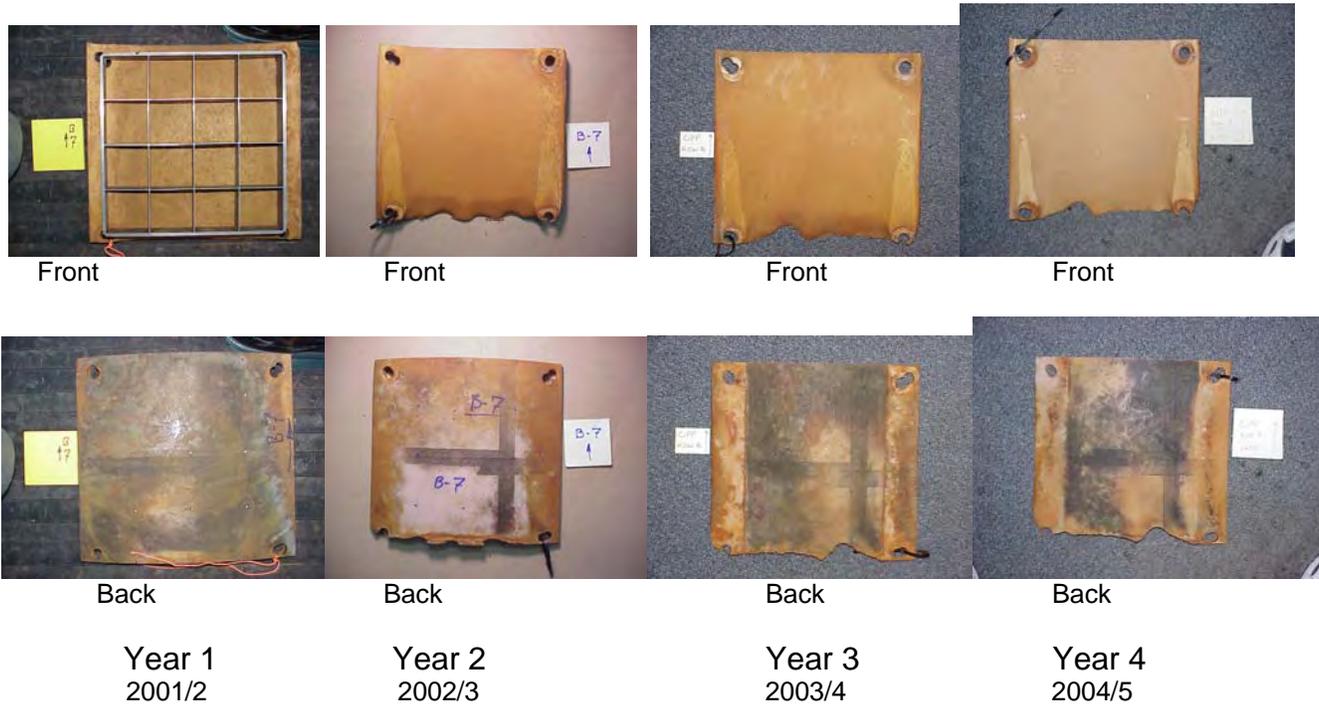
CIPP Row B

The smooth profile CIPP samples, along with the steel plate inside the culvert provide an excellent reflection of the previously discussed variable abrasion potential across the concrete apron from left to right (viewed downstream) and also of the variation in wear rate between the individual years of the study as a result the number and size of the storms and associated velocity (see pages 10 and 13). The CIPP panel in the more benign row D (where it is assumed that less bed-load was present) survived all five years of the test with virtually no wear during the first four years (1- 5 mils/year average wear recorded). However, year 5 produced a maximum of 54 mils of wear in one season and completely destroyed the panel in row B (or at the very least its anchorage – see pictures in Appendix C). With the smooth profile, the wear was distributed evenly to both panels. By the end of year 2, the leading edge to the panel in row B was significantly worn. This did not occur until year 5 in row D. The variability of the storm seasons for the first four years of this study is reflected best by the wear rates seen in the row B sample: Years 1 and 3 were very similar in terms of average wear compared to average and peak velocity generated during the same years:

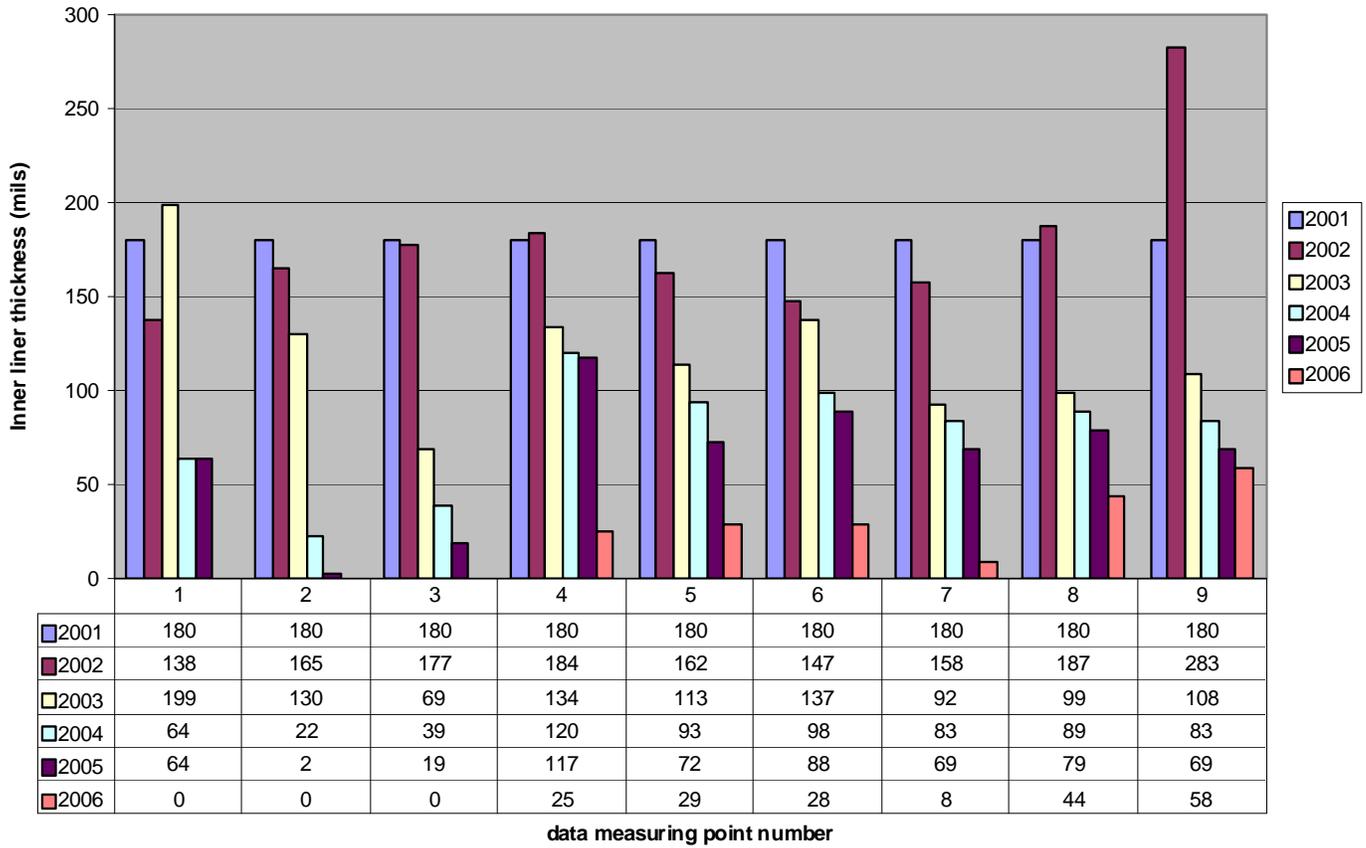
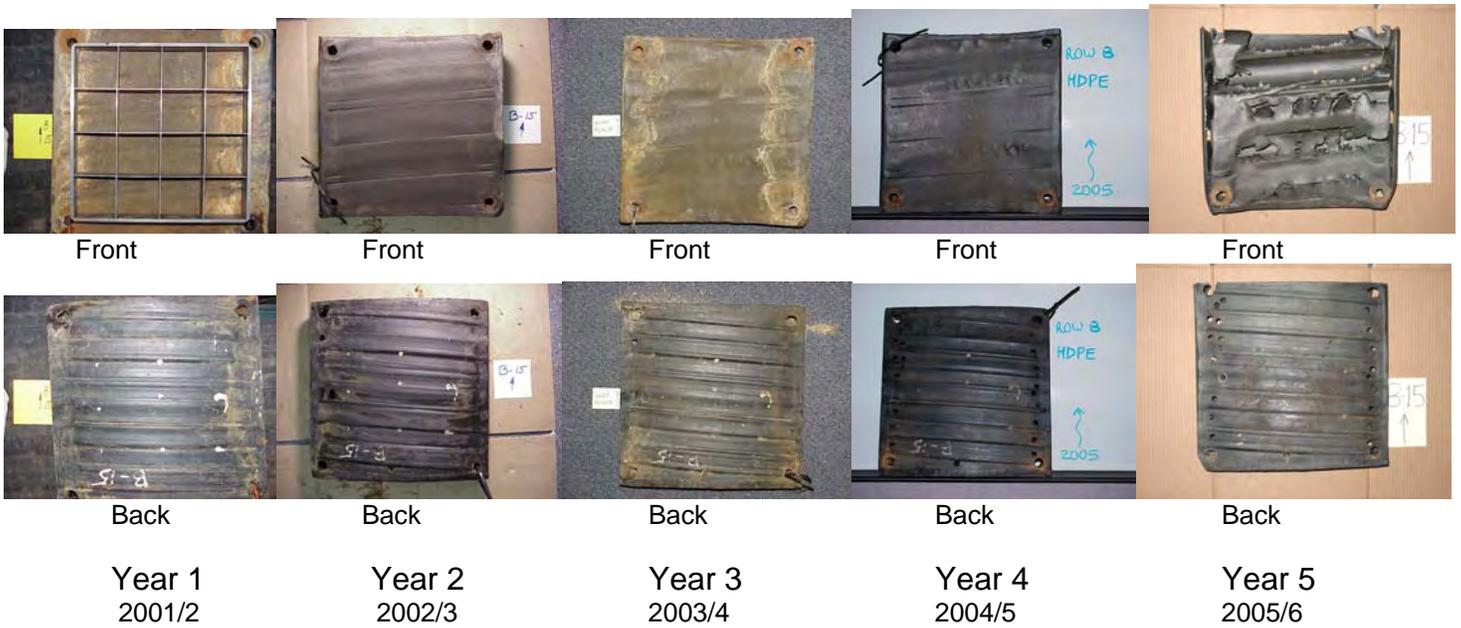
HDPE Row B

Except for the first year of the study, the recorded wear rates of the two HDPE samples also reflected the previously discussed varied abrasion potential across the concrete test apron. During years 2 through 5 the relative wear rate in row B was more than four times the rate in row D.

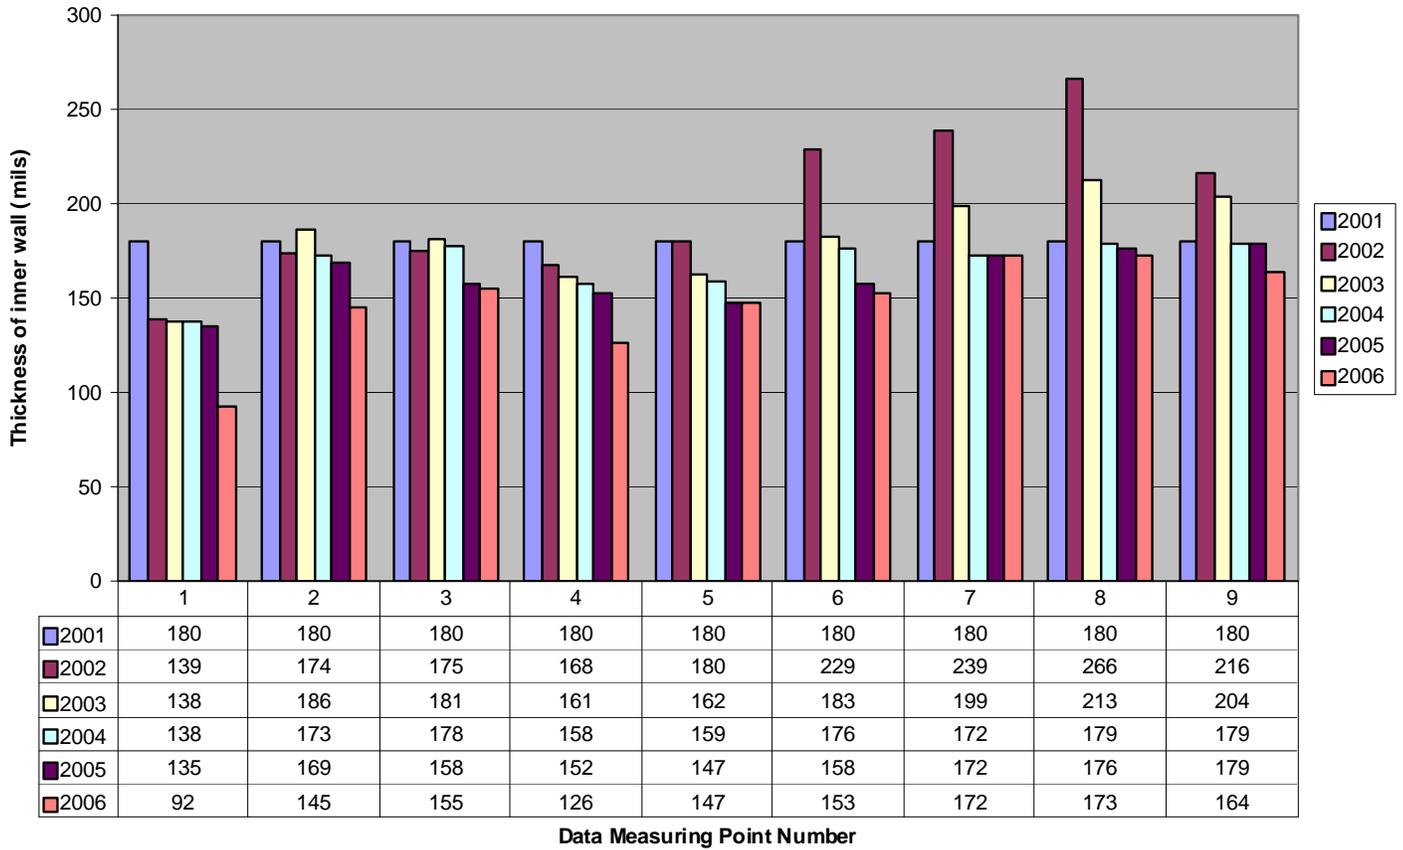
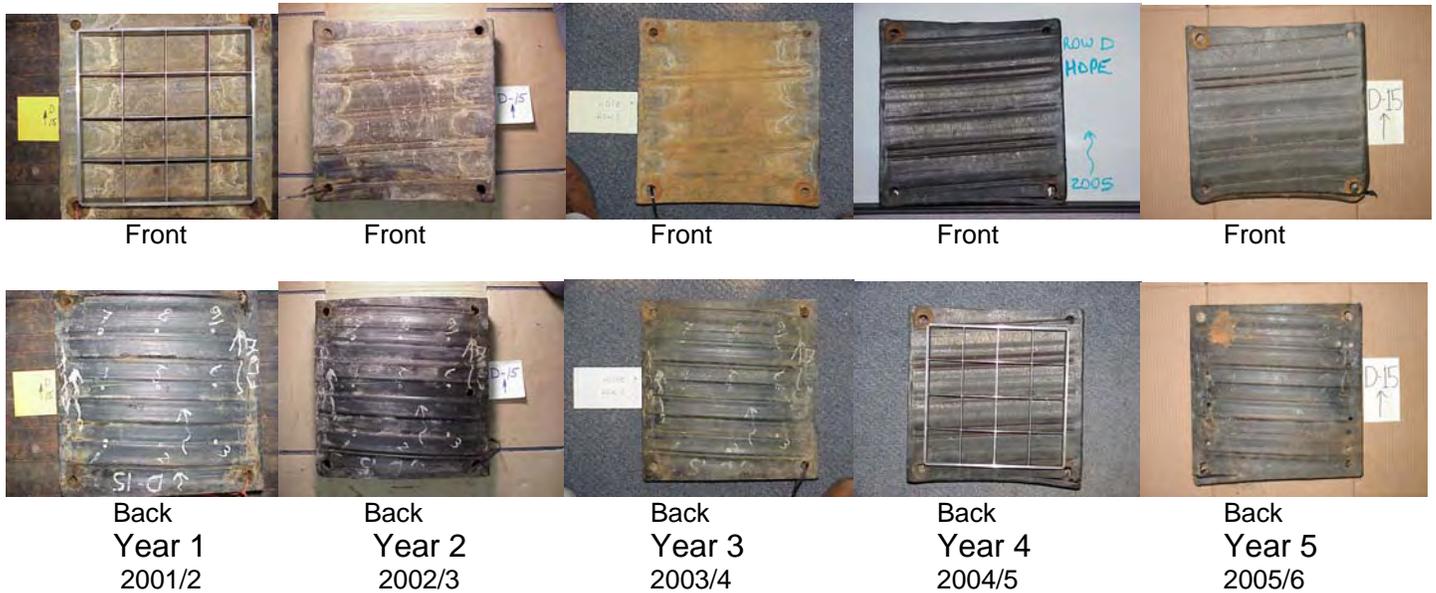
HDPE Row D

During the first four years in row D, the recorded wear rates at the data points for the other three resin-based products were approximately equal with one another and under similar conditions the HDPE panel abraded approximately two times faster (the peak rates were approximately four times higher). However, during the extreme conditions for the final year (Year 5), HDPE seemingly out-performed both PVC and polyester resin but may have been impacted by the loss of upstream panels. A notable lack of increase to the peak wear rates was noted for both of the HDPE panels during year 5 which may be attributed to the upstream panels being washed away exposing the square leading edge possibly causing a splash-over effect and deflecting flow.

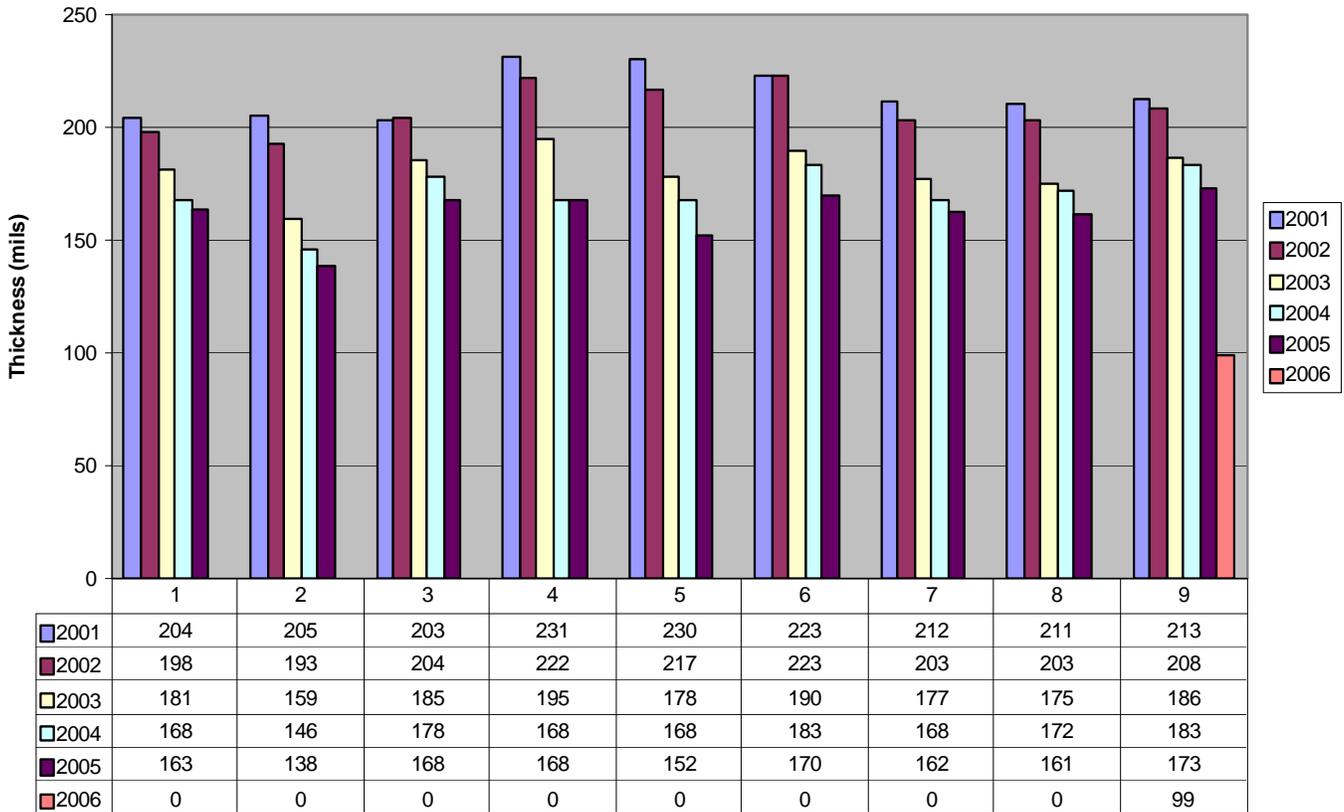
PVC Row B

liner. For the same time period in row B, the PVC wear rates were lower than both the polyester resin (CIPP) and HDPE samples and about the same as the polyethylene liner. During year 5, most of the sample in row B was destroyed, but for the one data point that remained, the recorded wear for year 5 was measured to be 74 mils.

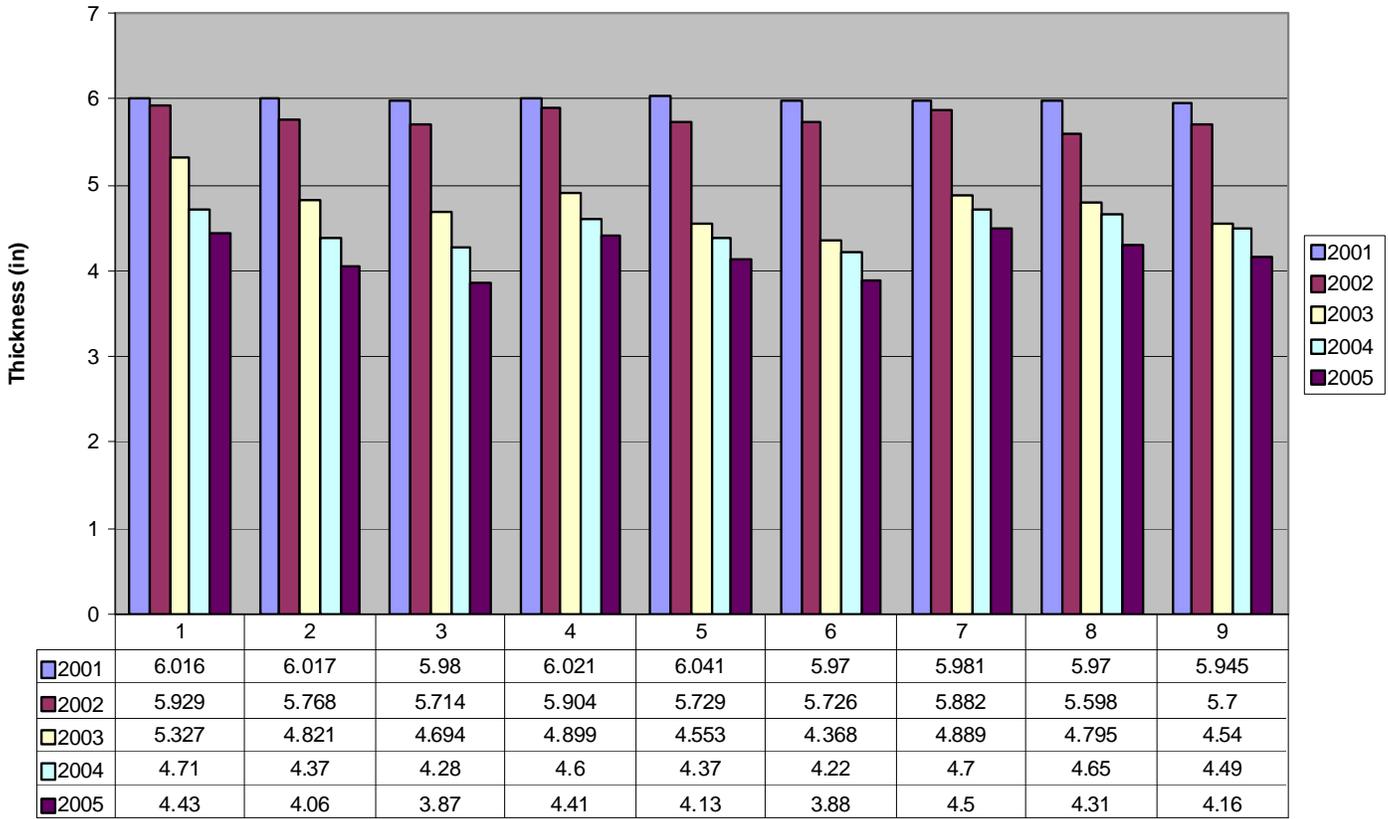
RCP - Row B

Row B: Unlike the panel in row D, the panel in the more aggressive row B experienced wear with similar wear rates at each data point during each of the first four years. However, similar to the polyester resin sample significantly higher (1.36 inches) wear rates were recorded during year 2 than during the other years even though year 4 was comparable regarding average and peak velocity and total number of events (see page 12). A small piece of the steel reinforcement was exposed on the right side in grid location D2 (A-D = x axis – see photos in Appendix C) during year 2. In both samples that were tested, the first layer of steel reinforcement was located approximately 1.6 inches below the exposed surface on the inside of the pipe (per AASHTO Designation: M 170-06, the protective covering shall be 1 in. with a permissible variation of +/- 10 percent of the wall thickness or +/- ½ in., whichever is greater. Both original wall thicknesses were slightly under 6 in.). Significantly more reinforcement was exposed during years 3 and 4. Besides year 2, the wear rates varied between 0.1 inches and 0.6 inches. It is assumed the panel was washed away (rather than totally worn away) during the higher flows of year 5 along with most of the other panels in row B. Therefore, no data was collected for the RCP panel in Row B for year 5. A total wear of approximately 4 inches was measured to the concrete apron nearby.

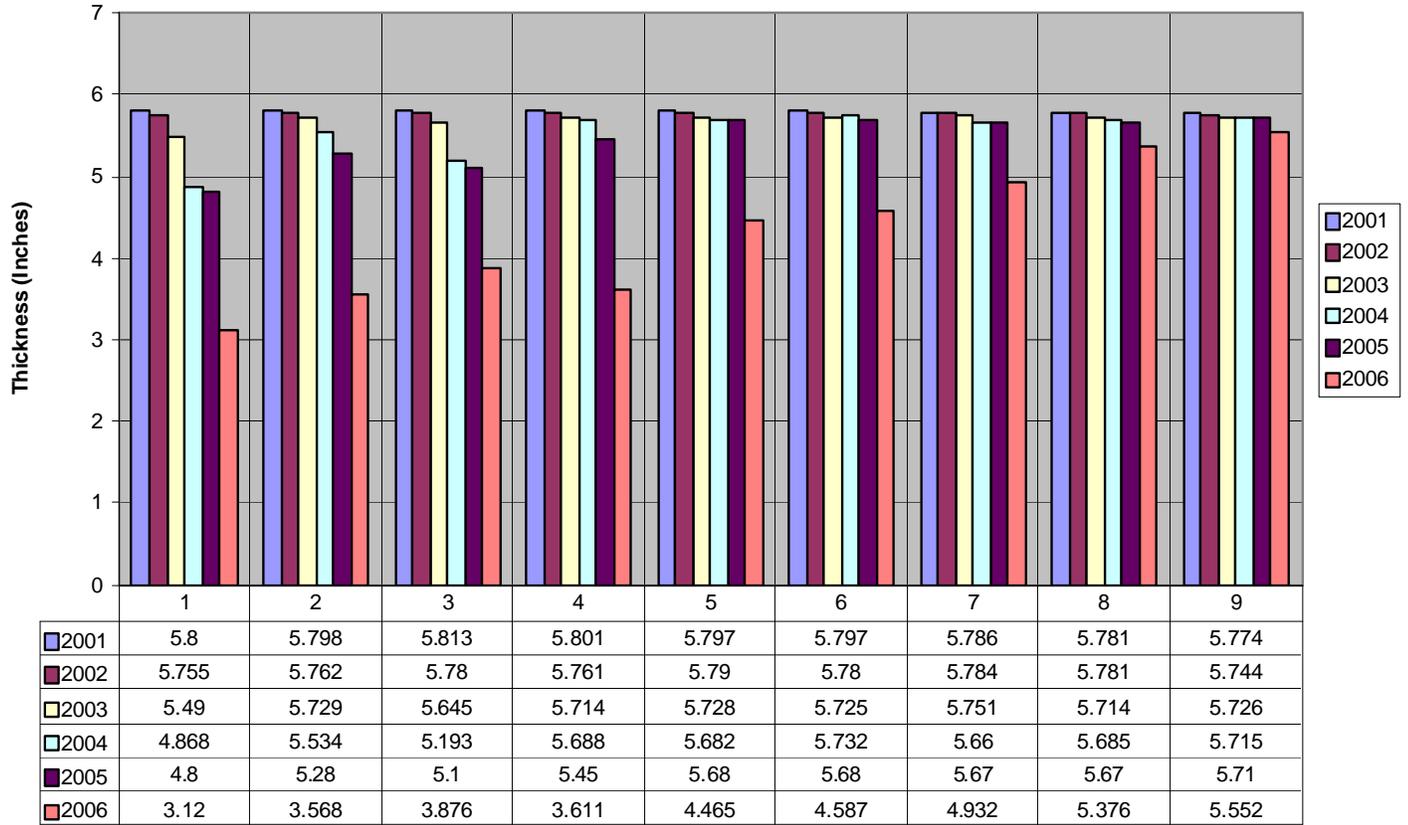
RCP Row D

** Panel impacted during Year 1 as a result of defective material being placed on test panel immediately upstream.

Row D: Along with the CIPP panel that remained in row D, the RCP panel in row D provided dramatic data that highlighted the contrast in wear rates between the first four years and the fifth year. This panel was impacted and suffered a prematurely exposed leading edge during year 1 as a result of defective (cementitious) material being placed on the test panel immediately upstream. However, the leading edge wear did not migrate to the three closest data points until year 3. See Appendix C. The first exposure of the steel reinforcement during year 2 was limited to the leading edge in row D. Besides the three data points closest to the leading edge, during years 1-4 the wear to the remainder of the panel was minimal (0-0.2 inches/year maximum wear) compared to the panel in row B. The beveling of the leading edge in row D may have deflected flow over the mid and rear sections to the panel resulting in potentially less wear. During the storms of year 5, which were large enough to transport significantly more sediment across all four rows, the leading edge wear pattern migrated downstream almost to the rear of the panel. Significant (maximum 1.7 inches/year) wear rates were recorded throughout the front and mid sections of the row D panel and more reinforcing steel was exposed and/or worn away.

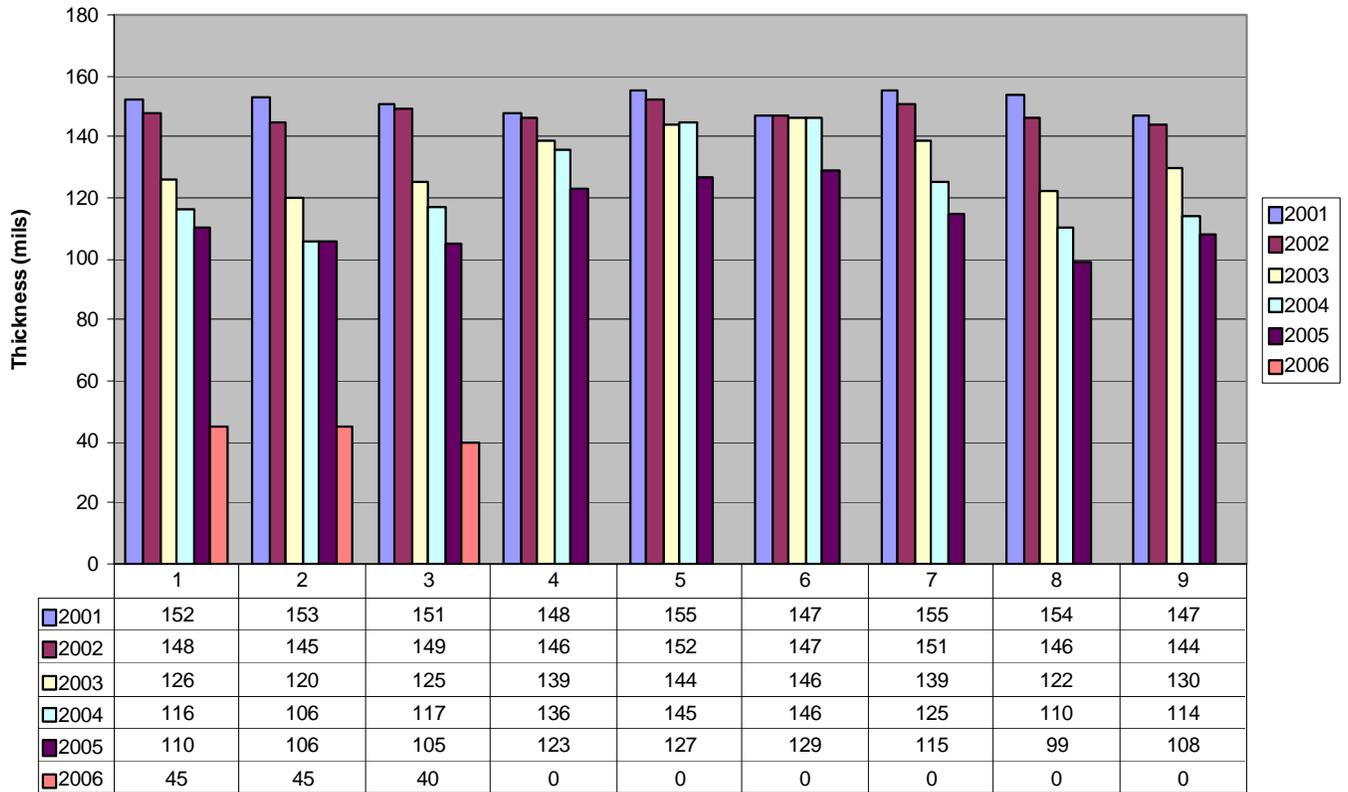
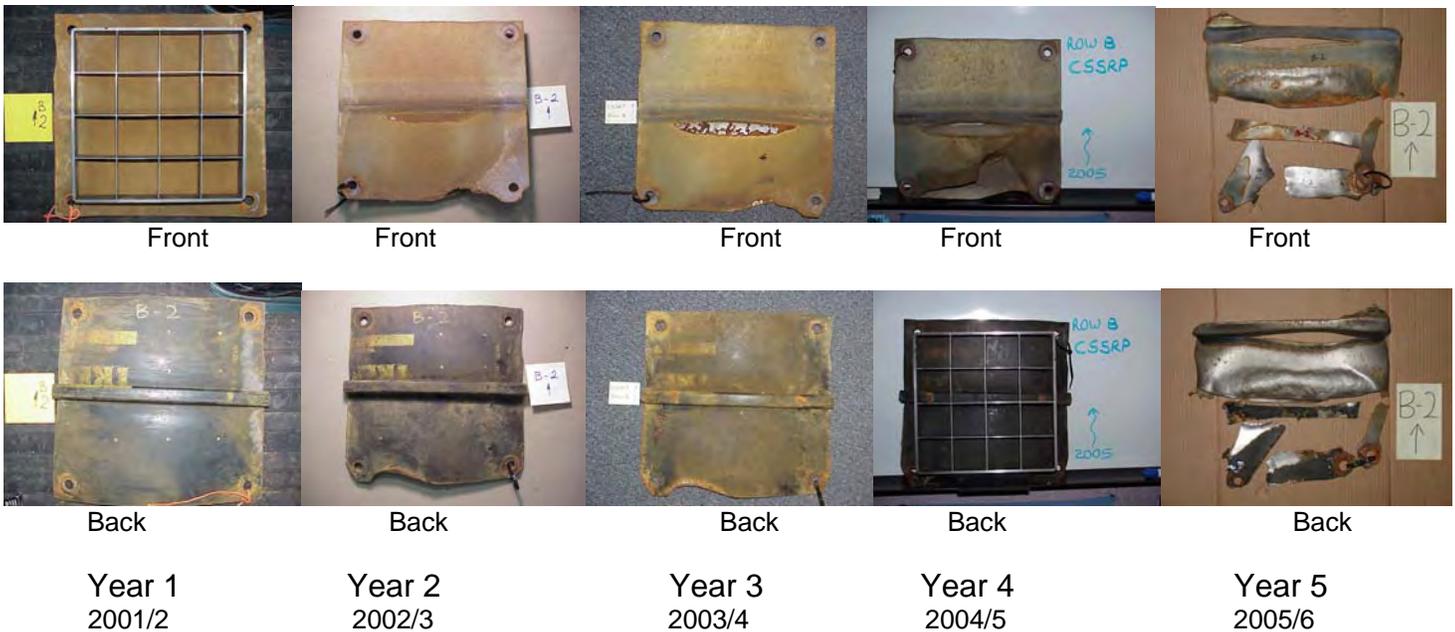
CSSRP Row B

Year 5, row B; only three data points remained. Measured wear to exposed steel was approximately 50 mils. Year 5, row D; Liner delaminated, perforated, and folded over deflecting flow.

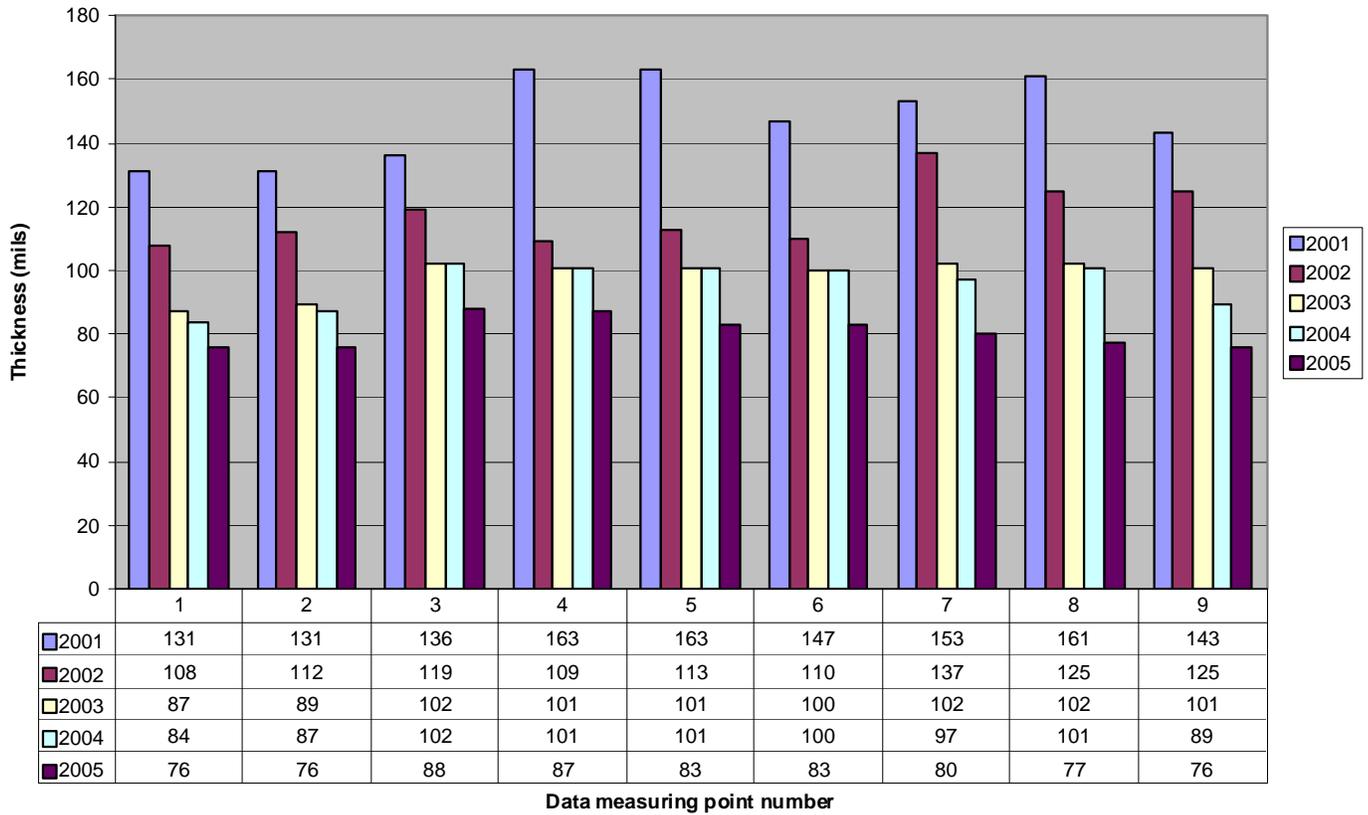
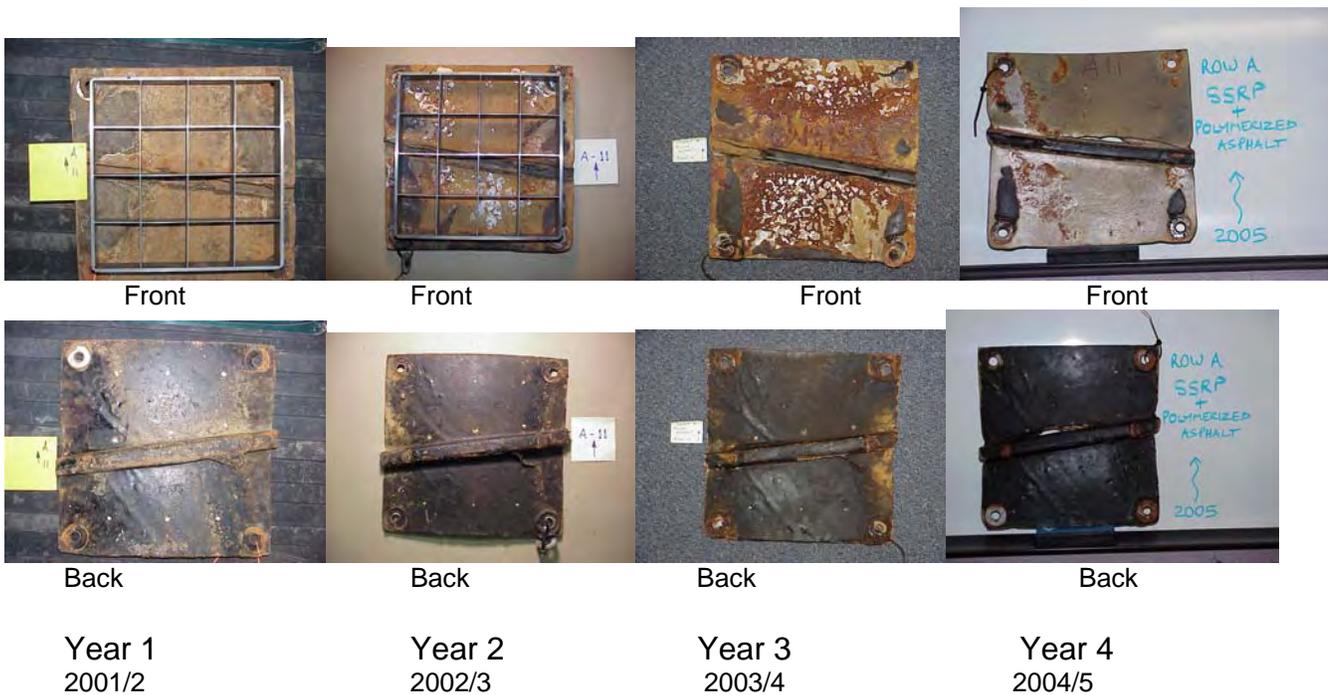
SSRP with Polymerized Asphalt Row A

** Total thickness including variable coating on both sides and 0.064" steel
First perforation (fp) to row A panel occurred during year 4. Both panels were destroyed in year 5. *Wear rate for fp is for 16 gage steel only and ignores the coating.
