**DEVELOPMENT AND CRASH TESTING OF AN AESTHETIC,
SEE-THROUGH BRIDGE RAIL, TYPE 90**

DEPARTMENT OF TRANSPORTATION
DIVISION OF RESEARCH AND INNOVATION
OFFICE OF SAFETY INNOVATION AND COOPERATIVE RESEARCH

December, 2008

1. REPORT NO. FHWA/CA08-0766	2. GOVERNMENT ACCESSION NO.	3. RECIPIENT'S CATALOG NO.	
4. TITLE AND SUBTITLE DEVELOPMENT AND CRASH TESTING OF AN AESTHETIC, SEE-THROUGH BRIDGE RAIL, TYPE 90		5. REPORT DATE December 2008

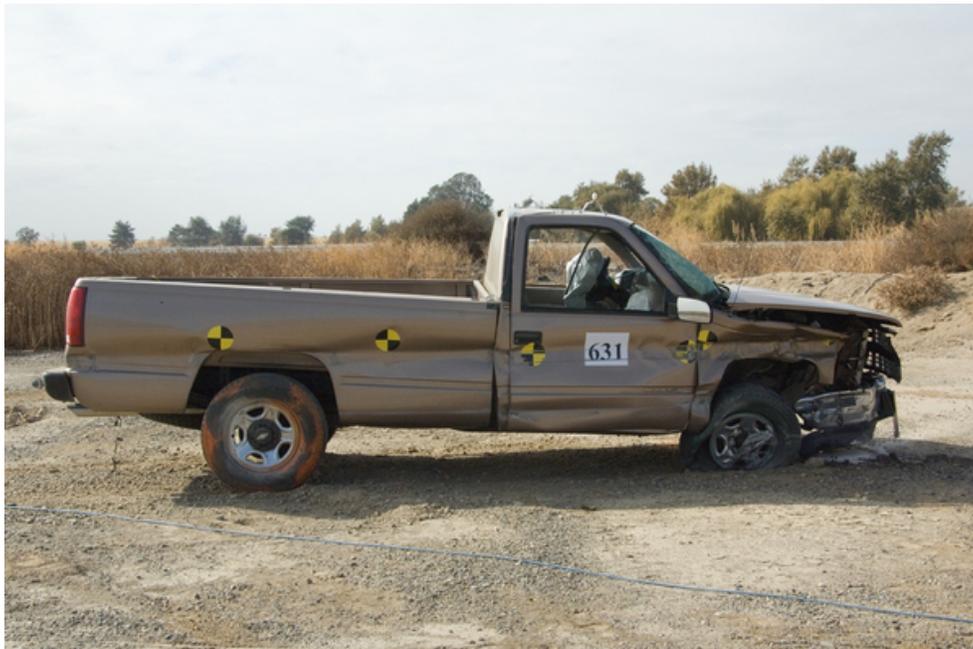
Figure 2-7 – Test vehicle after Test 631

The right front corner of the vehicle was moderately damaged in the initial impact with the barrier. The right front fender, hood, bumper, headlamp area, grille, and suspension components were all affected. The passenger side doorframe was deformed outward but the door remained latched. The right front tire was also ruptured. The steel rail caused denting along the entire length of the passenger side as the vehicle continued to contact the barrier after the initial impact. The right front tire was pushed rearward and slightly into the passenger side foot well area. The maximum amount of passenger compartment deformation was 124 mm¹, which occurred in the floorboard². The entire windshield spider-cracked but did not separate or enter the occupant compartment. However, this cracking was not caused entirely by the test. The windshield was inadvertently damaged (see Figure 2-10) on the impact side shortly before the test was run and it was decided that the damage was not significant enough to warrant postponing the test. Post-crash photos show the initial crack to be the weak point and the source of future cracking.

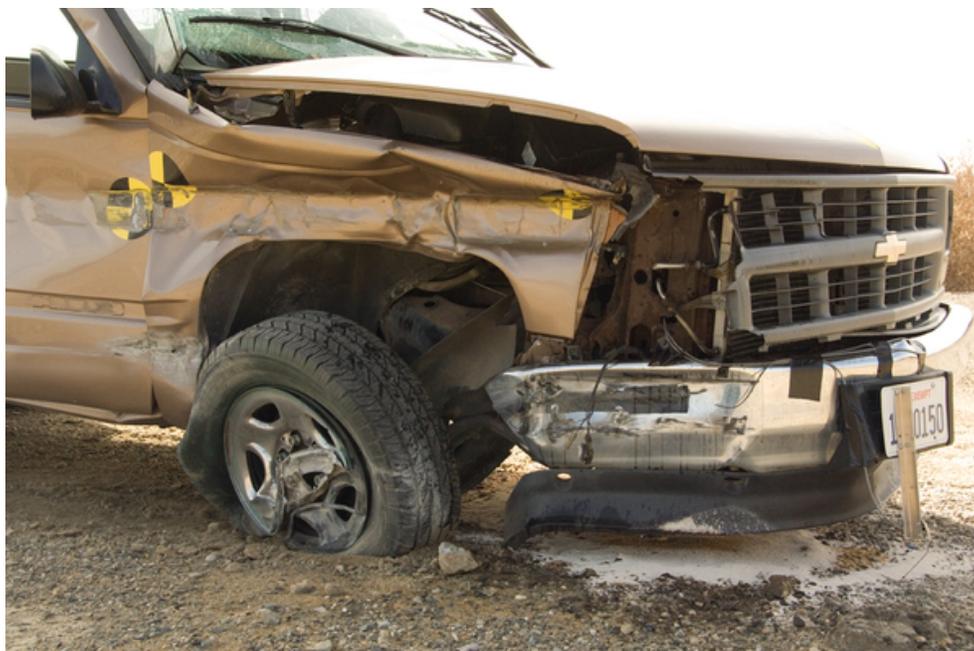
Figure 2-8 – Right front corner of test vehicle after Test 631

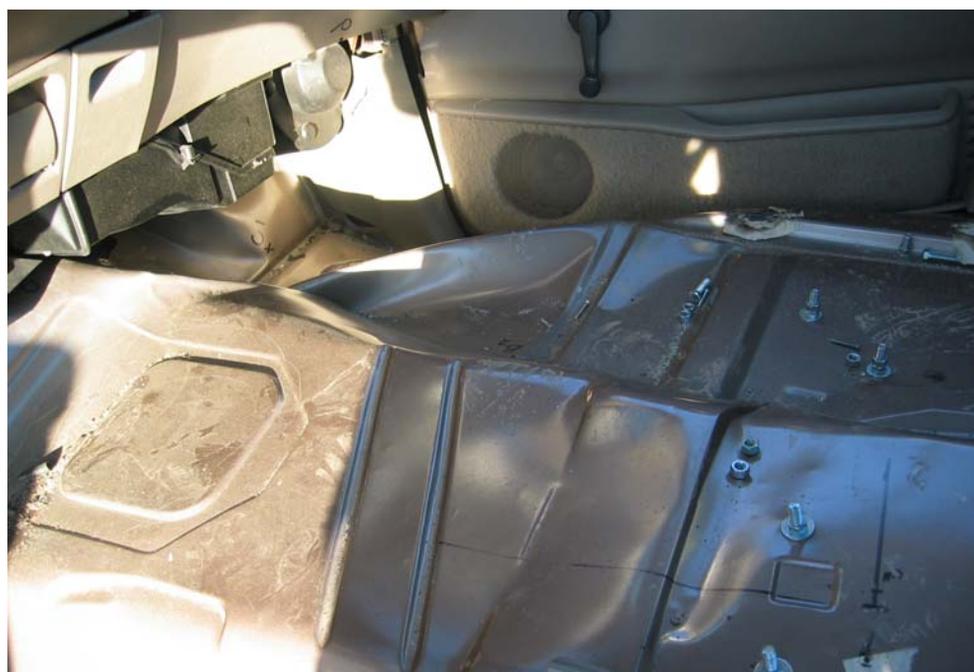
Figure 2-9 – Floorboard deformation of test vehicle after Test 631

¹ It was discovered after the test that there was significant corrosion of some non-structural components of the front grill above the bumper, which may have adversely affected the occupant compartment deformation.

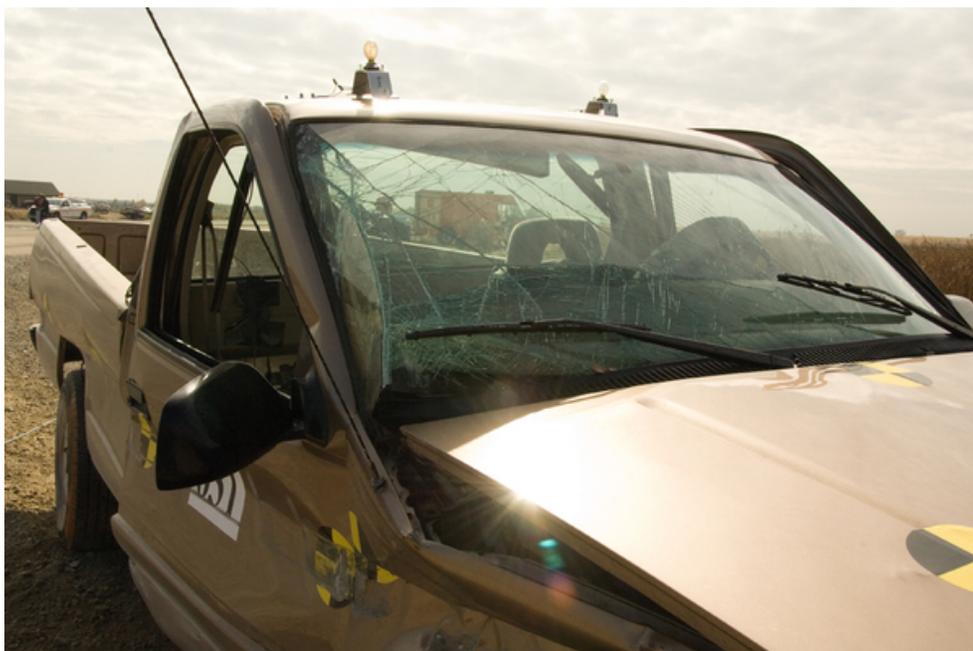
Figure 2-11 – Vehicle windshield after Test 631

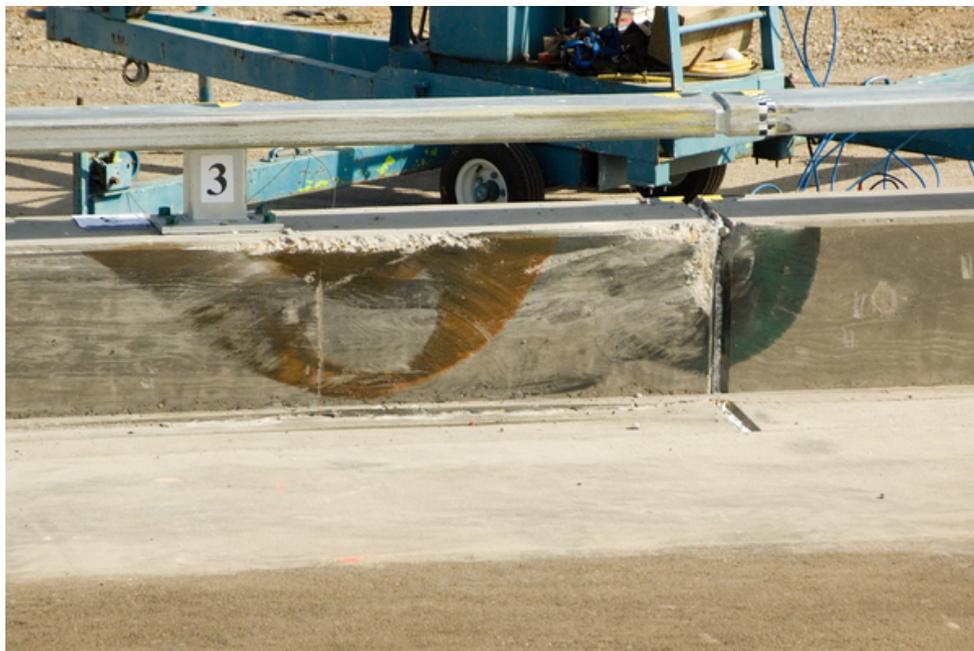
Figure 2-13 – Type 90 barrier face after Test 631

Barrier Damage: Maximum dynamic deflection in steel rail of 38 mm, superficial concrete spalling, and no permanent lateral deflection.

There was only minimal permanent damage to the barrier during Test 631. The steel rail scraped a small amount of paint off the vehicle along the length of contact. The vehicle caused some minor concrete spalling at the downstream vertical face of the expansion joint near the impact point and along the top of the curb for approximately 1.5 m. No rebar was exposed so there was no structural damage to warrant immediate repair. For aesthetic reasons and because the concrete cover over the rebar has been compromised, the damage should be repaired by maintenance crews.

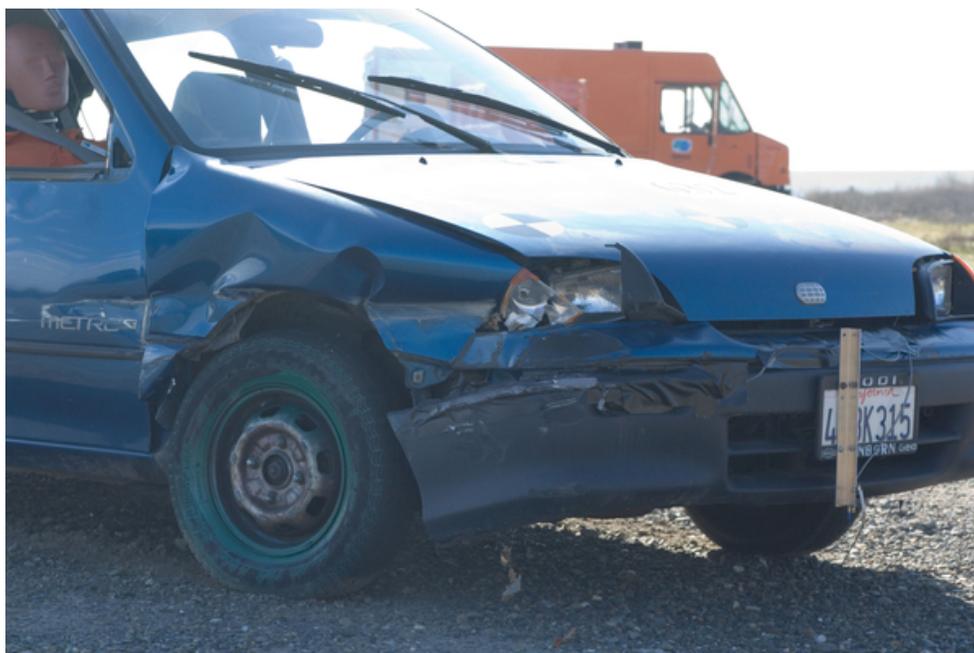
Figure 2-18 – Front right corner of test vehicle after Test 632

The right front corner of the vehicle was moderately damaged. The right front bumper and right fender were pushed rearward. The right front tire and wheel assembly were pushed rearward about 146 mm into wheel well, deforming it. The entire right side of the vehicle was moderately damaged. There was no significant passenger compartment or floorboard deformation. The passenger-side mirror was broken off.

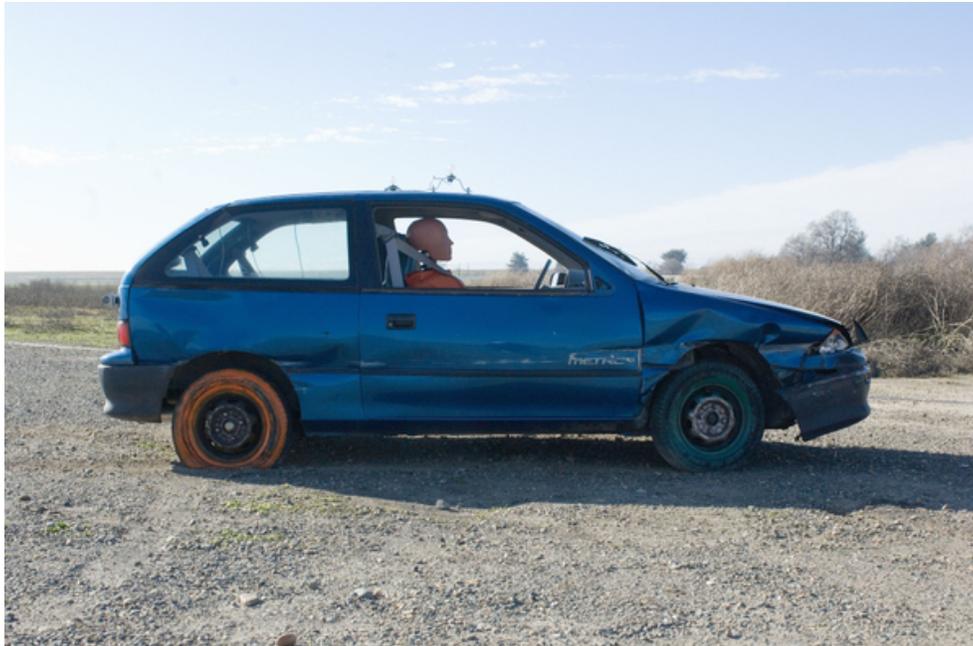
Figure 2-19 – Right side of test vehicle after Test 632

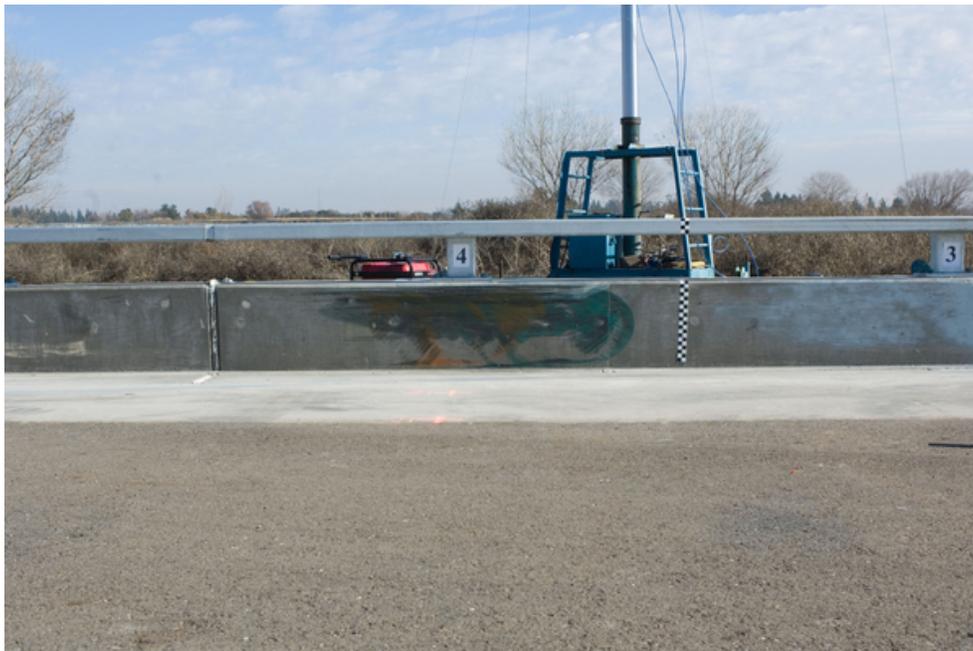
Figure 2-20 – Type 90 bridge rail face after Test 632

Barrier Damage: No dynamic deflection in steel rail, minor superficial concrete spalling.

There was essentially no permanent damage to the barrier during Test 632. The steel rail scraped a small amount of paint off the vehicle along the length of contact. There was a negligible amount of concrete spalling on the concrete curb. There would be no need for repair by a maintenance crews.

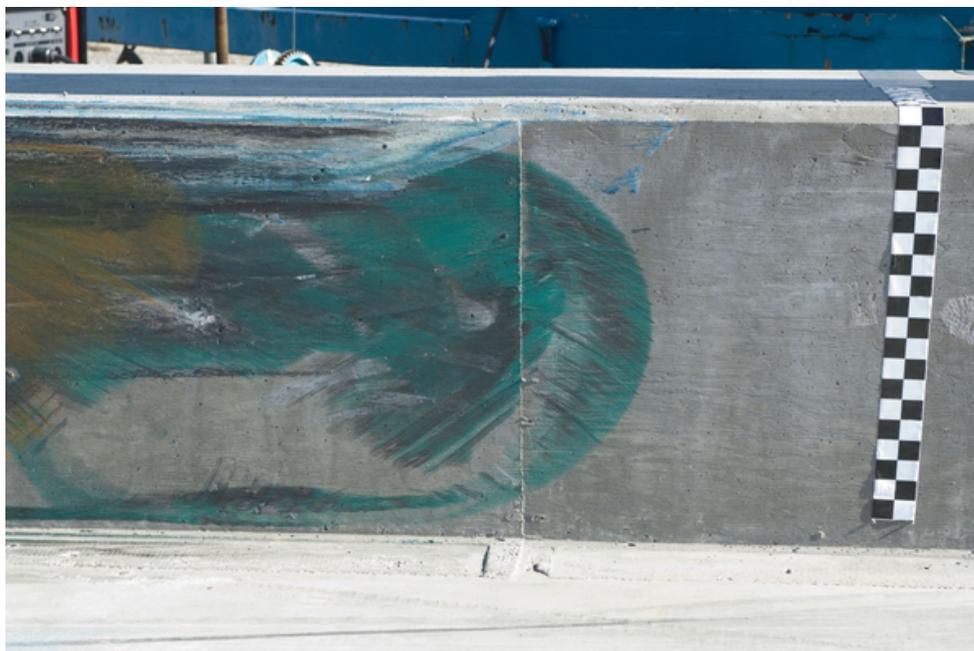
Figure 2-21 – Barrier face scraping after Test 632

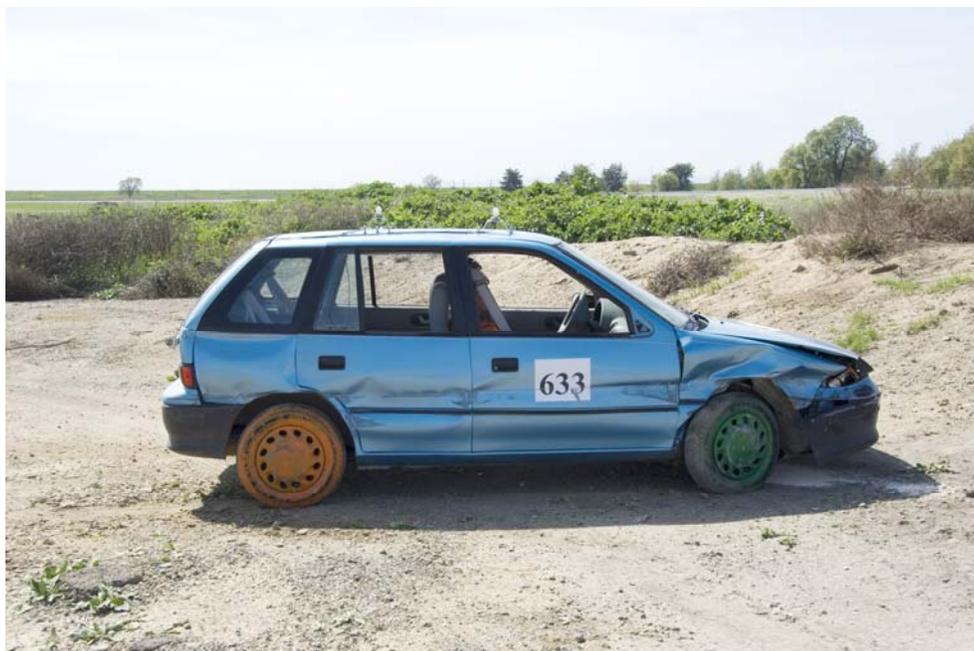
Figure 2-26 – Right side of test vehicle after Test 633

The right front corner of the vehicle was moderately damaged in the initial impact with the concrete curb. The right front bumper and right fender were pushed rearward. The right front tire and wheel assembly was pushed rearward about 130 mm into wheel well, deforming it. The entire right side of the vehicle was moderately damaged. There was no significant passenger compartment or floorboard deformation.

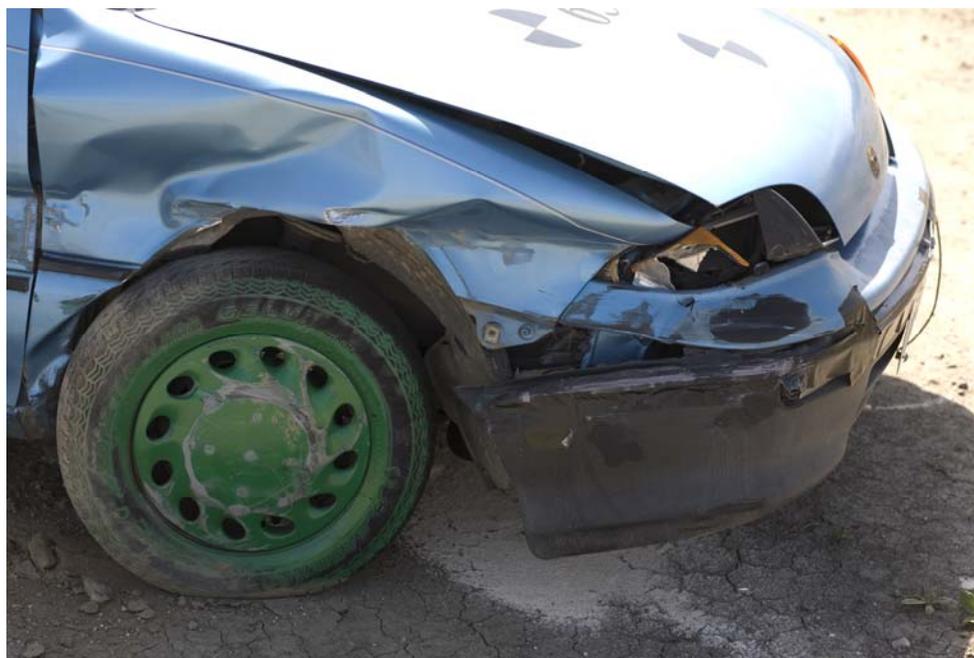
Figure 2-27 – Front right corner of test vehicle after Test 633

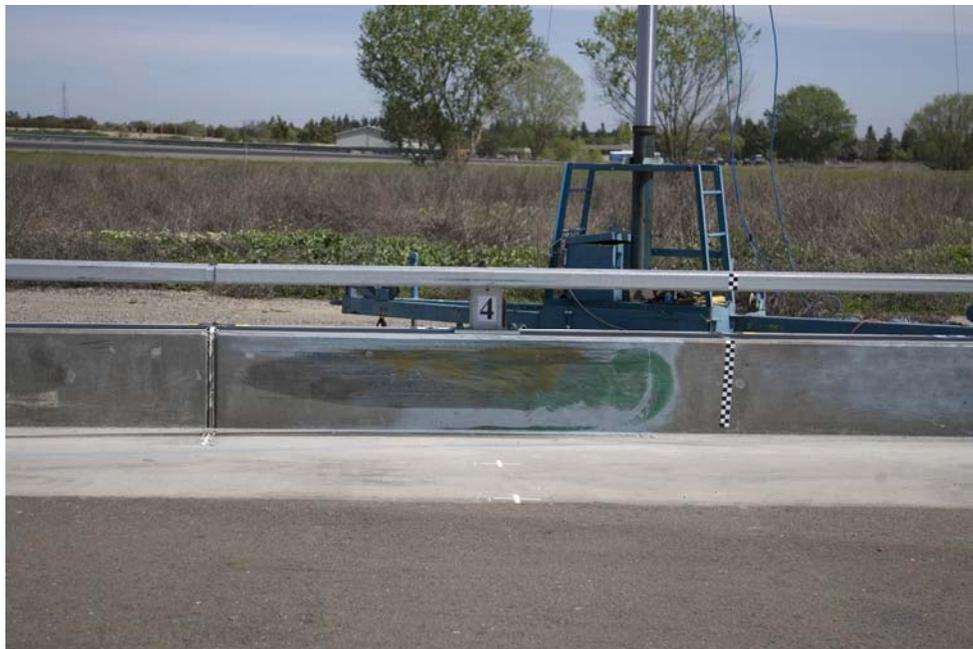
Figure 2-28 – Type 90 bridge rail face after Test 633

Barrier Damage: No dynamic deflection in steel rail, minor superficial concrete spalling.

As in Test 632, there was essentially no permanent damage to the barrier during Test 633. The steel rail scraped a small amount of paint off the vehicle along the length of contact. There was a negligible amount of concrete spalling on the concrete curb. There would be no need for repair by a maintenance crews.

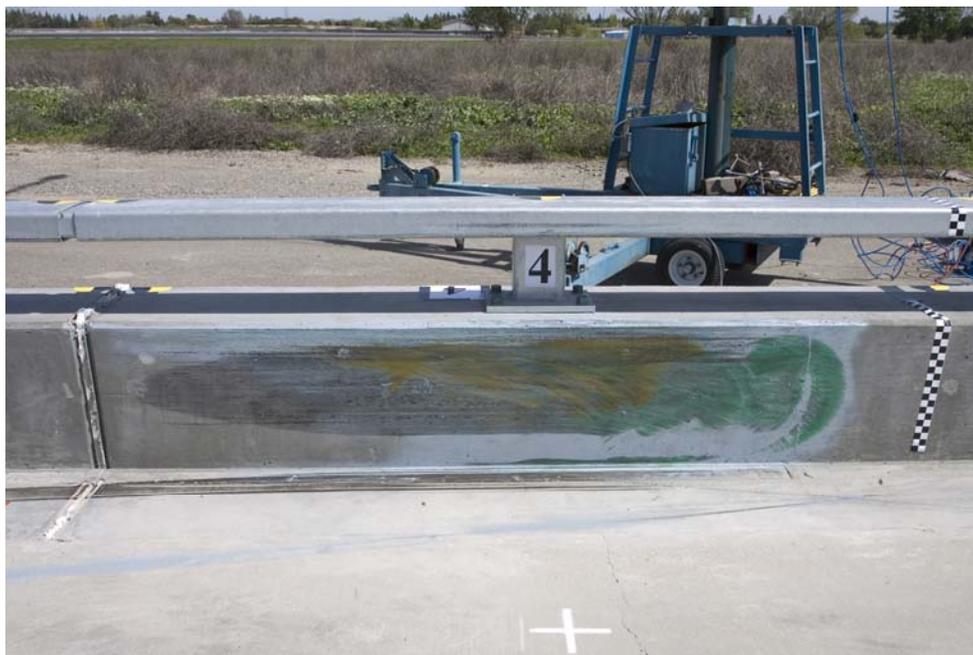
Figure 2-29 – Barrier face scraping after Test 633

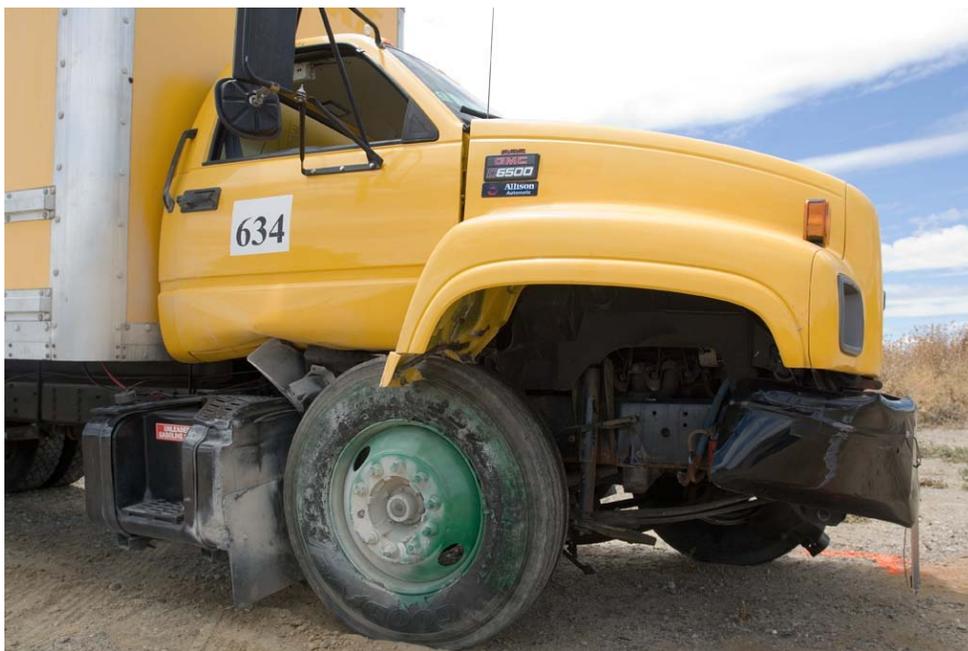
Figure 2-34 – Right side of test vehicle after Test 634

The impact of the right front tire with the barrier caused failure of several suspension components, including the right-side U-bolts which secure the axle to the leaf springs as well the end of the leaf spring on the right side. The axle shifted rearward 650 mm on the impact side and forward 160 mm on the driver side. When the front passenger side wheel was driven rearward, it crushed the battery box, the OEM fuel tank, the fender, and the door. Additionally, the front passenger side shock mounting bolt was sheared, a wheel stud on the front passenger tire sheared off, the passenger side of the front bumper was bent rearward, the rear passenger side wheel was damaged, and the bottom of the cargo bed was scraped at support locations from scraping the top of the steel rail. The passenger-side door remained latched even though the battery box was pushed upward into the bottom of the door, causing significant deformation. There was no significant passenger compartment or floorboard deformation. Additionally, all tires were still fully inflated after the test, despite the impact-side rims being bent and/or scraped during impact.

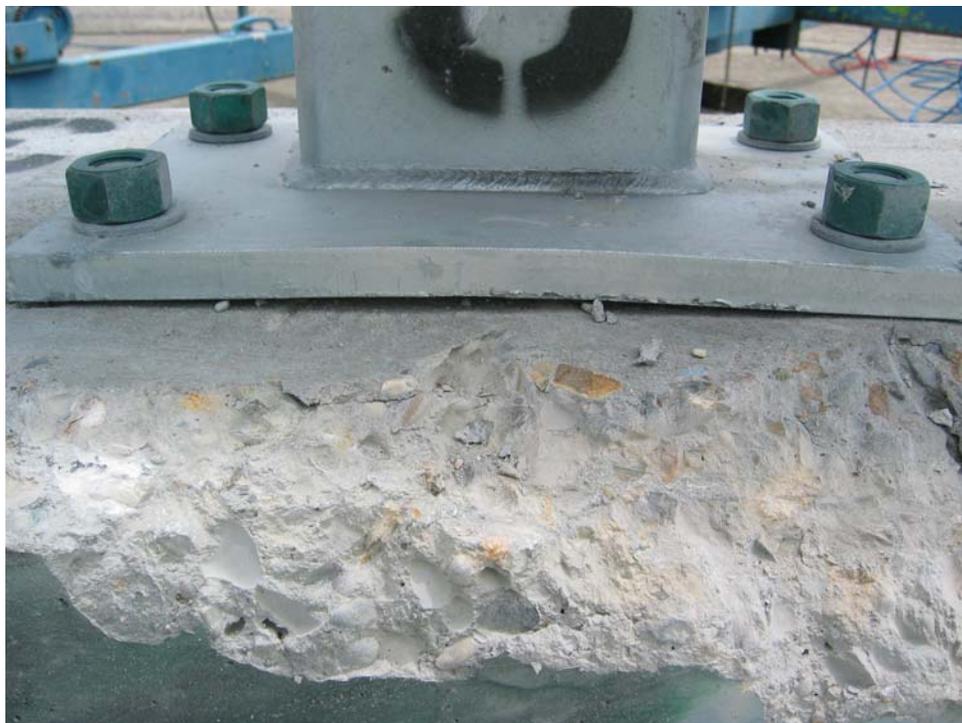
Figure 2-35 – Post 3 Close-up after Test 634

Unlike the previous tests, there was some permanent damage to the barrier. The vehicle lug nuts and rims caused gouging and spalling of the top of the concrete curb from just upstream of the initial impact point to where the rear tire lost contact with the rail, about 4.5 meter downstream of the impact point. At posts 3 and 4 the spalling extended to the front edge of the post base plate. As in Test 631, the gouging and spalling were superficial and not structural as evidenced by the lack of exposed rebar¹. More significantly, there was minor weld cracking at Post 3 (the post nearest the impact location) where the post was attached to the base plate. The welds were cracked approximately 6 mm on each side of all four corners, with a 0.05-mm gap at the crack locations. The center of the base plate was also bent upwards on the traffic and upstream sides, with the maximum deformation of 5 mm occurring on the traffic side. Additionally, the steel rail had a permanent lateral deflection of less than 15 mm. Because the weld cracking was minor, it is unlikely that damage to the steel rail would pose a safety concern to other vehicles before maintenance crews could repair the damage.

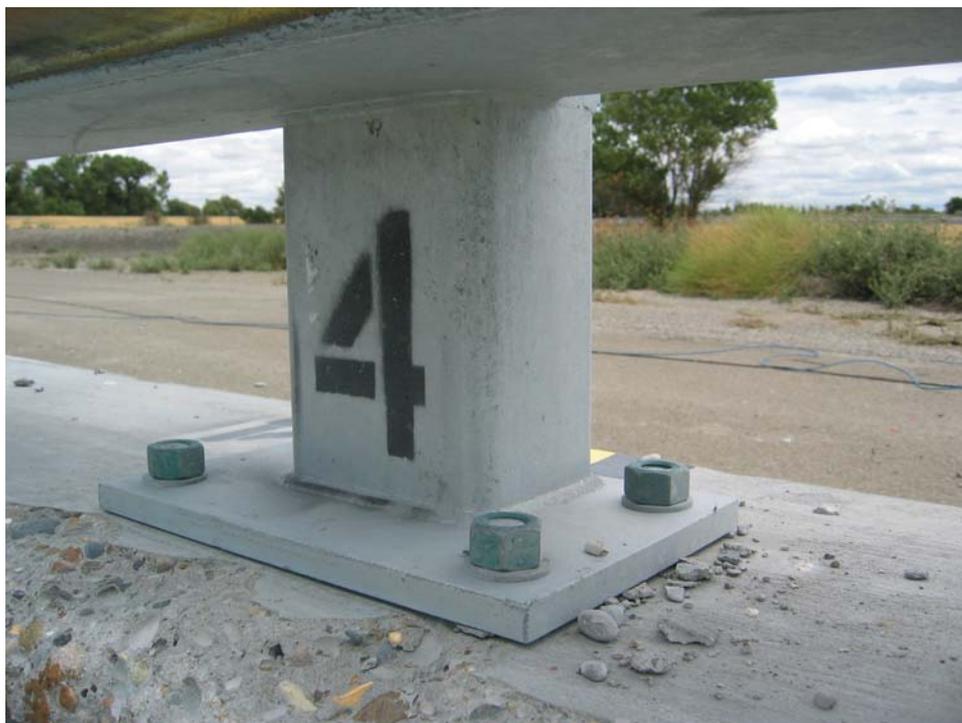
Figure 2-36 – Post 4 Close-up after Test 634

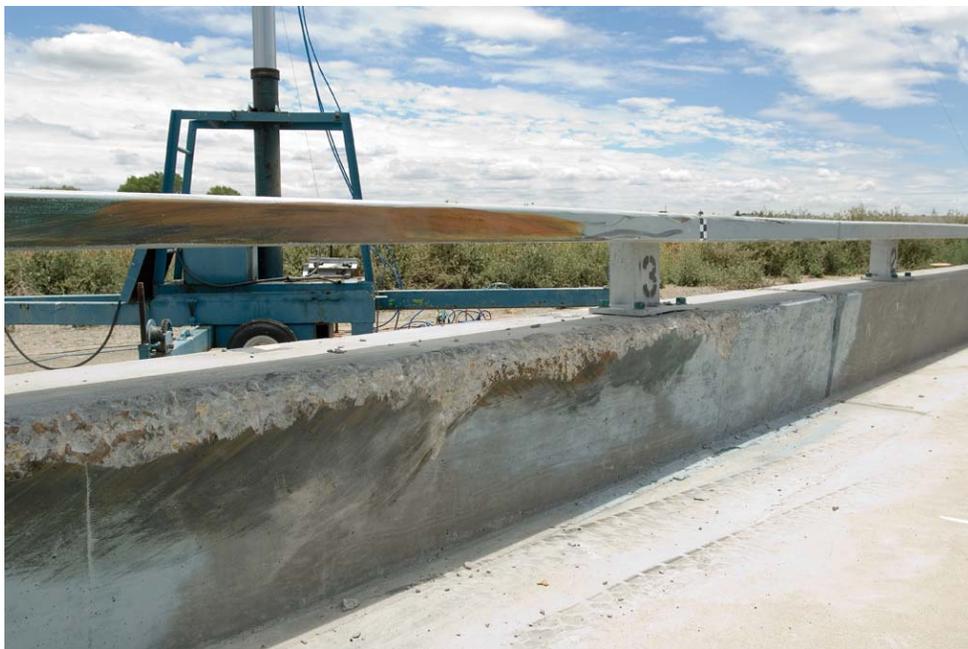
Figure 2-37 – Type 90 barrier face after Test 634

Barrier Damage: Maximum dynamic deflection in steel rail of <50 mm and <15 mm of permanent lateral deflection, moderate concrete spalling from vehicle lug nuts scraping, and <15 mm of permanent lateral deflection.

¹ The damage to the concrete, although not aesthetically pleasing, would not likely have an adverse affect on the crashworthiness of the barrier.
