Job Stamp 04-0120F4 SFOBB SAS

Report No.	_____			
Date	12/10/2007			
Inspectors	Start	09:40	Stop	11:50
Hours		13:20		14:00
Shift Hours	Start	07:00	Stop	15:30

ASSISTANT RESIDENT ENGINEER'S CONTRACTOR – ABFJV, Sub RPS

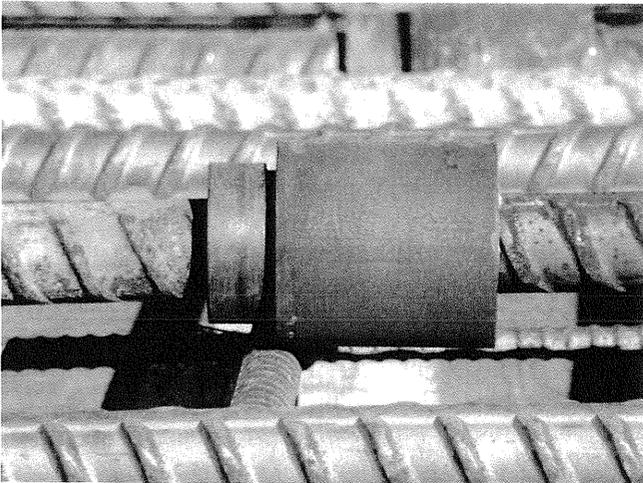
- 5.) No splices in Region 4 (not the bars that terminate near the pier top slab) at pier top slab, wrong bars may have been sent to jobsite.
 - 6.) Mechanical couplers have to be horizontal before being torqued to ensure that there is not kink in the bar at the connection (see submittal 293 for details).

File Name: DSC00342		File Name: DSC00344	
Date: 12-10-07	By Int: SH Song	Date: 12-10-07	By Int: SH Song
Description: Coupler hand tightened and not straight as recommended per the Manufacturer Headed Reinforcement Corp.'s "Slip Test Handling For Inspectors & Testing Agencies". Pamela and myself informed Lance they need to be straightened before applying 400 ft-lb torque to mechanical coupler.		Description: Welding at cap beam "B" near stringer 13.

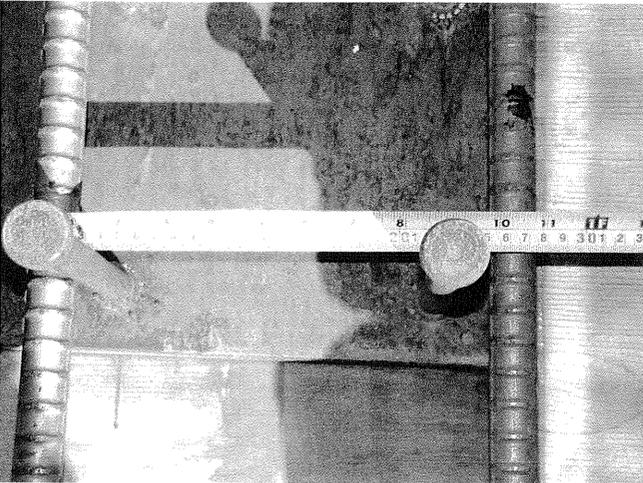
File Name: DSC00333		File Name: DSC00330	
Date: 12-10-07	By Int: SH Song	Date: 12-10-07	By Int: SH Song
Description: Need to provide clearance between Nelson Studs per Submittal 118. Refer to Conflict ID ME-2 in submittal.		Description: Reinforcement progress to date. RPS is close to address/correcting punchlist items for the B4 layer reinforcement (which is shown in the picture above) before proceeding with next layer of reinforcement.

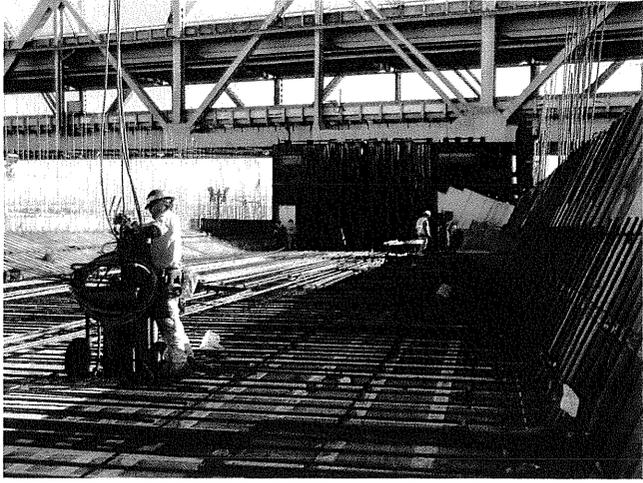
- 1.) Splice length and stagger length for the #25 Longitudinal Skin bars.
 - 2.) Cover at transverse tendon blockouts, vertical PT strand blockouts, jacking saddle forms, and pier top slab.

- 3.) Place #25 Longitudinal skin bar near jacking saddle that was missing.
 - 4.) A qualified Ironworker (Jason Jobe is the only one on record per SUB 293, & 293 R1 for this application) to use torque wrench for #43 transverse bars.

- Pamela and myself notified RPS foreman Lance several times today about punchlist items for the B4 Layer of reinforcement to which he agreed to fix before proceeding. These items include the following:
