Job Stamp
04-0120F4
SFOBB SAS

Report No.	692			
Date	12/11/2007			
Inspectors Hours	Start	0630	Stop	1630
Shift Hours	Start	0630	Stop	1500

ASSISTANT RESIDENT ENGINEER'S CONTRACTOR – ABFJV

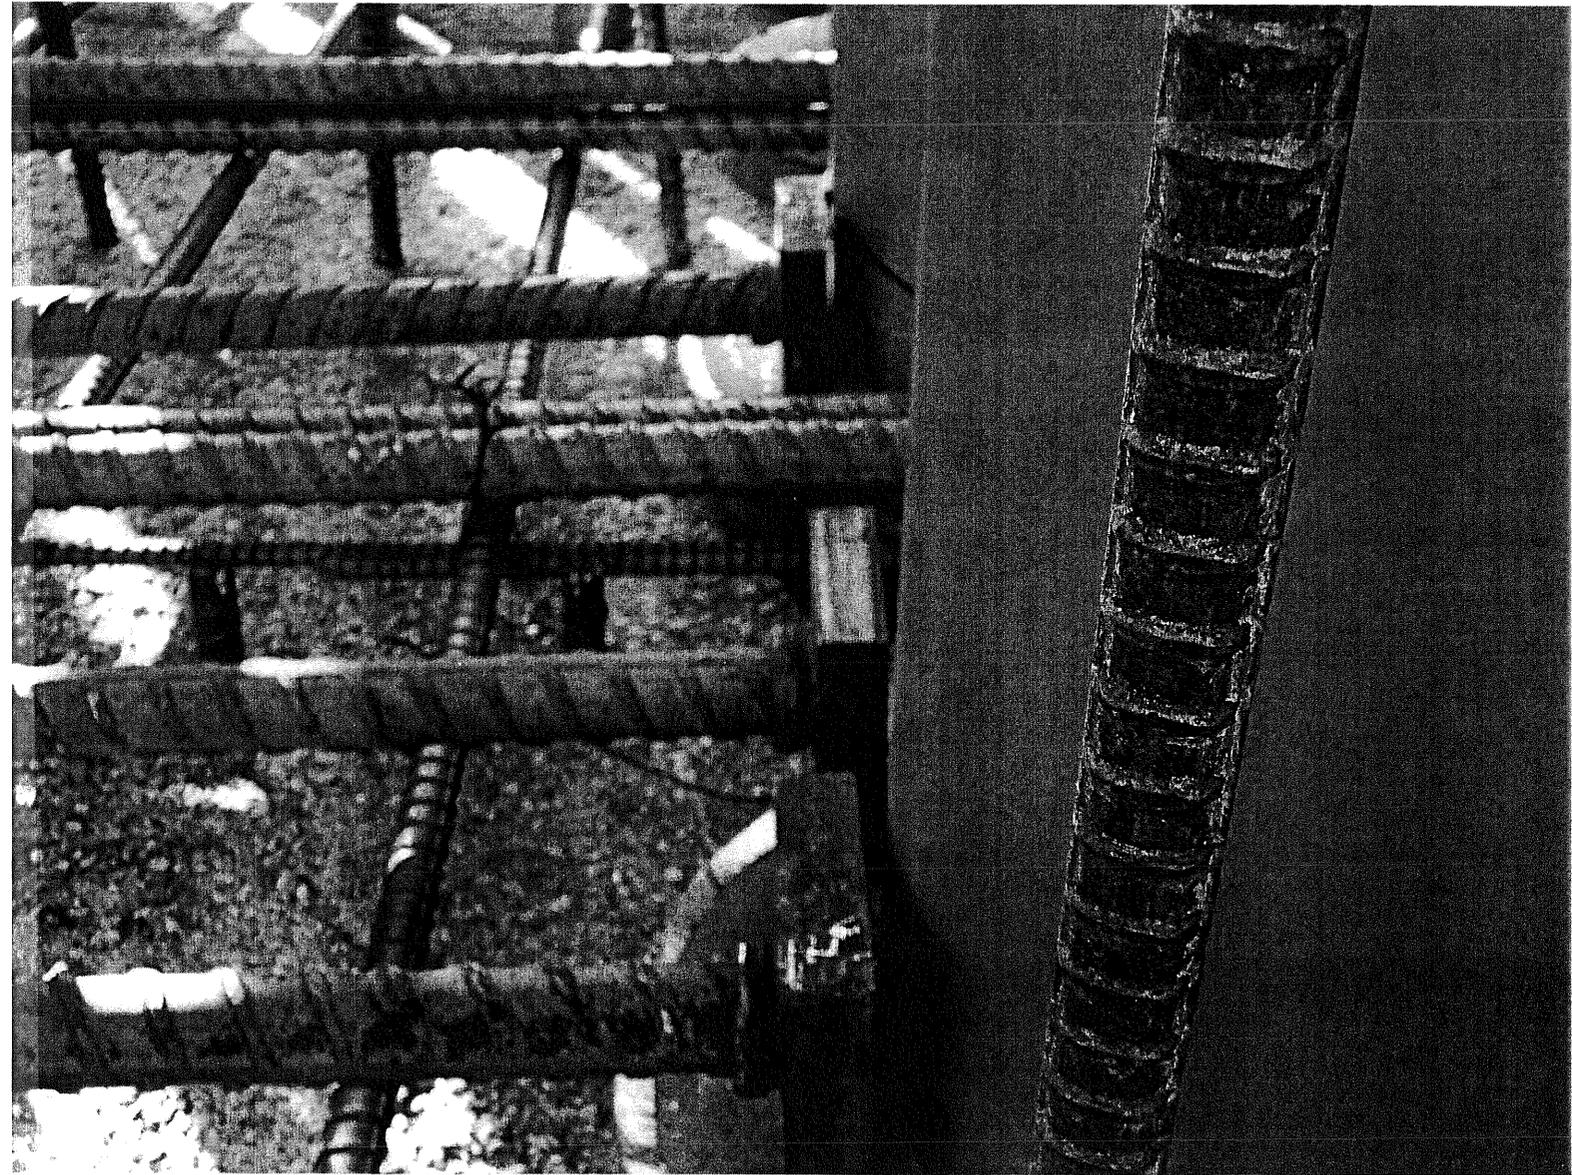
5. I observed the #43 T-heads fabrication do not provide sufficient clearance (80mm) both horizontally and vertically at cable tie-down pipes (see attached photo). Pointed out issue to Lance (RSP), Mark (ABF) and discussed with Ron Matin (Caltrans). Ron and I agreed to discuss with designers tomorrow.
