| Job Stamp 04-0120F4 SFOBB SAS |

| Date | 12/11/2007 | | | |

Description of Operations @ W2 Cap Beam:

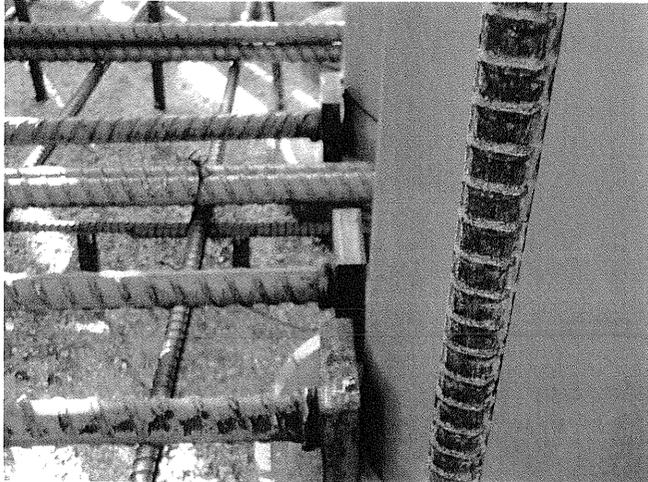
| File Name: | DSC00347 | | |

- Placement of #43 Transverse bars is continues for the B4 layer
The following is the issues related to the #43 transverse bar placement
 - 1.) T-Heads don't have adequate cover per sheet 488R1, this issue was discussed with ABF engineers Mark & Brandon, also see pictures on next page.

| Description: 2x3-43HB4T01* bars @ W2W east side have minimal or no cover between the cable tie-down pipes. The required amount per sheet 488R1 is 80mm. | | | |

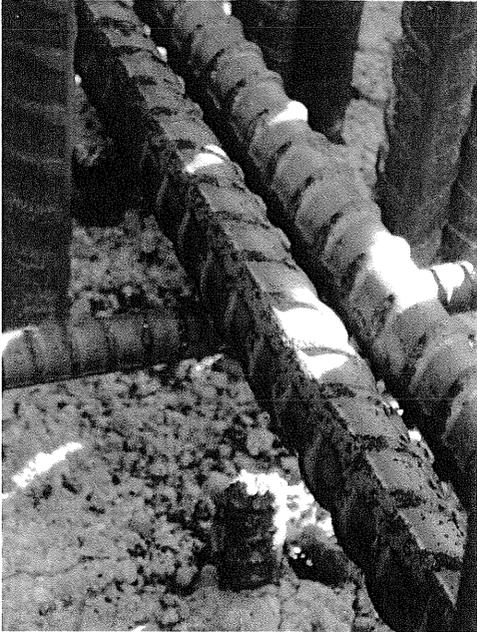
| File Name: | DSC00350 | | |

- 2.) 4 short # 25 vertical bars were cut at W2W to facilitate placement of 1-43B4T01* in between last two cable tie-down pipes on the east side, Total of 6 short bars were cut at W2W

| Description: #25 "Short" bars cut at W2W to facilitate placement of 2x1-43B4T02*. | | | |
