EA	04-0120F4
Co-Rte-KP (PM)	SF-080-13.2/13.9 (8.2/8.7)
Structure Rep.	Rick Morrow

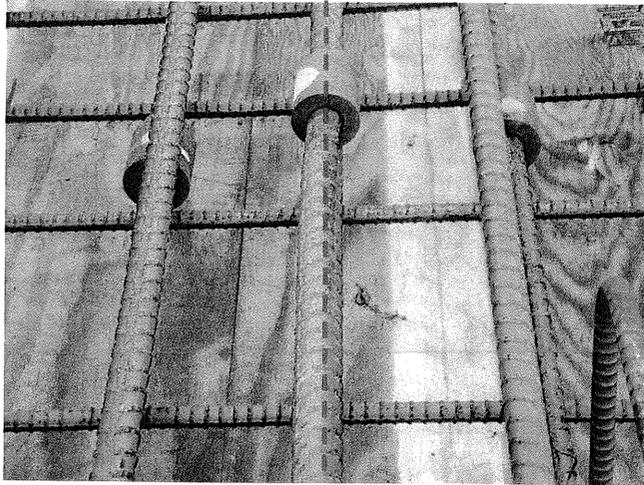
File Name:	DSC00398		
Date:	12-21-07	By Int:	SH Song
Description: #43 transverse bar with bend at mechanical coupler, this bar should be horizontal with no kinks or bends per the contract drawings.

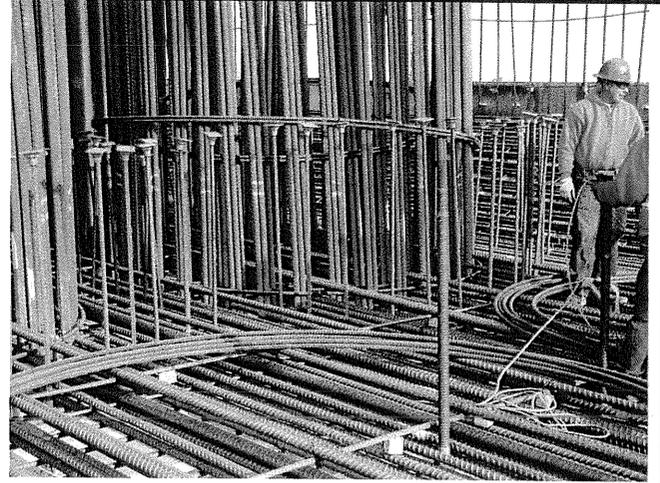
File Name:	DSC00406		
Date:	12-21-07	By Int:	M Bruce
Description: Continuing placement of #25 inner and outer welded hoops at W2W.

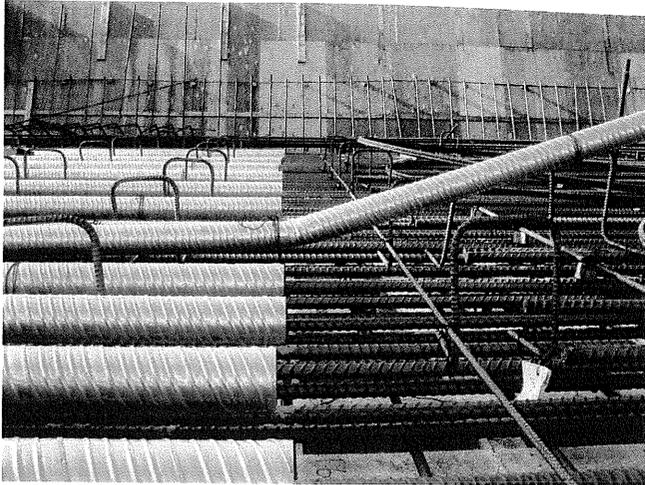
File Name:	DSC00411		
Date:	12-21-07	By Int:	M Bruce
Description: A potential issue for the first and subsequent concrete pours may be the extent of the profile for transverse tendons that are in multiple concrete pours. ABF Engineer and RPS Foreman Lance Gaige discussed the issue and I discussed with Lance. Brandon was going to consult with Schwagger Davis on this issue.

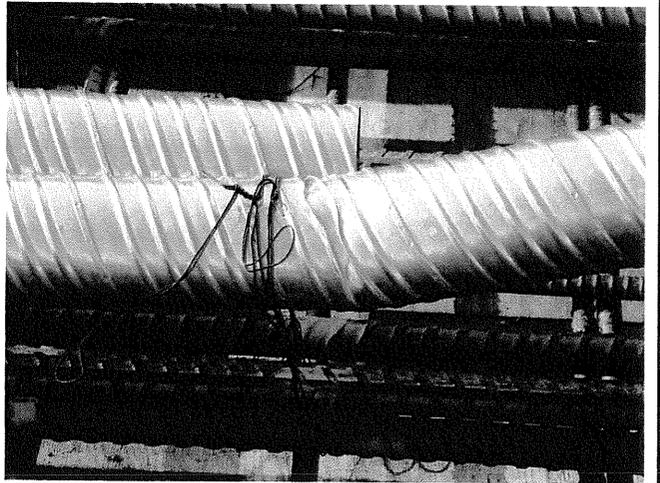
File Name:	DSC00413		
Date:	12-21-07	By Int:	M Bruce
Description: A smooth transition at the PI with no dents/kinks in the duct must be achieved to prevent friction loss and shearing of the prestressing strands. Note: Green spray paint denotes approximate location of the tendon PI's, and a dashed red keel mark was placed on the soffit prior to the spray paint.

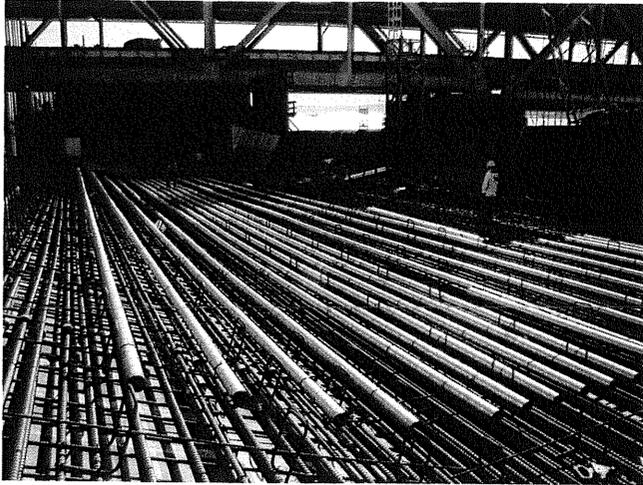
File Name:	DSC00424		
Date:	12-21-07	By Int:	M Bruce

Description: Progress of duct placement over the last two days.

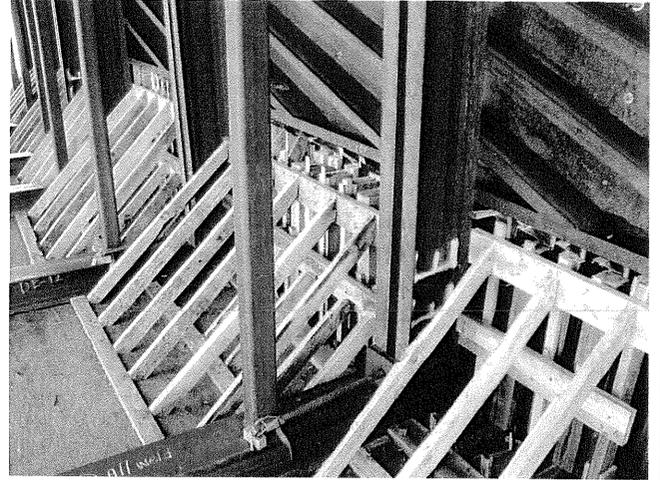
File Name:	DSC00425		
Date:	12-21-07	By Int:	M Bruce

Description: Braces installed this week on the sloping timber soffit forms at the north and south ends of the W2 cap beam.
