STATE OF CALIFORNIA	Job Stamp	7-day Const. Calendar	Day No. 386
DEPARTMENT OF TRANSPORTATION	SFOBB SAS	Project Work Day No.	Day No. 596
Form HC-10A (Rev. 6/80)	04-0120F4	Date	01/03/2008

ASSISTANT RESIDENT ENGINEER'S

Daily for Regional Steel

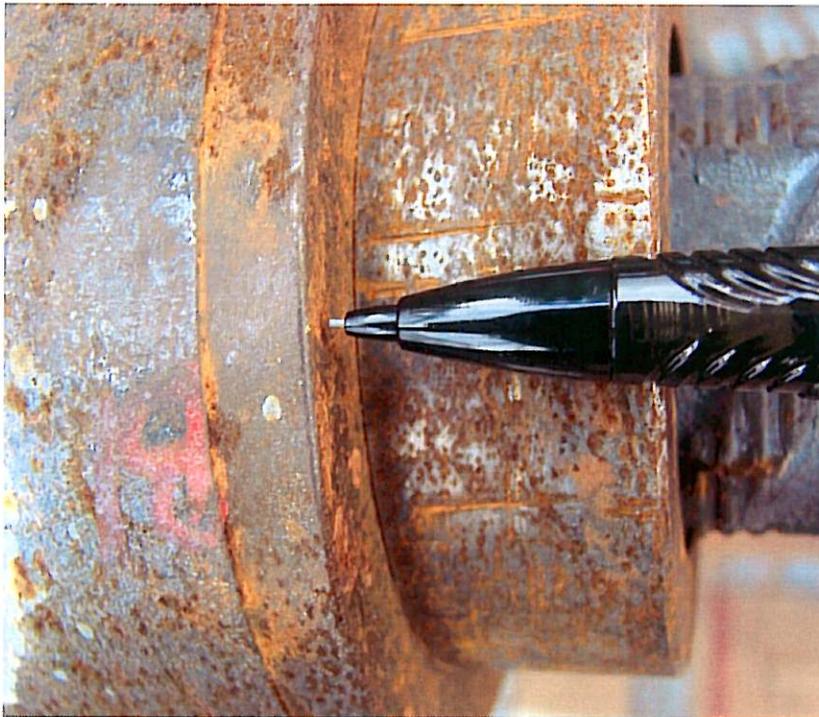
Note 1 photo:

1. I observed a bad coupler (no gap between male/female fittings) today on the southeast slope in B1 transverse matt. I informed Lance Gaige with RSC. See attached photo.

- Torque couplers for B2 transverse (3 bars along west side) matt.
 - Check clearance and dobies for B4 longitudinal/transverse matt.
 - Replace bad coupler (0 gap) in B1 transverse matt southeast slope 1st row 3rd coupler.
