Job Stamp 04-0120F4 SFOBB SAS

Const. Calendar:	413			
Project Work Day No.:	623			
Date	01/30/2008			
Inspectors	Start	09:50	Stop	15:00
Hours				
Shift Hours		07:00		15:30

Description of Operations @ W2 Cap Beam:

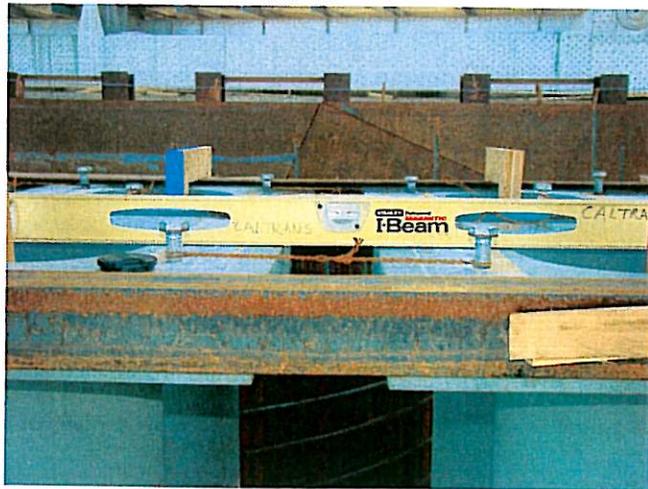
File Name:	DSC00747
Date:	01-30-08
By Int:	M Bruce

Description: Level bearing plates at W2E and the support system of tie wire, steel angles, and timber spacers/clamps.

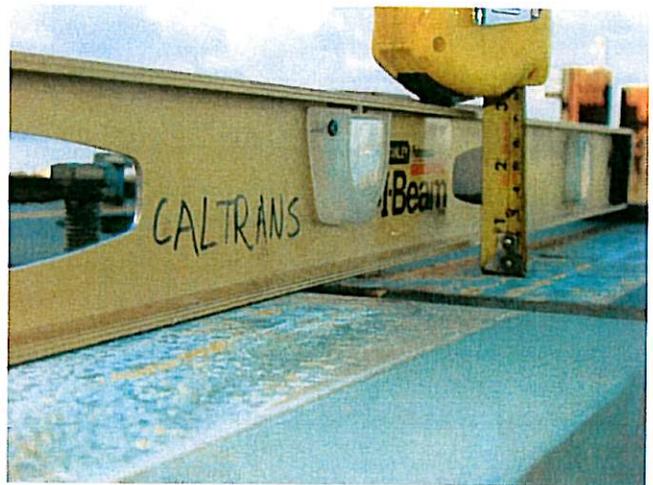
File Name:	DSC00751
Date:	01-30-08
By Int:	M Bruce

- Continued to plumb cable tiedown pipes at W2W. Most of the cable tiedown pipes at W2E and W2W are plumb and level at the top bearing plate. Approximately five pipes are close to the allowable tolerance for plumb. There also was a max 1/2" differential at W2E between two sets of bearing plates. The cable tiedown pipes have been secured fairly well (see pictures below), however the pipes will need to be checked again.
- Welding connections at cap beam B near stringer 4, cap beam D near stringer 4, 13, and 33.
- Construction of the stay-form blockout for the vertical bars continues in the northwest and southwest corners of the W2 cap beam.

Description: 1/2" difference in elevation between cable tiedown pipes at W2E.

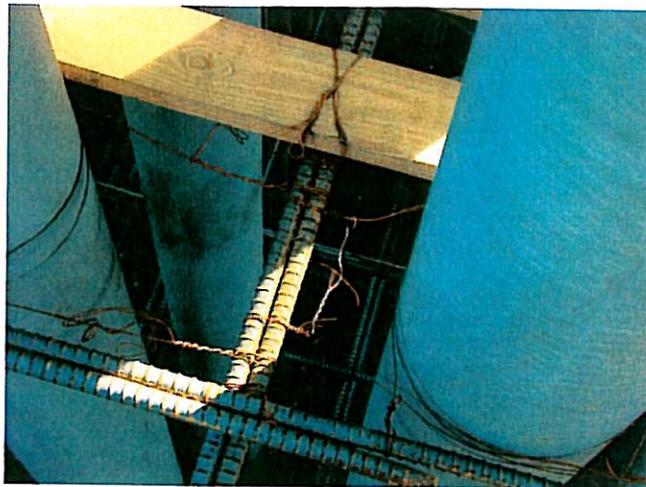
File Name:	DSC00757
Date:	01-30-08
By Int:	M Bruce

Description: Support system to keep the cable tiedown pipes at W2E plumb.

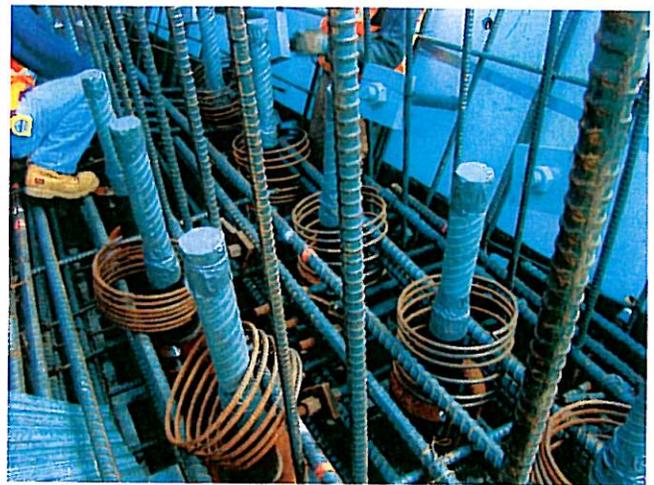
File Name:	DSC00764
Date:	01-30-08
By Int:	S Song

- Continued to address preliminary punchlist items see Pamela's diary for details.
- Began to place spirals on the south side for the VT1-16 vertical tendons. I noticed that they had trouble installing the spirals due to the #43 transverse bars, VT1-16 blockouts, and deviation saddle erection bolts, see picture below. While installing the spirals the ironworkers removed some of the trumpets from the bearing plate to make it more feasible to install this reinforcement. The trumpets had a silicone caulking around the connection of the trumpet to the bearing plate. RPS was reminded that the spirals need to be centered over the bearing plate, the spiral pitch needs to be adjusted, and the proper distance between the bearing plate and the spiral reinforcing needs to be maintained. ABF needs to secure and plumb the dead end blockouts/bearing plates for vertical tendons VT1-16 on both sides.

Description: Placement of spirals for VT1-16 vertical tendons near W2E.
