| 04-0120F4 |
| SFOBB SAS |

ASSISTANT RESIDENT ENGINEER'S

Description of Operations @ W2 Cap Beam:

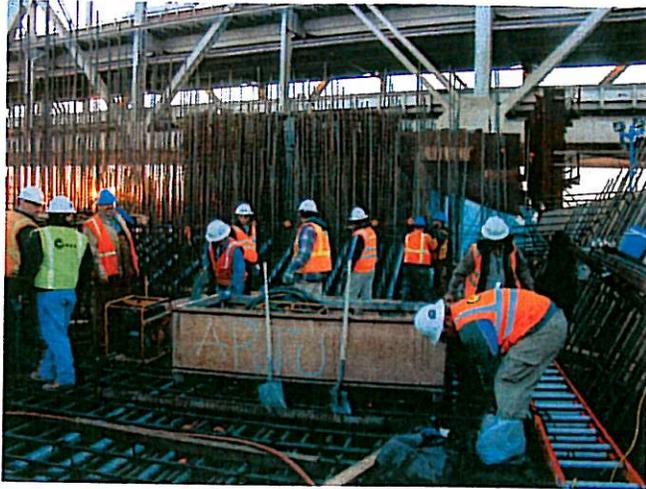
| File Name: | DSC00831 |

Description: Conco crew onsite at 7:00am as the concrete placement began at 7:30am in the NE rebar cage. Concrete placement began in the cages then proceeded in a counterclockwise direction to the north. Concrete was placed in two lifts.

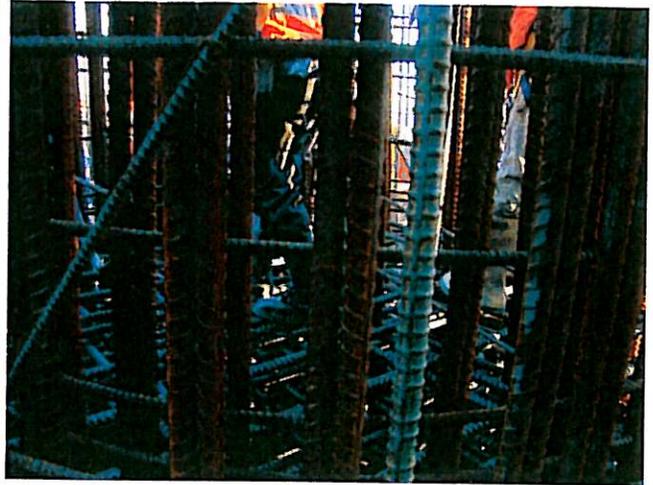
| File Name: | DSC00833 |

Description: Consolidating concrete near and inside the rebar cages.

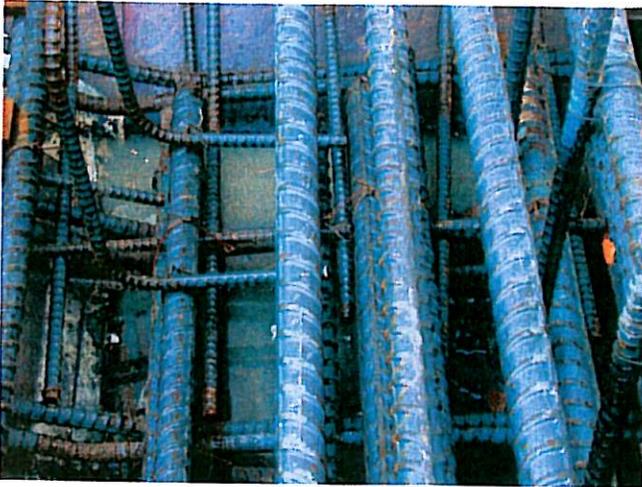
| File Name: | DSC00834 |

Description: Excess water from the top pier slab (SE corner) that was pushed during the concrete placement. ABF vacuumed all excess water from the forms.

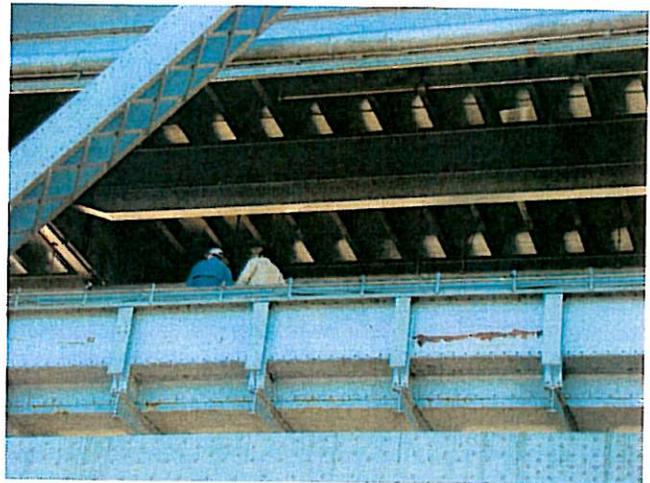
| File Name: | DSC00835 |

Description: An accident occurred at 8:30am on the existing eastbound SFOBB. Concrete trucks were delayed for approximately 30-40min. The concrete already placed in the forms remained relatively plastic during this time.

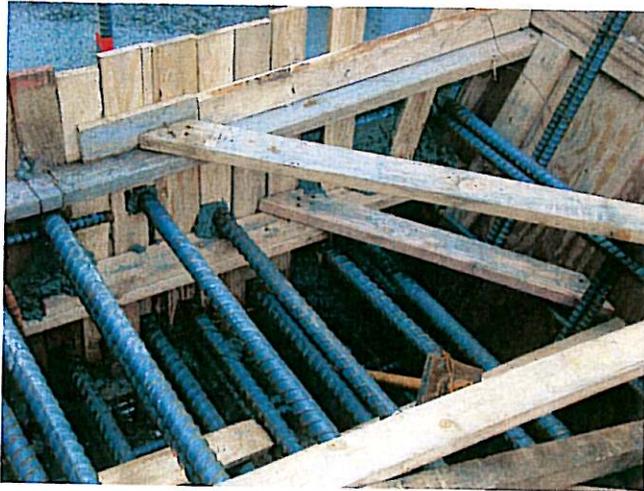
| File Name: | DSC00841 | | |

| Description: Concrete seeping through the stay form blockout used for the vertical bars in the SW corner. Generally the stay forms retained most of the concrete, no failure in members/connections or excessive deflections in the forms were found. | | | |

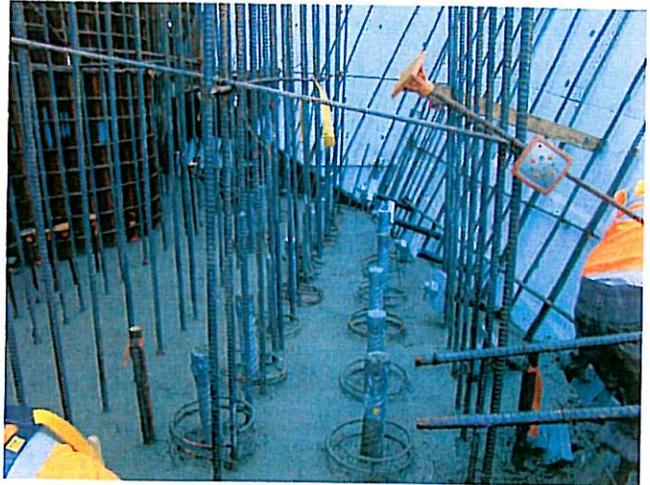
| File Name: | DSC00842 | | |

| Description: Finishing work done near the vertical tendons as the rigid duct wasn't embedded in this pour. | | | |

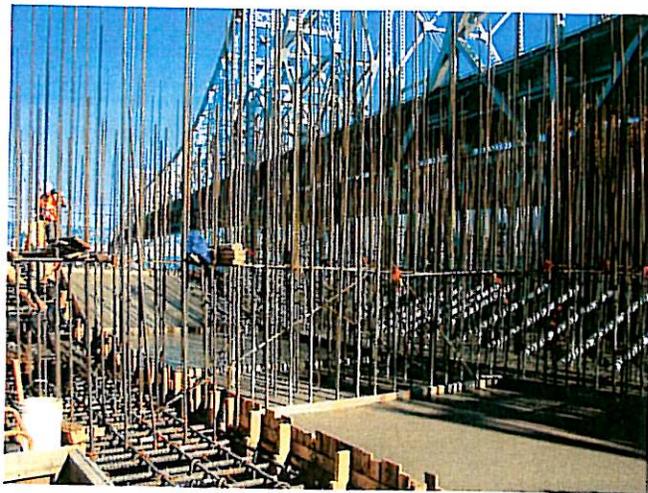
| File Name: | DSC00848 | | |

| Description: Concrete placement ended at 2:15pm with no significant problems during this operation. ABF wanted to place excess concrete in the column cage areas, this was not allowed per Caltrans field personnel. ABF or Conco didn't apply a curing compound or water to the exposed concrete surface before the curing mats were placed. They were told to do this per the Special Provisions in addition to what the Thermal Control Plan specified. | | | |

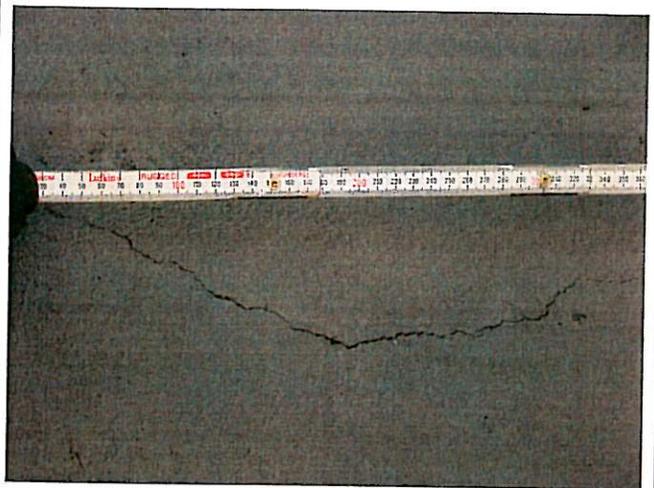
| File Name: | DSC00852 | | |

| Description: Crack found on the east sloping bulkhead at approximately 5:15pm. The concrete still was not hard enough to walk on at this point. | | | |

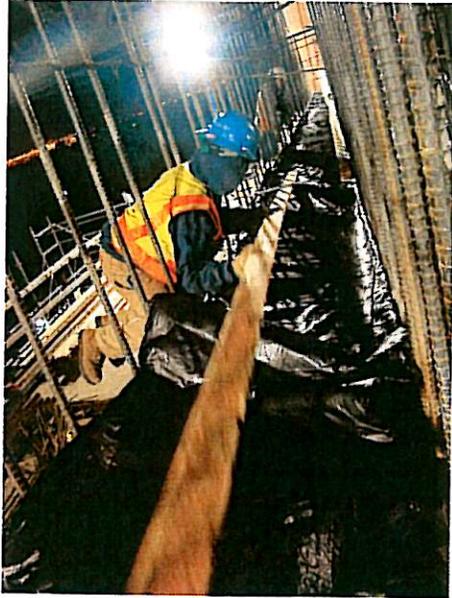
| File Name: | DSC00856 | | |

Description: ABF began placing curing mats approximately around 7:00pm with 6 piledrivers.

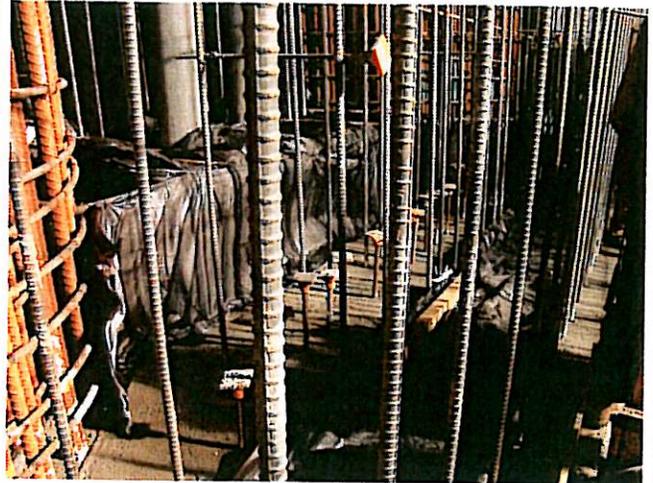
| File Name: | DSC00857 | | |

Description: Curing mats around the L & T-bars on the west side of the W2 cap beam looking east.

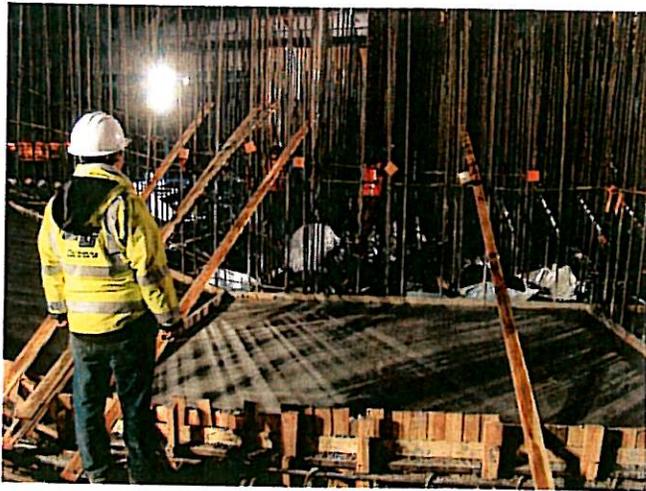
| File Name: | DSC00860 | | |

Description: Approximately half of the curing mats were placed at 9:00pm at which time myself and Seong left the jobsite.
