Job Stamp 04-0120F4 SFOBB SAS

Const. Calendar:	420			
Project Work Day No.:	630			
Date	02/06/2008			
Inspectors	Start	10:00	Stop	12:00
Hours				
Shift Hours		07:00		15:30

ASSISTANT RESIDENT ENGINEER'S **CONTRACTOR – ABFJV, Sub RPS**

EA	04-0120F4
Co-Rte-KP (PM)	SF-080-13.2/13.9 (8.2/8.7)
Structure Rep.	Rick Morrow

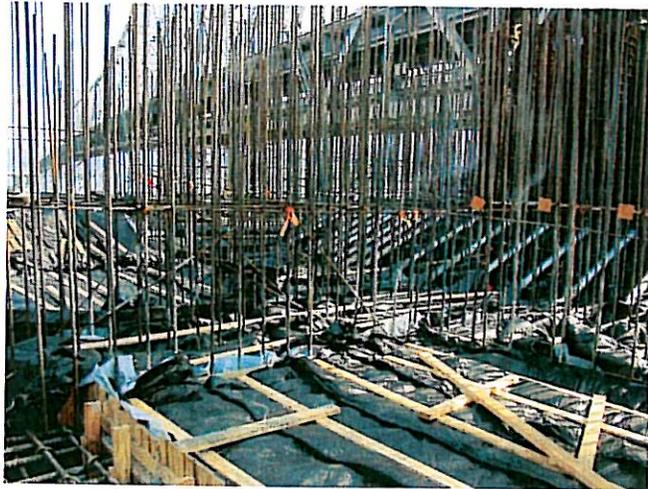
File Name:	DSC00864
Date:	02-06-08
By Int:	M Bruce

Description: ABF general foreman Terry Cronk told me that they finished placing the curing mats around 11:00pm last night. It took a total of 4-5 hrs for this operation.

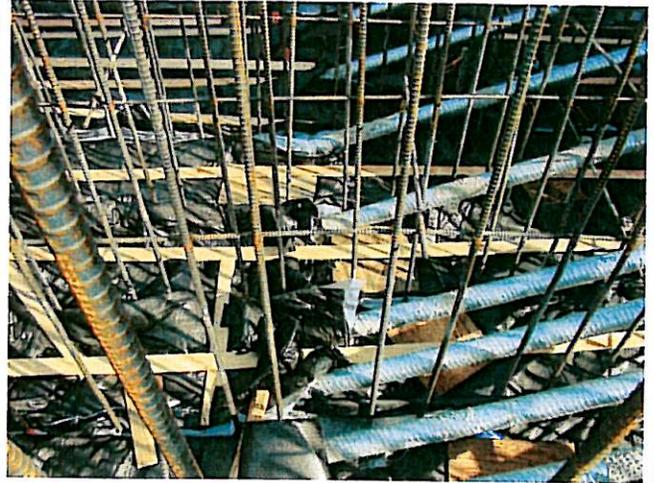
File Name:	DSC00865
Date:	02-06-08
By Int:	M Bruce

Description: Curing mat placement near the CBT ducts. It appears that the mats need to be sealed better near the concrete to duct interface.

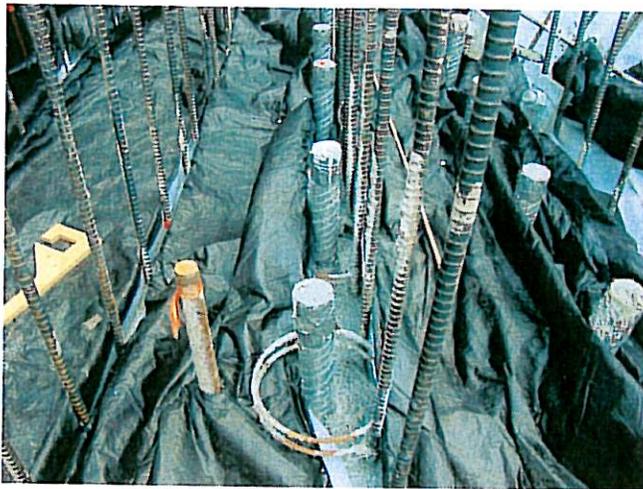
File Name:	DSC00868
Date:	02-06-08
By Int:	M Bruce

Description: Curing mat placement near the VT ducts. Similar to the photo above the mats need to be sealed better near the concrete to duct interface.

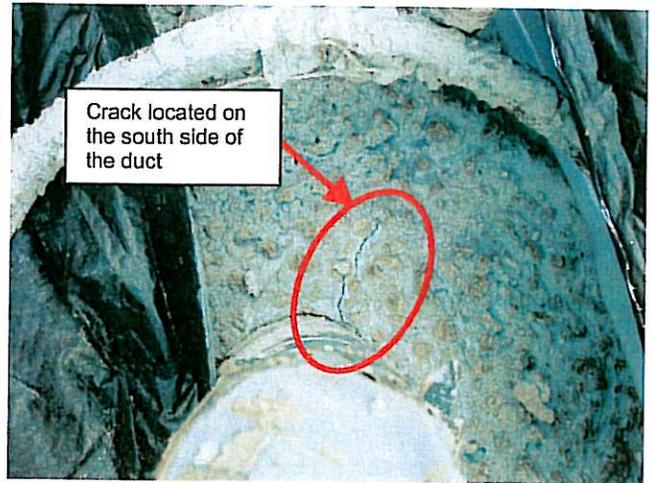
File Name:	DSC00869
Date:	02-06-08
By Int:	M Bruce

Description: Crack found near VT-2.
