04-0120F4

SFOBB SAS

Construction Calendar

01/11/2008

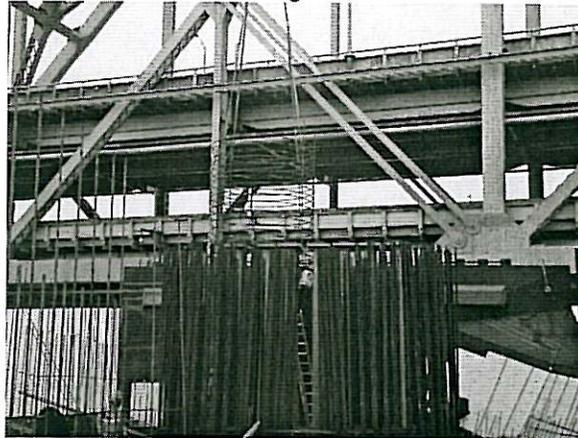
Fig. 1

- See Lalit Mathur's diary for ABF labor, equipment, materials, weather, and comments.
- Daily activity of Regional Steel (R.S.) and ABF
 - R.S. continued to place hoops at ESE and ESW

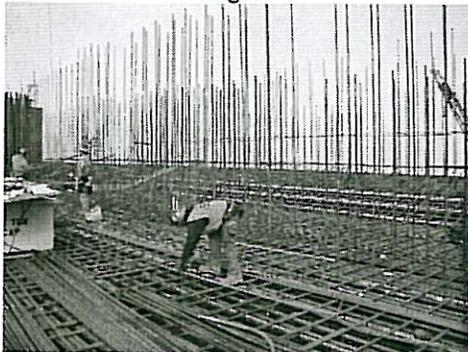
Fig. 2

- R.S. placed vertical bars of the transverse diaphragm.

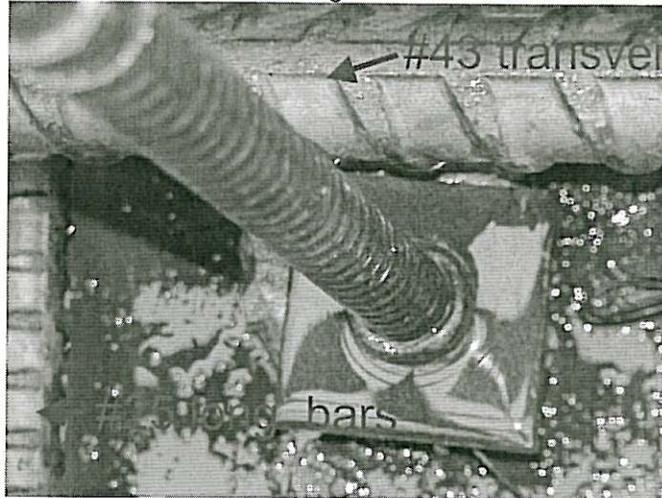
Fig. 4

- Had a conversation with Pam, Matt and T.Y. Lin engineers regarding the position of the T-headed bar which were placed at the longitudinal diaphragm. The T-headed bars should be located underneath #25 longitudinal bar based on the plan. However, the T.Y. Lin engineers are fine with current position of the T-headed bar (see Figure 4) provided that they are placed with equal spacing and underneath #43 transverse bars as much as possible.

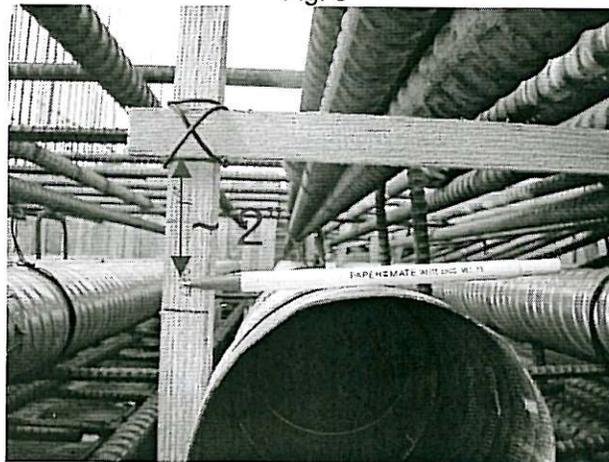
Fig. 5

- Noticed that the elevation of the duct is approximately 1 to 2 inch lower than the one of the plan and informed Lance, a superintendent, on it. He indicated that R.S. plans to move them up till they are located within the tolerance specified in the submittal.

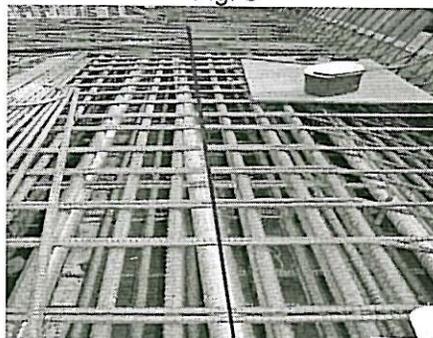
Fig. 5

- Noticed that the duct is not straight (let Matt Bruce know it and he will take care of it).
