Job Stamp 04-0120F4 SFOBB SAS
-------------------------------------

Const. Calendar:	427			
Project Work Day No.:	637			
Date	02/13/2008			
Inspectors	Start	09:50	Stop	11:30
Hours		12:00		13:30
Shift Hours		07:00		15:30

**Description of Operations @ W2 Cap Beam:**

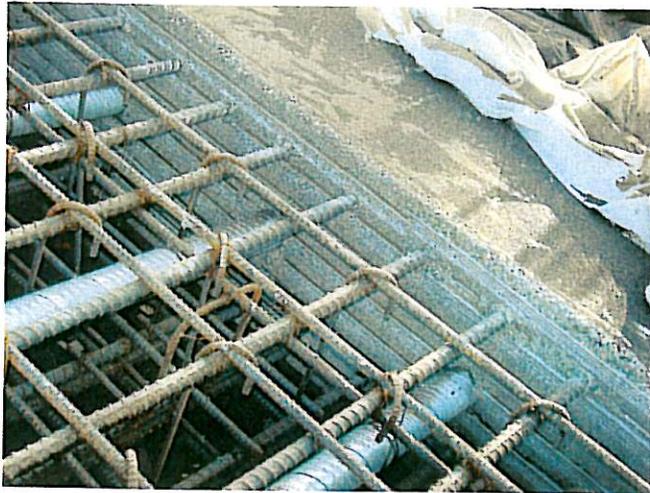
File Name:	DSC00513		
Date:	02-13-08	By Int:	M Bruce
Description: South construction joint on the east sloped bulkhead. Sandblasting material has not yet been cleaned.

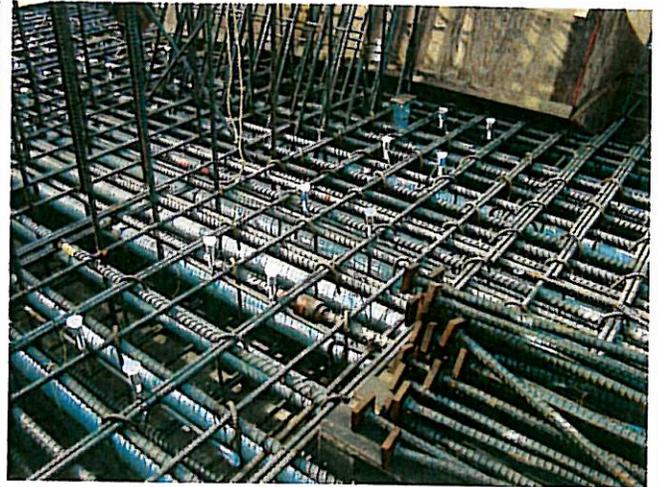
File Name:	DSC00518		
Date:	02-13-08	By Int:	M Bruce
Description: Ferrule inserts placed yesterday for jacking saddle erection supports.

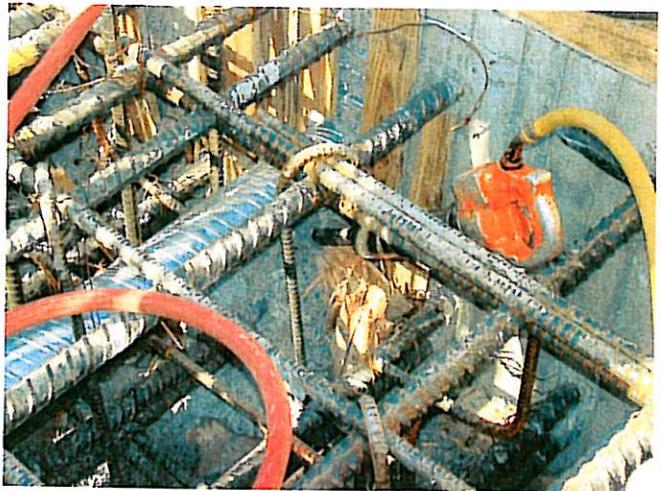
File Name:	DSC00522		
Date:	02-13-08	By Int:	M Bruce
Description: Excess concrete that seeped through the forms at the north construction joint. The foremen and crew were reminded to be conscious not to step on, move, or hit the PT ducts while preparing the joint. Crowbars and jackhammers were used to remove excess concrete and pieces of stay form.

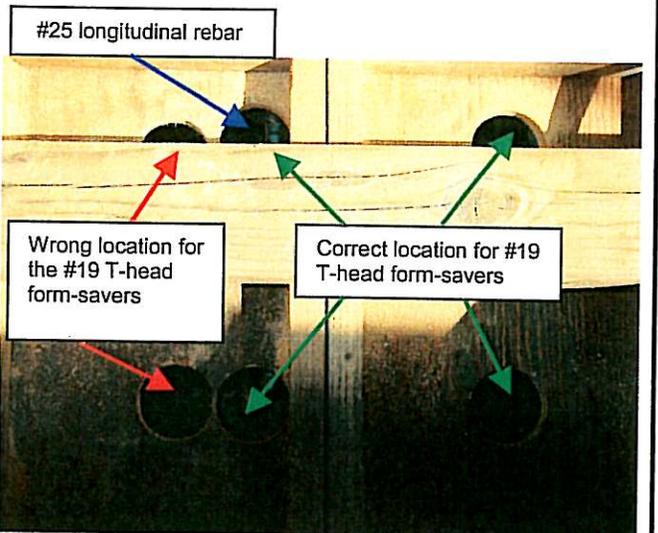
File Name:	DSC00525		
Date:	02-13-08	By Int:	M Bruce
Description: Initial location of the holes to assist the placement of the 18-#19 T-head form-savers was incorrect. The holes were drilled to the correct locations after lunch.
