Job Stamp  
04-0120F4  
SFOBB SAS

Const. Calendar: 428  
Project Work Day No.: 638  
Date: 02/14/2008  
Inspectors Hours: Start 10:15 Stop 14:30  
Shift Hours: 07:00 15:30

ASSISTANT RESIDENT ENGINEER'S **CONTRACTOR – ABFJV, Sub RPS**

**Description of Operations @ W2 Cap Beam:**

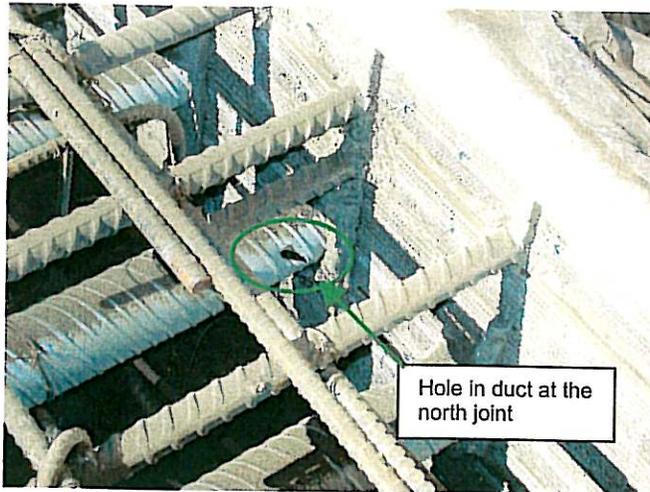
File Name:	DSC00527
Date:	02-14-08
By Int:	M Bruce

Damage of transverse tendon ducts at the construction joint														
Joint Location	CBT	9	10	11	12	25	13	26	14	27	15	28	29	30
	South	D	H	G	G	G	H	D	G	G	D	G	G	D
North	G	G	D	D	G	D	G	D	D	D	G	G	D	D
CBT	31	32	33	34	16	35	17	36	18	19	20	21	22	
South	D	G	G	G	D	D	G	G	G	D	H	G	G	
North	G	D	H	G	H	D	D	D	D	D	G	G	G

G = Duct appeared to be in good condition  
D = Dents were found which were major to minor, see pictures below  
H = Hole found in duct  
Note: The top of the duct and parts of the side were inspected as it was difficult to see the bottom side of the duct.

Hole in duct at the north joint

Description: Damaged duct due to the method of removing the forms the previous day.

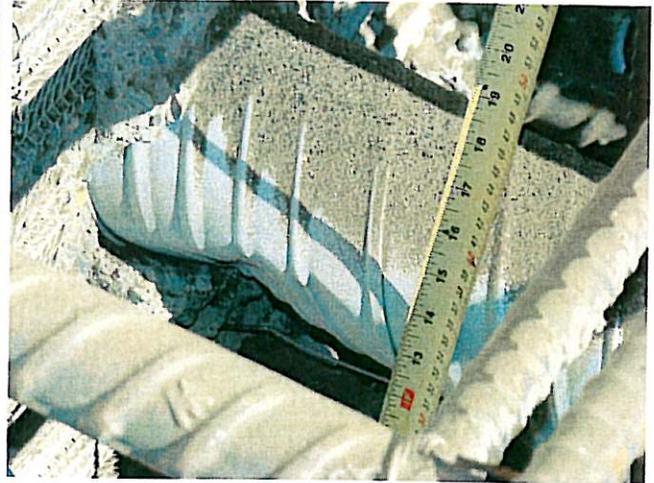
File Name:	DSC00530
Date:	02-14-08
By Int:	M Bruce

Major dent found at the north construction joint.

Description: Major dent found at the north construction joint.

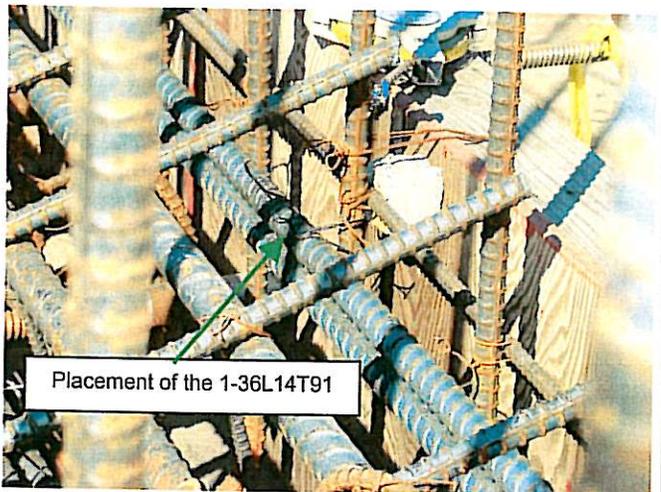
File Name:	DSC00539
Date:	02-14-08
By Int:	M Bruce

- Placed 4-25L14L21 and 4-25L15L21 bars in the longitudinal diaphragm, see sheet 497S4R1.
- Placed 1-36L14T91 bar at east face which is shorter than called out in the plans, see Pamela's diary for details regarding TY-Lin's response to this issue and sheet 497S1.

Placement of the 1-36L14T91

Description: 1-36L14T91 bar placed at the east face which is shorter than called out in the plans.

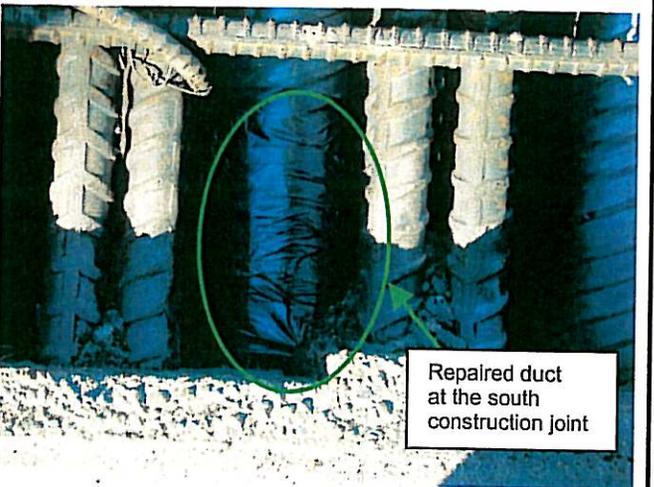
File Name:	DSC00542
Date:	02-14-08
By Int:	M Bruce

Repaired duct at the south construction joint

Description: Damaged ducts were covered with metal flashing and then duck tape as seen in the photo above. Some dents and frayed edges were "smoothed out" before the metal flashing and duck tape was applied. Only four ducts were repaired when I left the jobsite.
