Job Stamp 04-0120F4 SFOBB SAS

Const. Calendar:	429			
Project Work Day No.:	639			
Date	02/15/2008			
Inspectors	Start	06:00	Stop	14:30
Hours				
Shift Hours		06:00		14:30

ASSISTANT RESIDENT ENGINEER'S **CONTRACTOR – ABFJV, Sub RPS and Conco**

Description of Operations @ W2 Cap Beam:

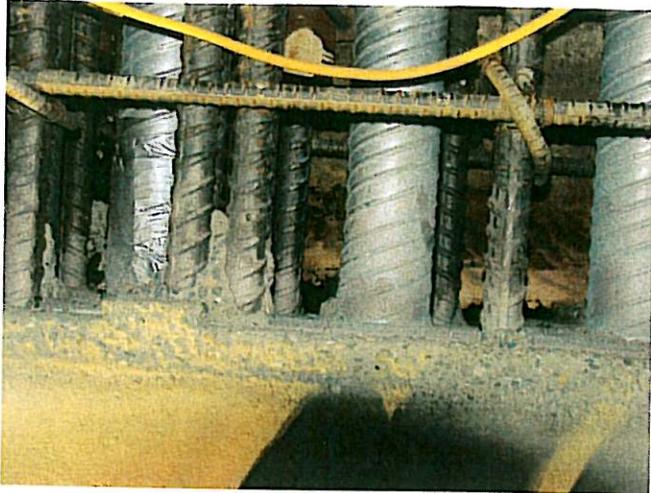
File Name:	DSC00544
Date:	02-15-08
By Int:	M Bruce

Description: Sandblasting debris near the south construction joint, which was cleaned prior to concrete placement.

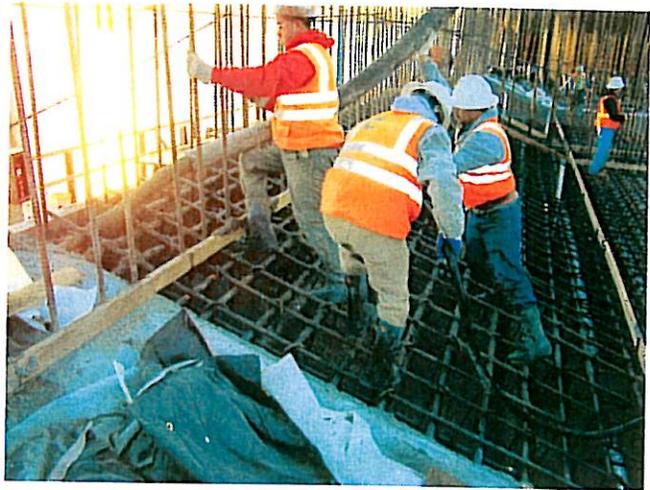
File Name:	DSC00547
Date:	02-15-08
By Int:	M Bruce

Description: Concrete placement began approximately at 7:20am in the northeast corner of the center slab section.

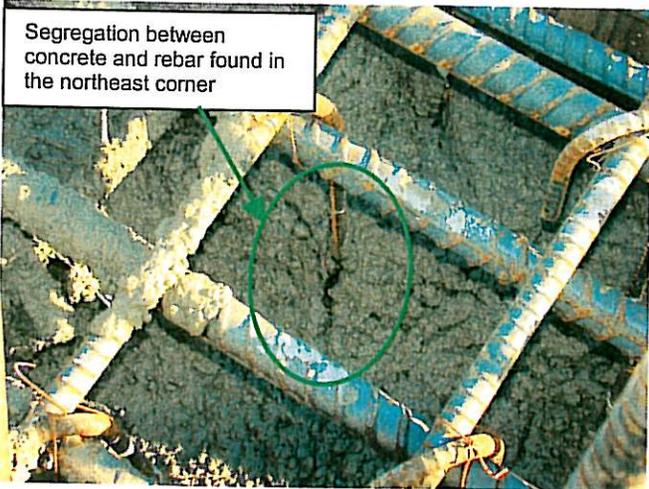
File Name:	DSC00551
Date:	02-15-08
By Int:	M Bruce

Segregation between concrete and rebar found in the northeast corner

Description: While placing concrete on the sloped portion at approximately 8:40am the condition in the photo above was found. The concrete was re-vibrated in areas where this condition existed.

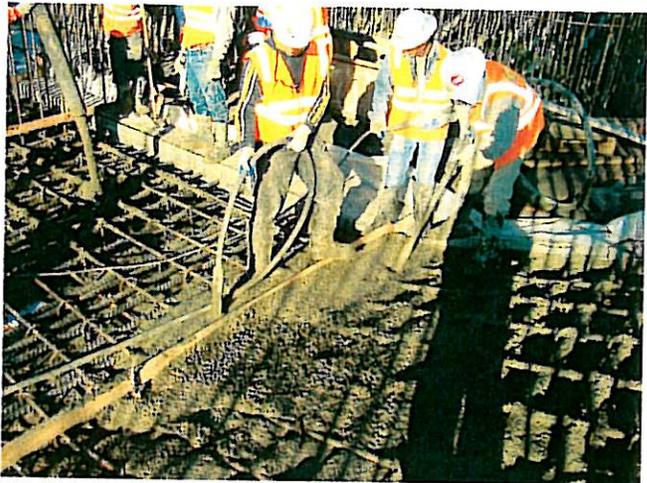
File Name:	DSC00552
Date:	02-15-08
By Int:	M Bruce

Description: Placement in the sloped area was difficult due to the high slump of the concrete. Laborers were constantly reminded to vibrate through both layers even if it was difficult to finish the concrete in the sloped portion.

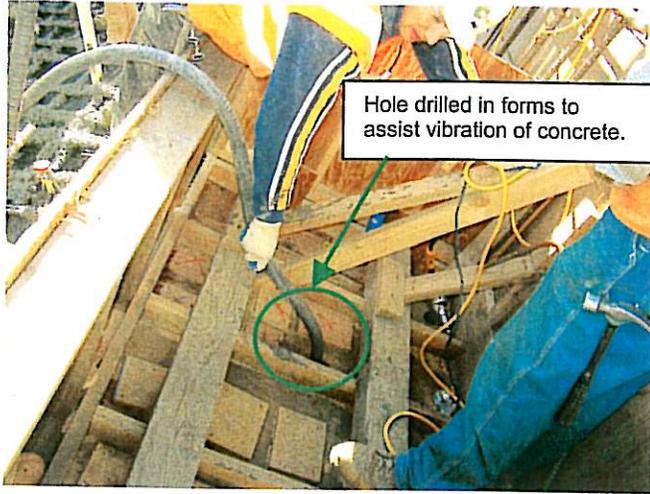
File Name:	DSC00557
Date:	02-15-08
By Int:	M Bruce

Description: Holes were drilled in the jacking saddle forms to help assist consolidation of concrete. Forms were "tapped" with a wrench after vibration was done to see if concrete was in contact with the form. Vibration was done through the holes, on the forms, and at the sides.

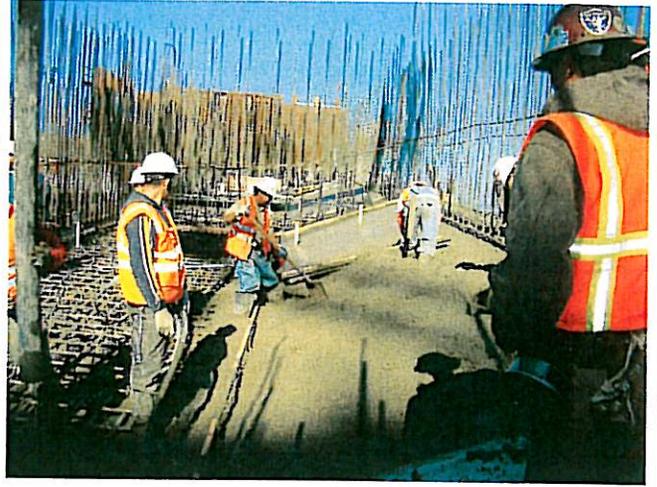
File Name:	DSC00560
Date:	02-15-08
By Int:	M Bruce

Description: Finishing work on the sloped portion of the center slab.

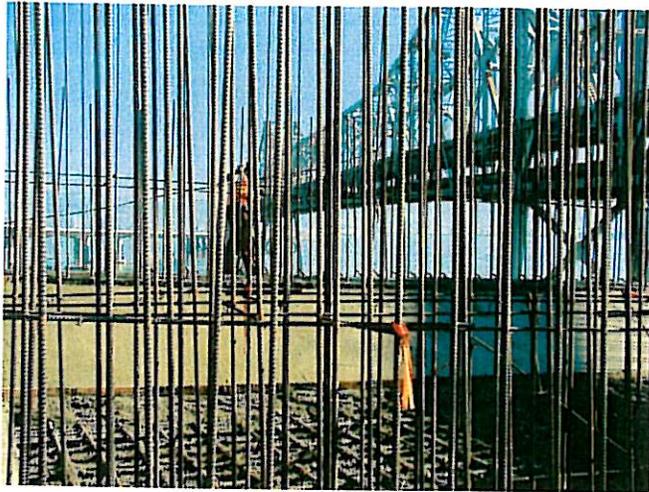
File Name:	DSC00561
Date:	02-15-08
By Int:	M Bruce

Description: Water spraying began at 10:52am and continued at intervals of 20-30min. ABF was constantly reminded to do this task.

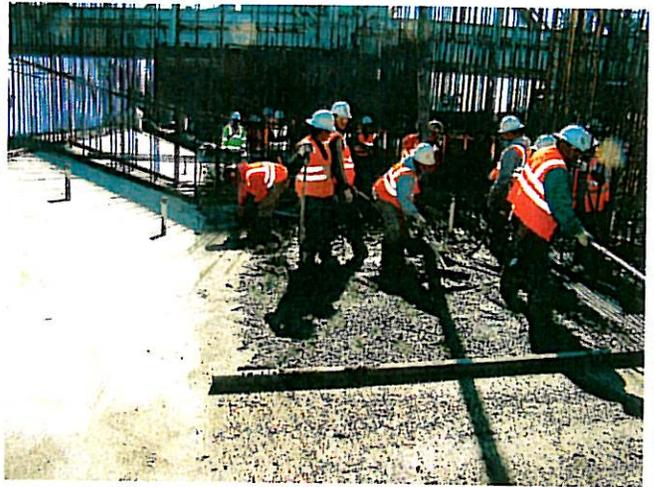
File Name:	DSC00564
Date:	02-15-08
By Int:	M Bruce

Description: Finishing work on the north side 11:15am. Concrete placement was done at 1:23pm.
