Job Stamp 04-0120F4 SFOBB SAS

ASSISTANT RESIDENT ENGINEER'S **CONTRACTOR – ABFJV, Sub RPS**

Description of Operations @ W2 Cap Beam:

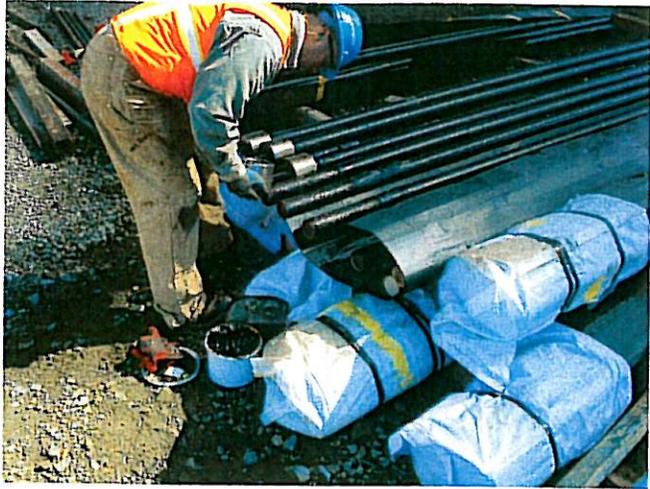
File Name:	DSC00714
Date:	02-25-08

By Int: M Bruce
 Description: Denso paste was applied to exposed portions of the Macalloy rods prior to placement.

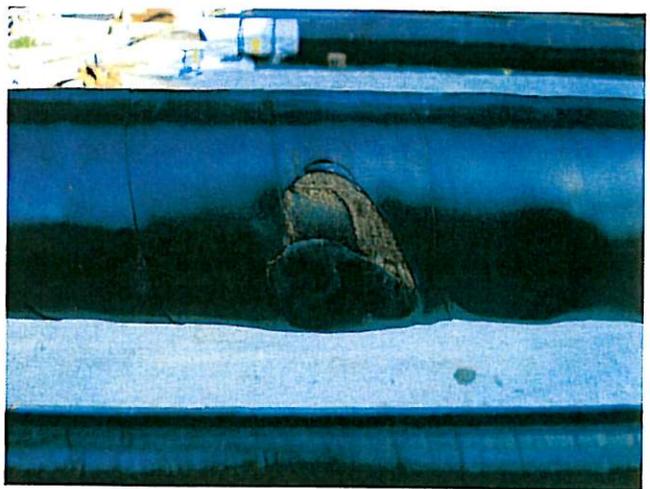
File Name:	DSC00719
Date:	02-25-08

By Int: M Bruce
 Description: Damage to Denso tape from the delivery of the Macalloy rods to the jobsite.

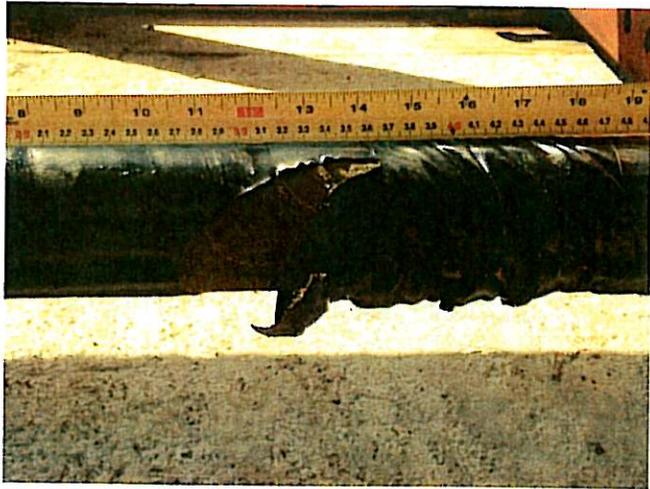
File Name:	DSC00725
Date:	02-25-08

By Int: M Bruce
 Description: Damage to Denso tape from the delivery of the Macalloy rods to the jobsite.

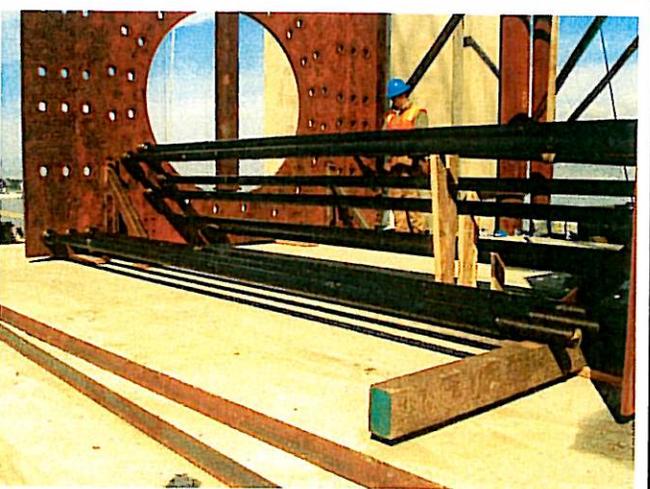
File Name:	DSC00723
Date:	02-25-08

By Int: M Bruce
 Description: Macalloy rod placement into 60mm anchor plate, timber forms yet to be built around the rods.
