Job Stamp
04-0120F4
SFOBB SAS

Const. Calendar:	441		
Project Work Day No.:	651		
Date	02/27/2008		
Inspectors	Start	09:40	Stop 14:40
Hours			
Shift Hours		07:00	15:30

**Description of Operations @ W2 Cap Beam:**

EA	04-0120F4
Co-Rte-KP (PM)	SF-080-13.2/13.9 (8.2/8.7)
Structure Rep.	Rick Morrow

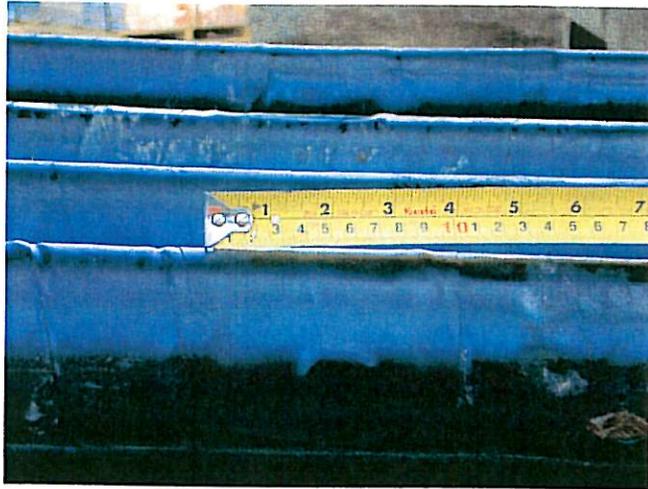
File Name:	DSC00766
Date:	02-27-08
By Int:	M Bruce

Description: Typical repaired section with denso tape covering exposing portions of the Macalloy rod. This task was done while the formwork was being prepared for rod placement.

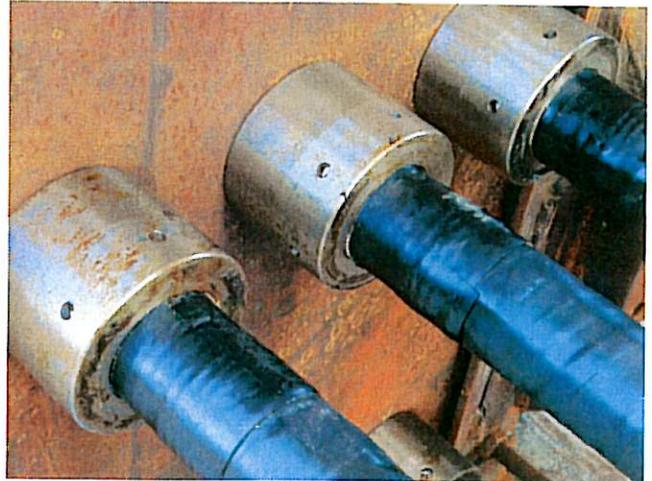
File Name:	DSC00777
Date:	02-27-08
By Int:	M Bruce

Description: Shop drawings per submittal 142R0 show a 50mm clear distance between the nut and Denso tape limits. TY-Lin verbally approved that the tape placed within this area was acceptable. The 50mm clear area is a tolerance to ensure that there is no conflict between the nut and the denso tape.

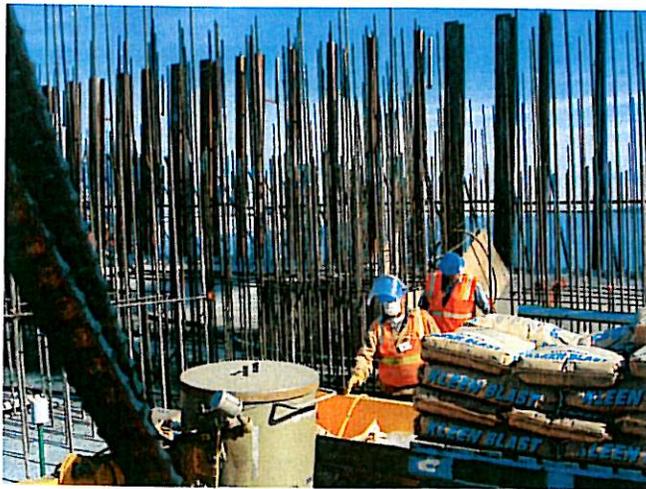
File Name:	DSC00770
Date:	02-27-08
By Int:	M Bruce

Description: Sandblasting of the transverse wall construction joint.

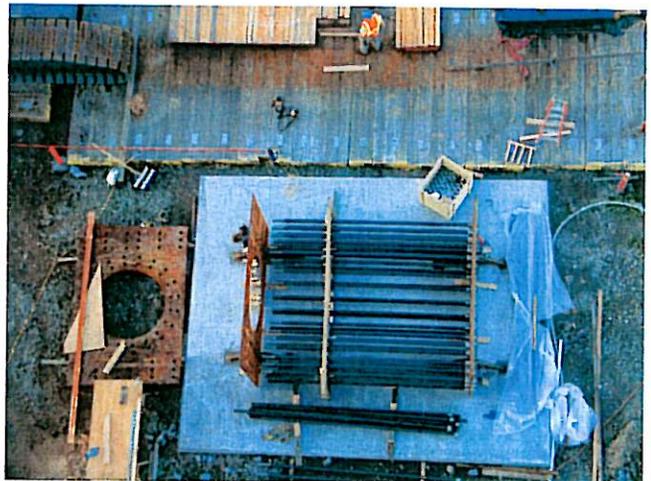
File Name:	DSC00771
Date:	02-27-08
By Int:	M Bruce

Description: Work area for Hinge K assembly taken from the top of the W2 falsework.

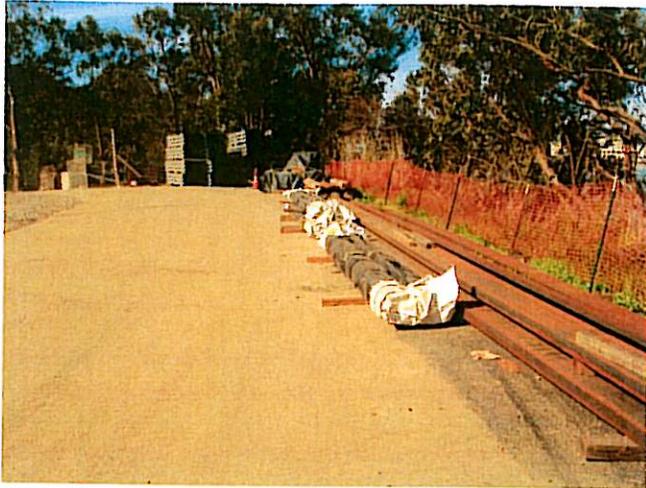
File Name:	DSC00773
Date:	02-27-08
By Int:	M Bruce

Description: Approximately 80 Macalloy rods were shipped to the jobsite today from the pier 7 warehouse. The rods were stored in this location due to the limited space; ABF representatives were made aware of the potential risk of placing the rods on the road.

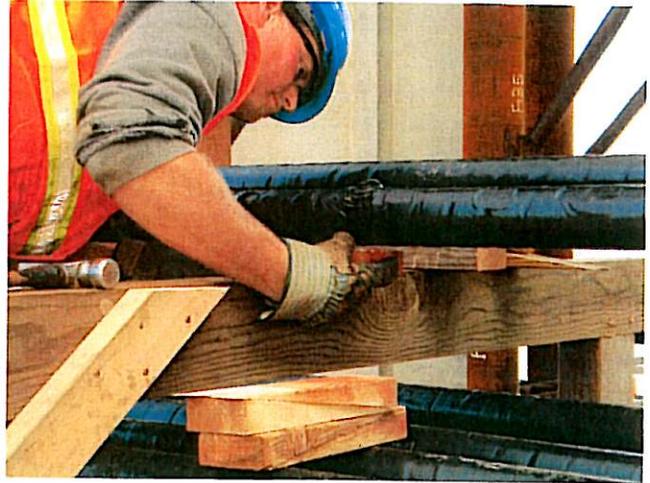
File Name:	DSC00774
Date:	02-27-08
By Int:	M Bruce

Description: Timber wedges were used today to shim the Macalloy rods to align the rods with the template holes.

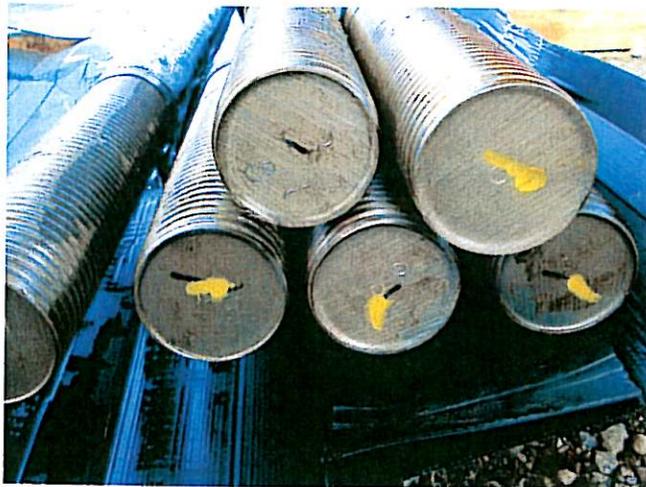
File Name:	DSC00776
Date:	02-27-08
By Int:	M Bruce

\*Denotes rods placed that were originally marked yellow then marked with a red X.

Description: 9 non-high strength Macalloy rods (ID No. 8) were marked yellow located on the east side of the working slab. ABF engineer Branden Bedwell was notified of this error and then marked the rods with a red X.

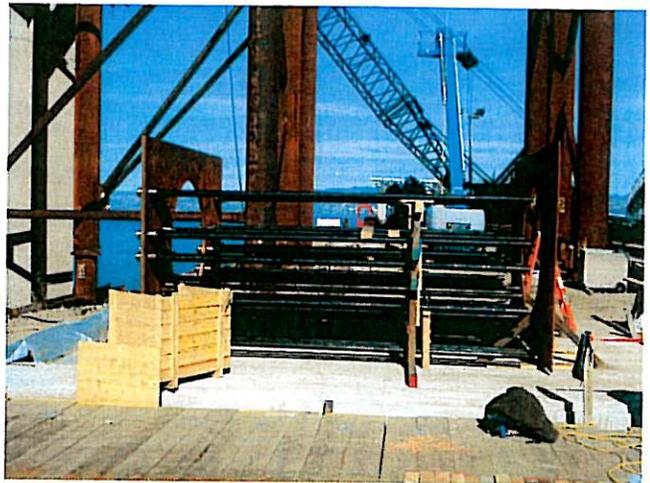
File Name:	DSC00782
Date:	02-27-08
By Int:	M Bruce

Description: 26 Macalloy rods were placed today and a total of 54 rods have been installed for the first Hinge K assembly. This assembly is probably going to be used for ES-Hinge K pipe beam.
