Job Stamp 04-0120F4 SFOBB SAS

ASSISTANT RESIDENT ENGINEER'S **CONTRACTOR – ABFJV, Sub RPS**

Description of Operations @ W2 Cap Beam:

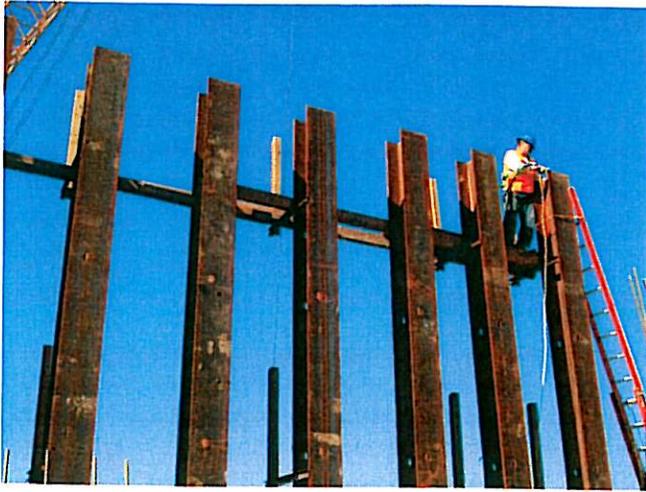
File Name:	DSC00834
Date:	03-05-08
By Int:	M Bruce

Description: Walkway installation for the west vertical forms.

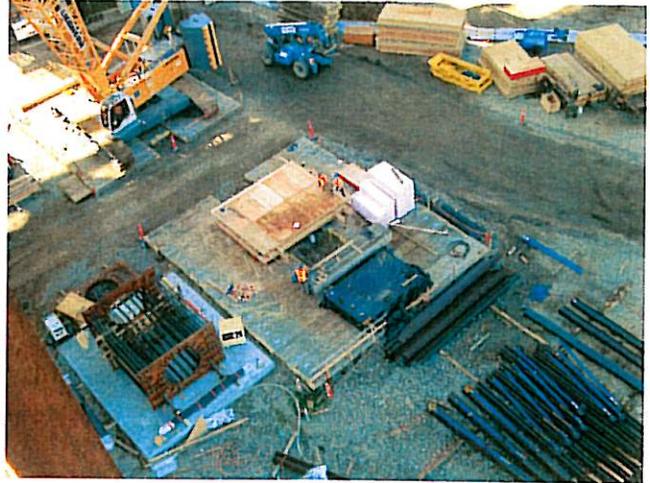
File Name:	DSC00842
Date:	03-05-08
By Int:	D Chung

Description: Hinge K work area as the first rod assembly is complete and blackout form construction is in progress.

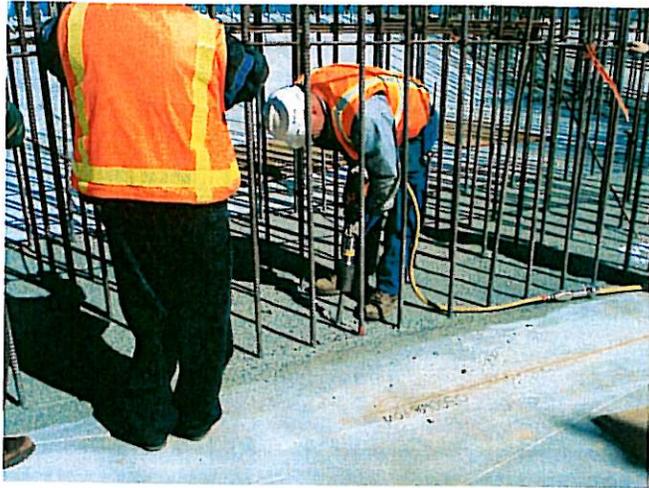
File Name:	DSC00852
Date:	03-05-08
By Int:	M Bruce

Attended field meeting @ 1:00pm regarding the cracks in the concrete from pour 1A, 1B, and 1C. White spray paint was used to identify four locations for coring samples. Also a crack in the transverse diaphragm (north section) was chipped to see the depth of the crack.

Description: Field meeting to investigate the depth or severity of some cracks found. This crack was chipped on the transverse diaphragm wall in the north.

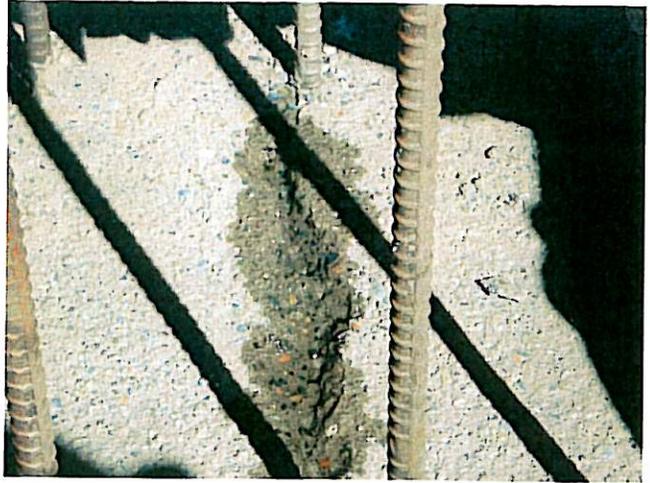
File Name:	DSC00855
Date:	03-05-08
By Int:	M Bruce

Description: Water was placed on the crack chipped in the previous picture. It appeared that no water drained from the chipped area, however bubbles were seen in certain spots.
