Job Stamp:
04-SF-80-13.2/13.9 04-0120F4
SFOBB SAS
San Francisco Co. in San Francisco
Fm 0.6 km to 1.3 km East of Yerba Buena
Tunnel East Portal

Report No. **46.B**

ASSISTANT RESIDENT ENGINEER'S DAILY

| Location: W2 Cap Beam | 7-day const. cal.: 439 | Weather: Partly cloudy |

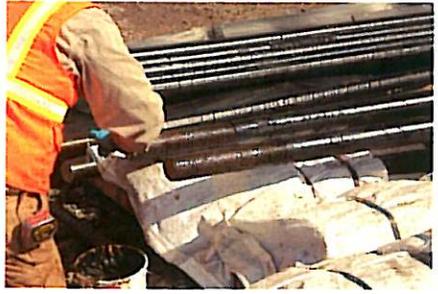
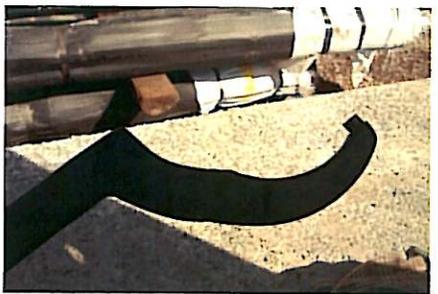
Field inspection today highlighted concern for the ends of the HS rods, specifically the threads. With the HS-rod diameters being 75mm and the holes of the template being 80mm, there is virtually no room for error when sliding the steel template on. In theory, if the HS-rod steel was harder than the template steel, this would be little concern. Regardless, damage of the ends of the HS-rods can/will prove to make stressing of the rods difficult. Further concern was the length of time that these rods would be out in the field. Terry (ABF foreman) stated he will cover the unused rods. Today, 18 rods were placed. The higher strength rods were placed at the pre-designated locations. A combination of lower and higher strength rods were placed at 13-15, 16-18, 34 & 35, 53,55, 57-64. As of ~14:20, they ran out of nuts and discontinued rod placement and started brainstorming how to align the template in the correct position. As it sits, it is roughly 1/4 inch low on one side. As far as the rods go, they only have 20 lower strength bars (#8) left on site. Putting a 4-foot level on the rods revealed that they were placed level. Last friday, we revealed the template and PL 60 were placed plumb. Therefore, these rods are square to the plate and the rods should not be experiencing any stress at the plate connection. To torque the nuts at the plate, they were using a special device shipped with the nuts (pic attached). My concern was if they were slamming their hammers directly on these nuts, there would develop a micro crack and eventually be enough to develop into a larger crack later.
