Job Stamp:  
04-SF-80-13.2/13.9 04-0120F4  
SFOBB SAS  
San Francisco Co. in San Francisco  
Fm 0.6 km to 1.3 km East of Yerba Buena  
Tunnel East Portal

**ASSISTANT RESIDENT ENGINEER'S DAILY BRIDGE REPORT**

Location: W2 Cap Beam	7-day const. cal.: 440	Weather: few clouds
Remark: Continue assembling Hinge K	Project work day: 650	Hi 61F / Lo 43F

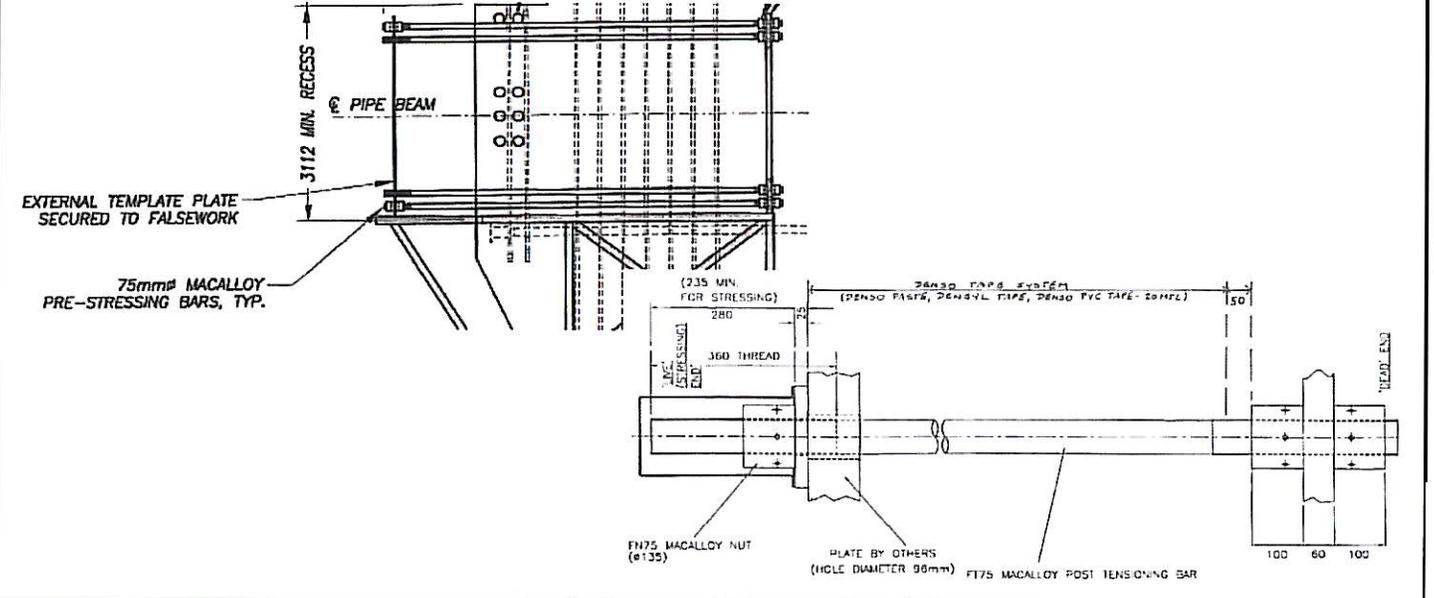
Concern arose over the application of the Densyl Tape around the HS Rods. If the tape was applied *beyond* what was required, the template would not be able to fit on the rods. As they exist, the holes of the template are 80mm in diameter and the rod diameter is 75mm. With the Densyl tape applied, the rods being inserted into the template is an impossibility. However, field measurement revealed that the application in fact will not inhibit the template from being installed on the ends of the rods. The template was previously mistaken to be installed farther beyond its intentional position. The template lies at the end of the rod where the final plate will eventually be installed - all within the threaded length of the end of the rod. The template will then be removed for the post-tension plate to be placed.
