Job Stamp:  
04-SF-80-13.2/13.9 04-0120F4  
SFOBB SAS  
San Francisco Co. in San Francisco  
Fm 0.6 km to 1.3 km East of Yerba Buena  
Tunnel East Portal

**ASSISTANT RESIDENT ENGINEER'S DAILY BRIDGE REPORT**

Location: <b>W2 Cap Beam</b>	7-day const. cal.: 448	Weather: clear, cold
Remark: <b>Hinge K Assembly</b>	Project work day: 658	Hi 65F/Lo 53F

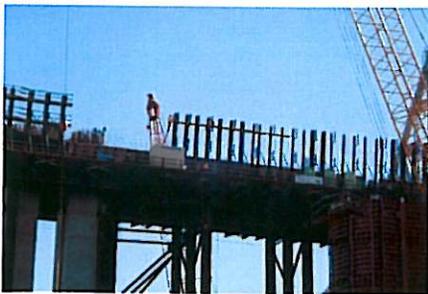
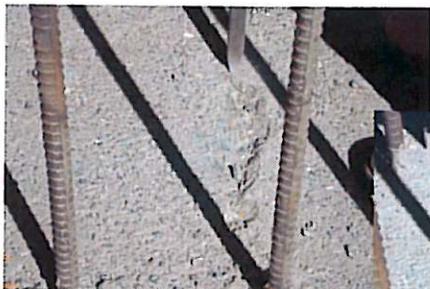
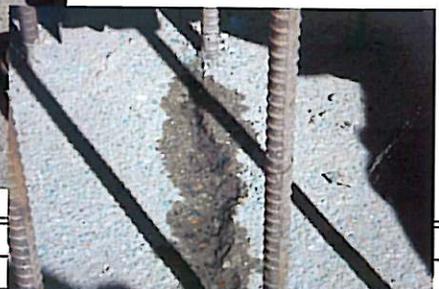
A site visit in the afternoon by Caltrans/ABF/T.Y.Lin took place to begin an initial survey of the cracks. Locations for core samples were circled with white paint. Caltrans has not yet informed ABF of the need to core them. The first is located ~10 feet into the south end from where the face of concrete would be, ~ 5 feet west of the west side of the intermediate diaphragm. The second is about 7 feet north of the north manhole of the intermediate diaphragm. The 3rd is about halfway on the east side of the cap beam on the slope about halfway between the longitudinal diaphragm and east mass pour. The fourth is on adjacent to the east face of the longitudinal diaphragm, on the west side of the cap beam.

A large crack found at the construction joint in the intermediate diaphragm on the north side of the longitudinal diaphragm, roughly 10 feet from the manhole. The crack was investigated by chipping until the crack showed no evidence of further propagation. Ron Matin (CT) poured water in this groove; after roughly 4 seconds, air bubbles were seen coming up. However, when the water was blown out, the crack could not be located. The overall consensus is that these are surface cracks and may not be critical - though a final decision has not yet been made.
