TOLL PROGRAM/DIST. 4 CONSTR.

Job Stamp:  
04-SF-80-13.2/13.9 04-0120F4  
SFOBB SAS  
San Francisco Co. in San Francisco  
Fm 0.6 km to 1.3 km East of Yerba Buena  
Tunnel East Portal

Report No. **46.B**

**ASSISTANT RESIDENT ENGINEER'S DAILY**

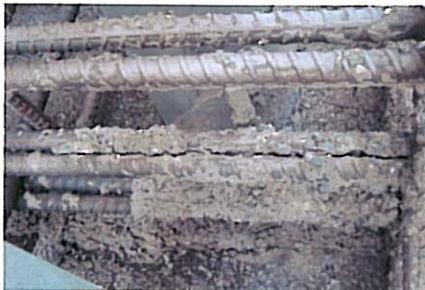
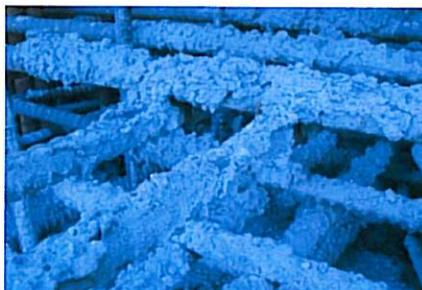
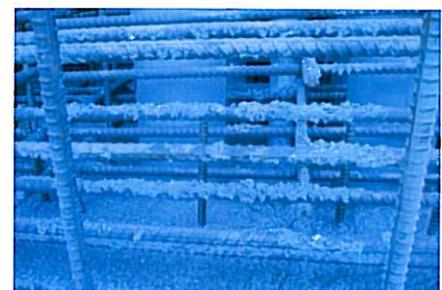
An internal meeting in the field to observe the cracks, accept/reject the construction joint, and discuss concrete debris on un-embedded steel reinforcement revealed that the steel reinforcement for pour 2 is rejected due to uncleanliness. During concrete placement of pour 1, concrete debris was left over on the steel reinforcement. Gordy (ABF) claims that they tried to clean it off but was unsuccessful. To date, the only method that I have witnessed of cleaning is sandblasting the construction joint and steel reinforcement. The aggregate has been exposed on some of the reinforcement, but on other bars it does not look as if any attempt has been made to clean off the concrete debris. Attached pictures show some effort (left) and no effort (center) into sandblasting debris. Gordy claims that the bars are inaccessible and therefore cleaning by means of hitting it would be extremely difficult. The picture on the right shows bars on the east side of the column area which are easily accessible.

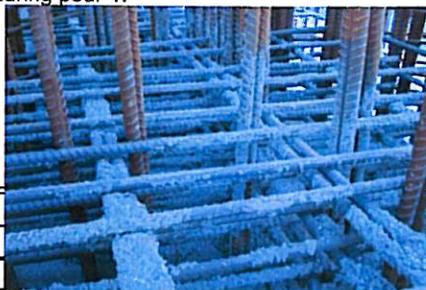
Furthermore, Marco (ABF) claims that a laborer attempted to remove the concrete by hitting it for three days, with no success. However, Matt (CT) and I took a few swings at the concrete and it chipped off. Also, Matt and I showed Gordy that a wedging action between two horizontal bars could break some of the bonds (above left). Ron (CT) and Pam (CT) states that Marco did agree that the bars were not clean but refused to provide any more effort at cleaning them. The pictures below are examples of the extent of the concrete debris and absence of care when placing the concrete during pour 1.
