Job Stamp:
04-SF-80-13.2/13.9 04-0120F4
SFOBB SAS
San Francisco Co. in San Francisco
Fm 0.6 km to 1.3 km East of Yerba Buena
Tunnel East Portal

Report No. **46.B**

ASSISTANT RESIDENT ENGINEER'S DAILY

Location: W2 Cap Beam	7-day const. cal.: 455	Weather: overcast
Remark: Pour 2 forms	Project work day: 665	Hi 59F/Lo 50F

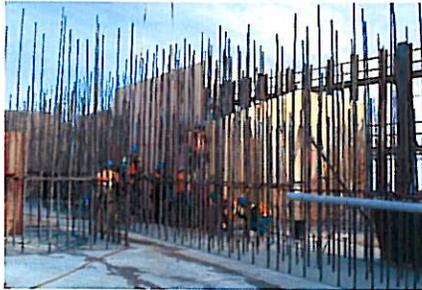
In the field: The carpentry crew is in the process of erecting panels on the southeast corner of the intermediate diaphragm on the north side of the longitudinal diaphragm.

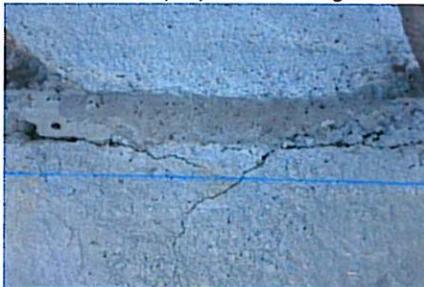
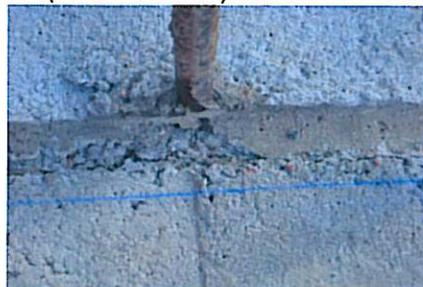
I found a crack in the concrete along the interior layer of vertical reinforcement at the east side of the cap beam. I noticed that the top surface looked discolored and that the crack pattern was not common for gravity or thermal cracks that I have seen. I borrowed a hammer and started knocking the concrete. There were obvious points of unsound concrete, as if it were hollow.

A video clip (with sound) was taken of Matt (CT) also knocking on the concrete (MOV00901.MPG).
