Job Stamp:
04-SF-80-13.2/13.9 04-0120F4
SFOBB SAS
San Francisco Co. in San Francisco
Fm 0.6 km to 1.3 km East of Yerba Buena
Tunnel East Portal

Report No. **46.B**

ASSISTANT RESIDENT ENGINEER'S DAILY BRIDGE REPORT

Location: W2 Cap Beam	7-day const. cal.: 457	Weather: Overcast
Remark: bushel concrete debris	Project work day: 667	Hi 58F/Lo 52F

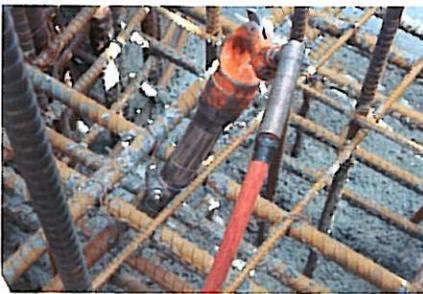
Jim Davidson (ABF) came to the Caltrans office (Pam's cubicle) to see the cores. A picture was taken for each core sample with a tape measure for scaling. These pictures were given to Davidson as hard copies, along with a layout of where the samples were taken with measurements. Field visit revealed that ABF has started busheling the steel reinforcement with an impact hammer. The method so far has gotten most of the larger portions of concrete debris off.

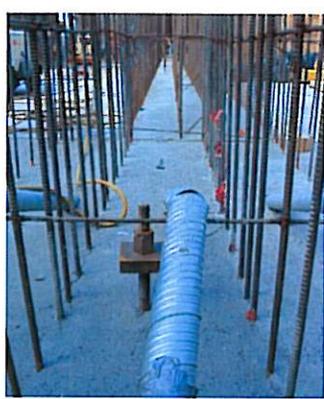
Upon leaving the column area, I noticed that a transverse tendon duct was bent and damaged. I notified Gordy (ABF) to patch the hole before any rain or miscellaneous objects get in.

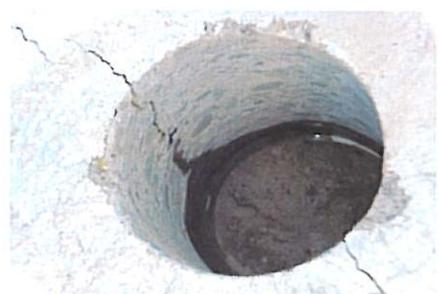
The cored holes from yesterday show a declining waterline. This goes to show that the water is still flowing through the cracks. In the picture, there is a wet perimeter up from the actual waterline.
