Job Stamp 04-0120F4 SFOBB SAS

Const. Calendar:	456			
Project Work Day No.:	666			
Date	03/13/2008			
Inspectors	Start	10:20	Stop	13:45
Hours				
Shift Hours		07:00		15:30

Description of Operations @ W2 Cap Beam:

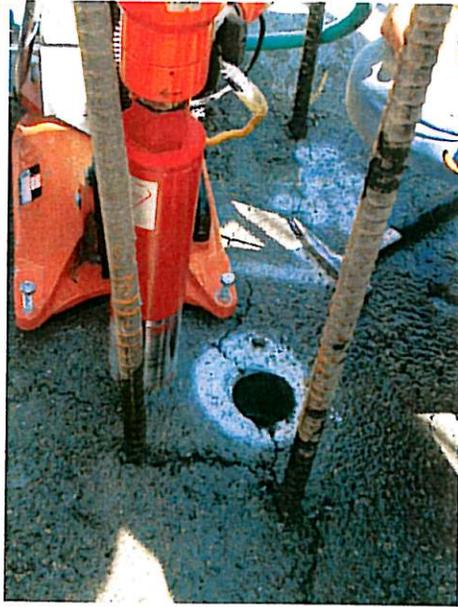
File Name:	DSC00931		
Date:	03-13-08	By Int:	D Chung

Description: Coring done at location number 1, which was the location where the rebar locator was unsuccessfully used.

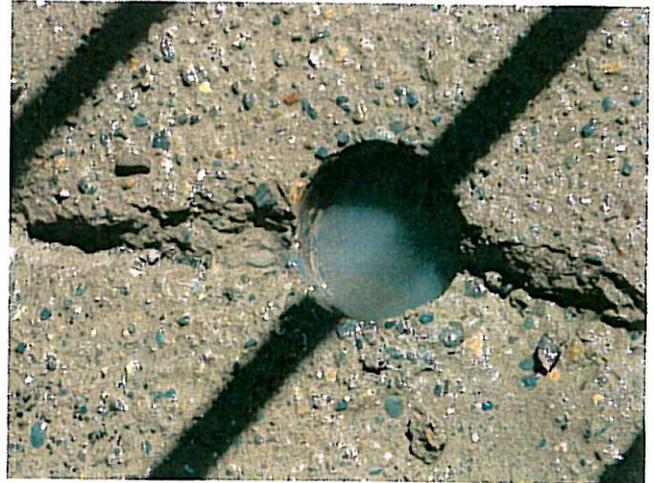
File Name:	DSC00938		
Date:	03-13-08	By Int:	D Chung

Description: Coring done at point 5, where chipping was done at the March 5th, 2008 field meeting with Caltrans, ABF, and TY-Lin representatives.

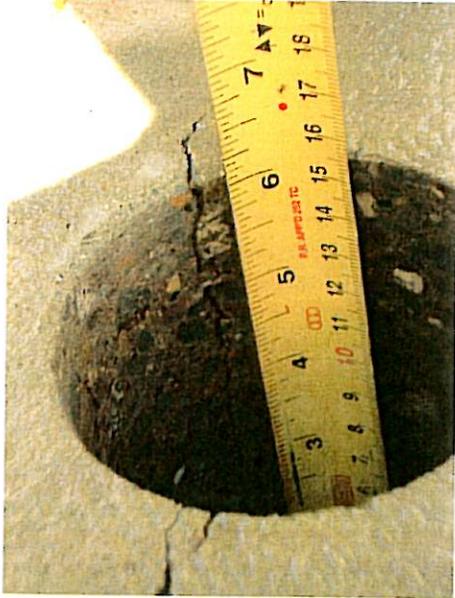
File Name:	DSC00951		
Date:	03-13-08	By Int:	D Chung

Description: Coring hole at location number 6 as the crack propagates down the height of the hole.

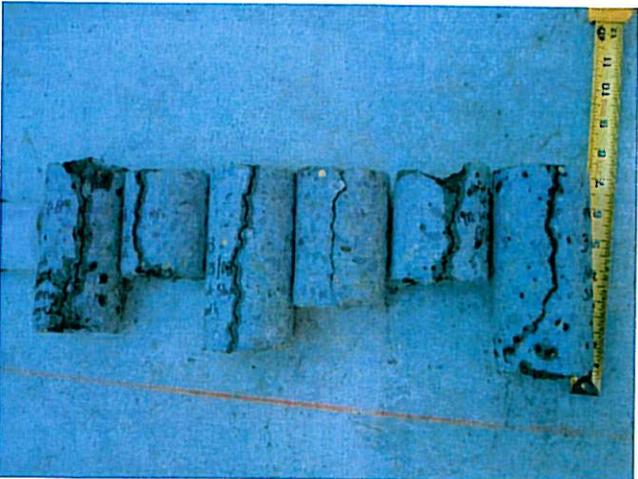
File Name:	DSC00957		
Date:	03-13-08	By Int:	D Chung

Description: Six coring samples were taken today. Four locations were originally designated March 5th 2008 with white spray paint labeled 1-4. Two more coring samples were taken in the field today.
