Job Stamp 04-0120F4 SFOBB SAS
-------------------------------------

ASSISTANT RESIDENT ENGINEER'S **CONTRACTOR – ABFJV, Sub RPS**

**Description of Operations @ W2 Cap Beam:**

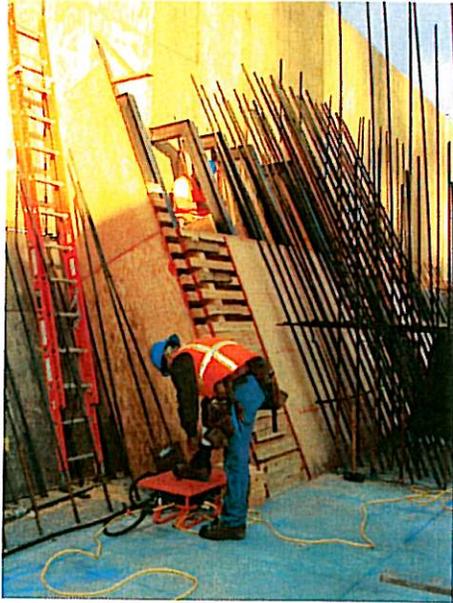
File Name:	DSC01045		
Date:	03-24-08	By Int:	D Chung

Description: Jacking saddle blockout form construction, which was almost complete at the end of the day.

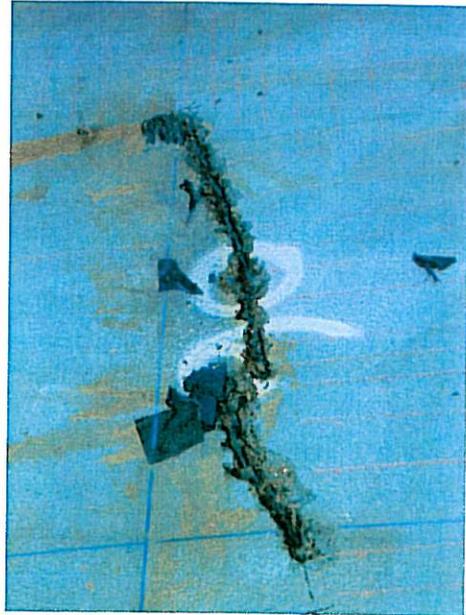
File Name:	DSC01050		
Date:	03-24-08	By Int:	D Chung

Description: Crack on the southeast slope identified by Caltrans as location number 6. All cracks were chipped then epoxied before coring. ISI used a ferrosan to locate rebar and marked with red keel on the surface before coring.

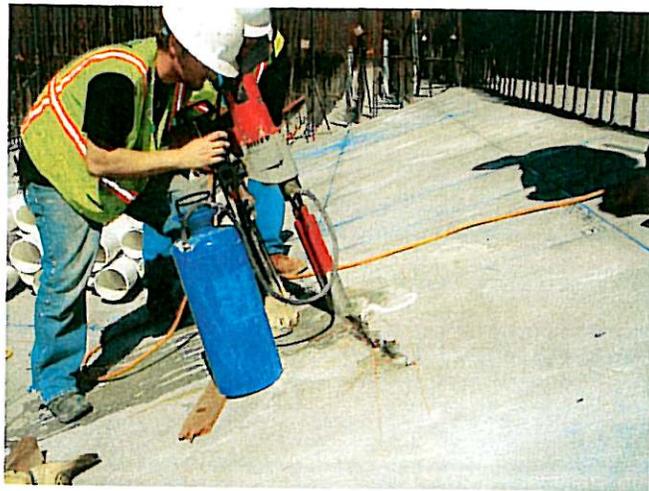
File Name:	DSC01069		
Date:	03-24-08	By Int:	D Chung

Description: ISI's coring operations.

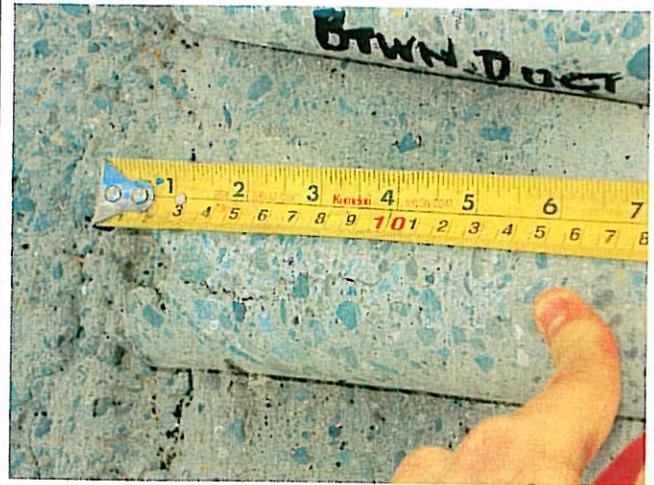
File Name:	DSC01076		
Date:	03-24-08	By Int:	D Chung

Description: Coring sample taken by ISI.
