RSC on site today to provide support on rebar/PT issues arising during concrete pour.

### Concrete Pour

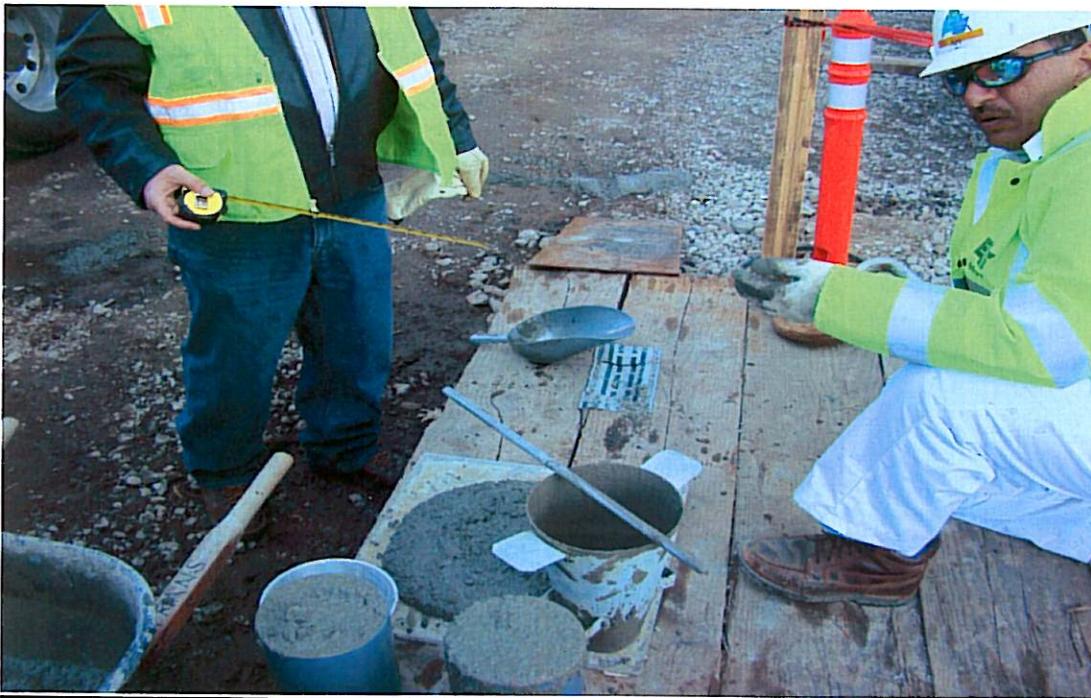
- Concrete was being delivered to job site with 8.5" slope (see photo 1-2 below) and being placed in forms from high point to low along east slope (see photo 3 below). I called Braden Bedwell ABF and informed him Conco's placement operation was producing a bad product by causing the concrete to slip down the slope (see photo 4 below) and produced voids (see photo 5 below) on the low side of the rebar (see photo 5 below). Brandon informed me that ABF requested wet concrete and it should not be a problem. I also expressed my concerns to Conco's foreman.

Photo #1: Slump test.

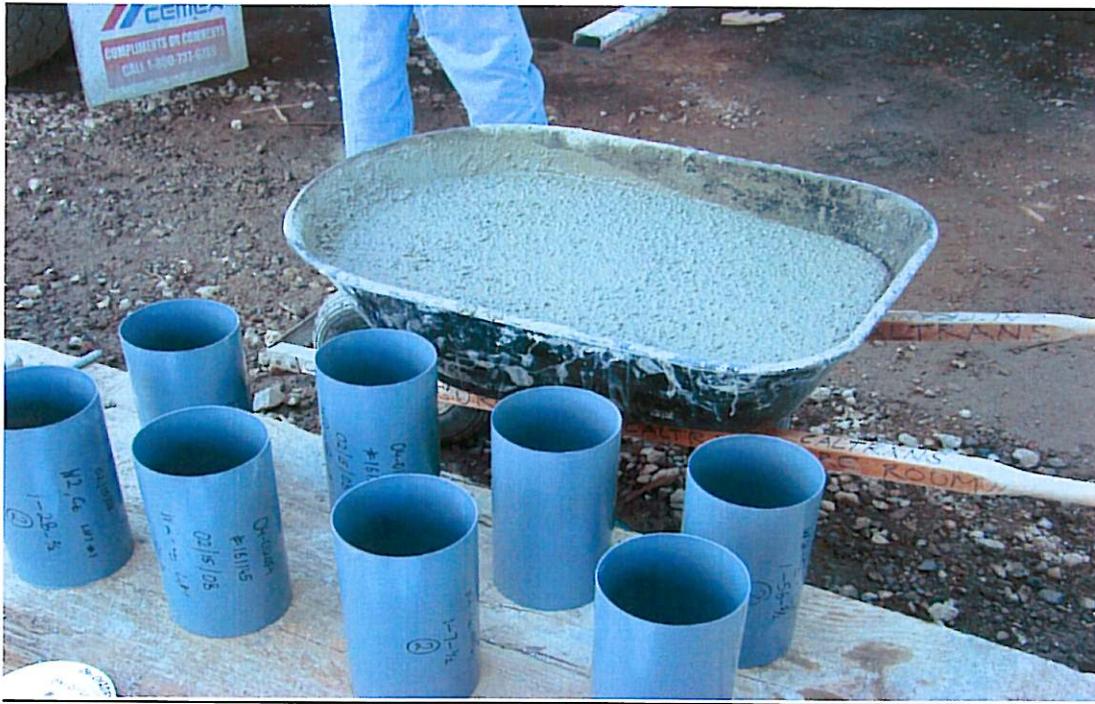
**Photo #2:** Wet concrete in wheelbarrow.

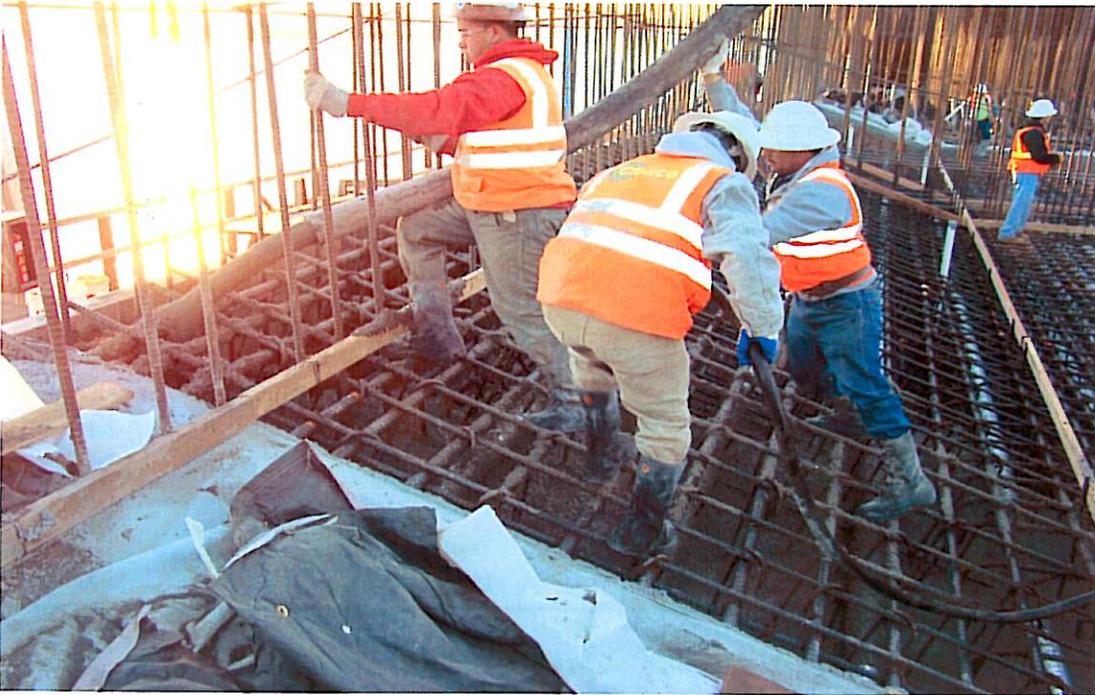
**Photo #3:** Concrete being placed in forms from high point to low along east slope.

- I also requested Conco's superintendent to place the wet concrete from the lowest point in the forms proceeding to higher points. He agreed and informed his foreman.

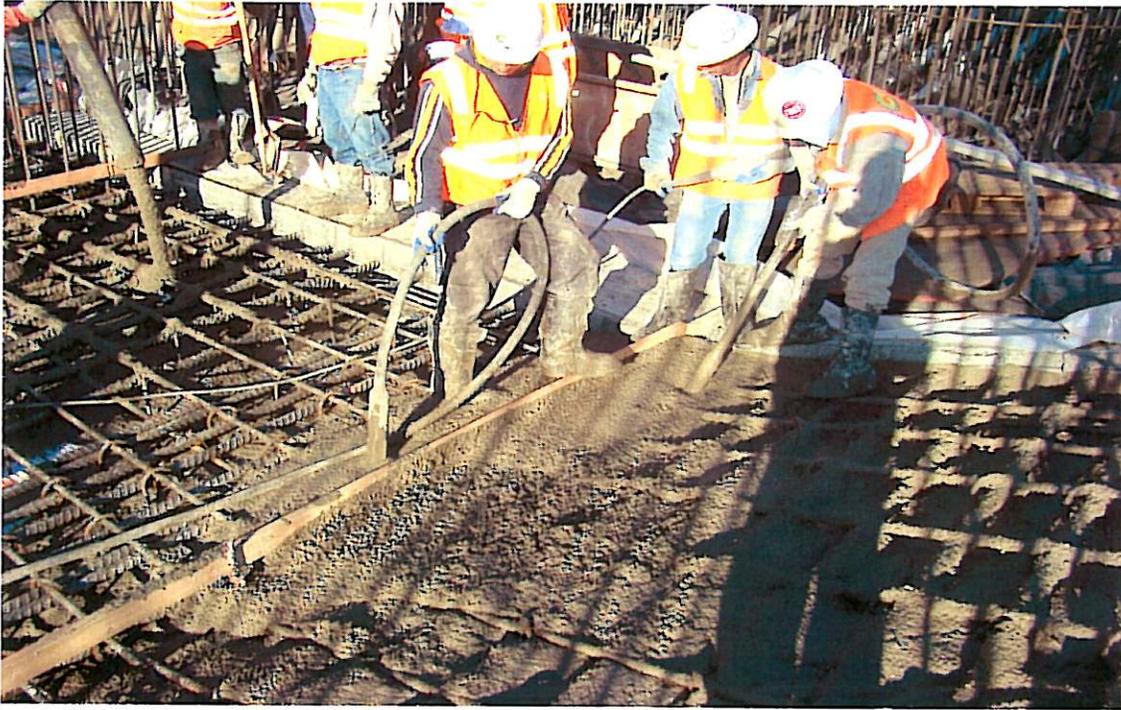
**Photo #4:** Concrete being placed in forms from high point to low along east slope. Concrete is sliding down slope to low point.

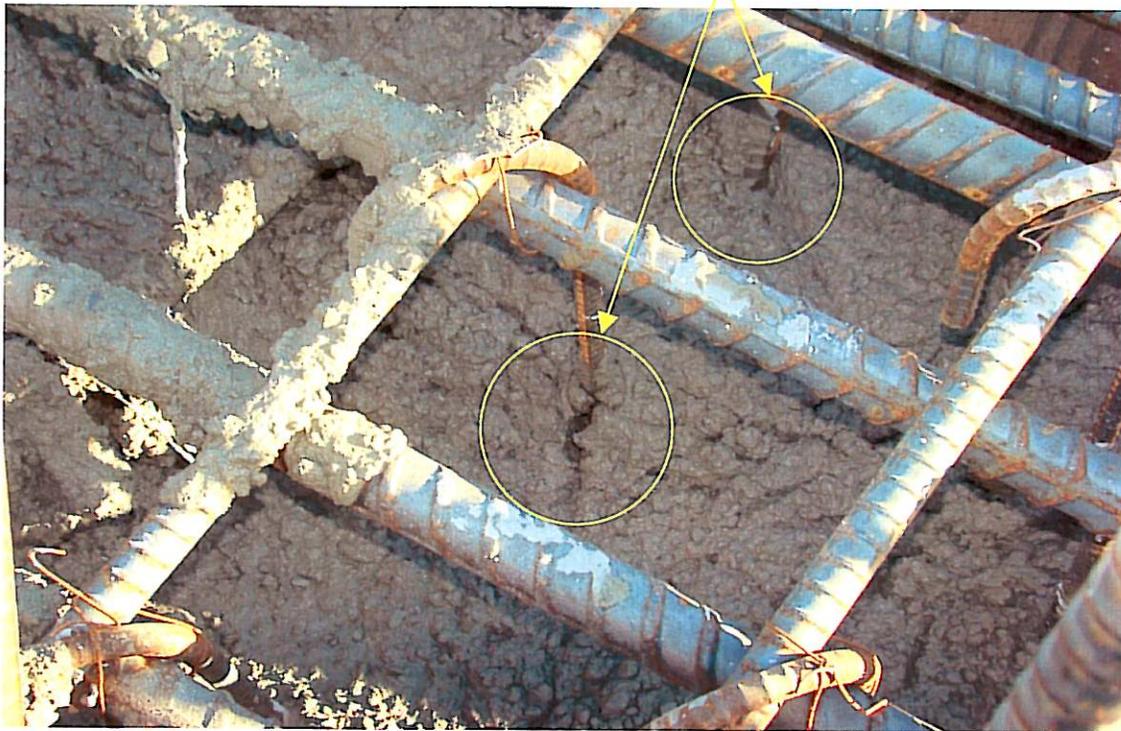
- The unacceptable operation continued and I informed Gil Klebanov CT and Chuck Kanapicki ABF the concrete was too wet and causing voids around the rebar in the concrete.

**Photo #5:** Concrete slipping down the slope producing voids around rebar.

- C. Kanapicki worked with Cemix batch plant to provide appropriate slump concrete to the job site.
- Concrete pours finished placing concrete at approximately 2:00pm.
