STATE OF CALIFORNIA	Job Stamp	7-day Const. Calendar	Day No. 467
DEPARTMENT OF TRANSPORTATION	SFOBB SAS	Project Work Day No.	Day No. 677
Form HC-10A (Rev. 6/80)	04-0120F4	Date	03/24/2008

ASSISTANT RESIDENT ENGINEER'S

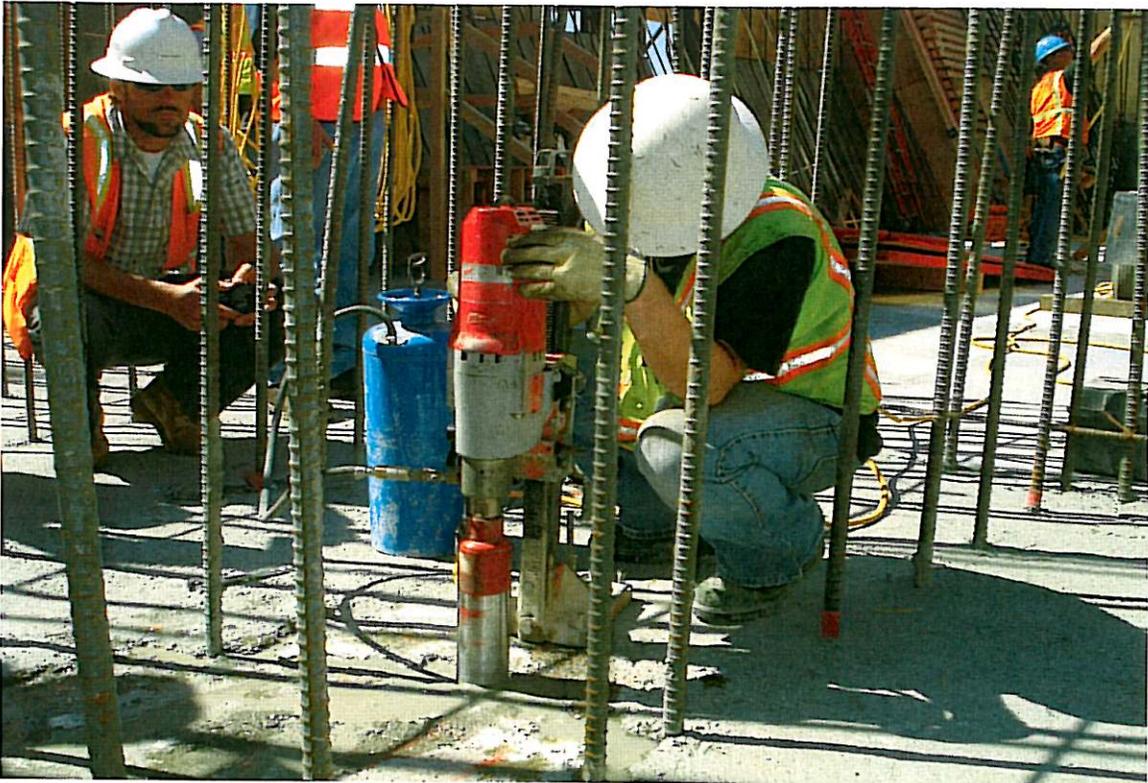
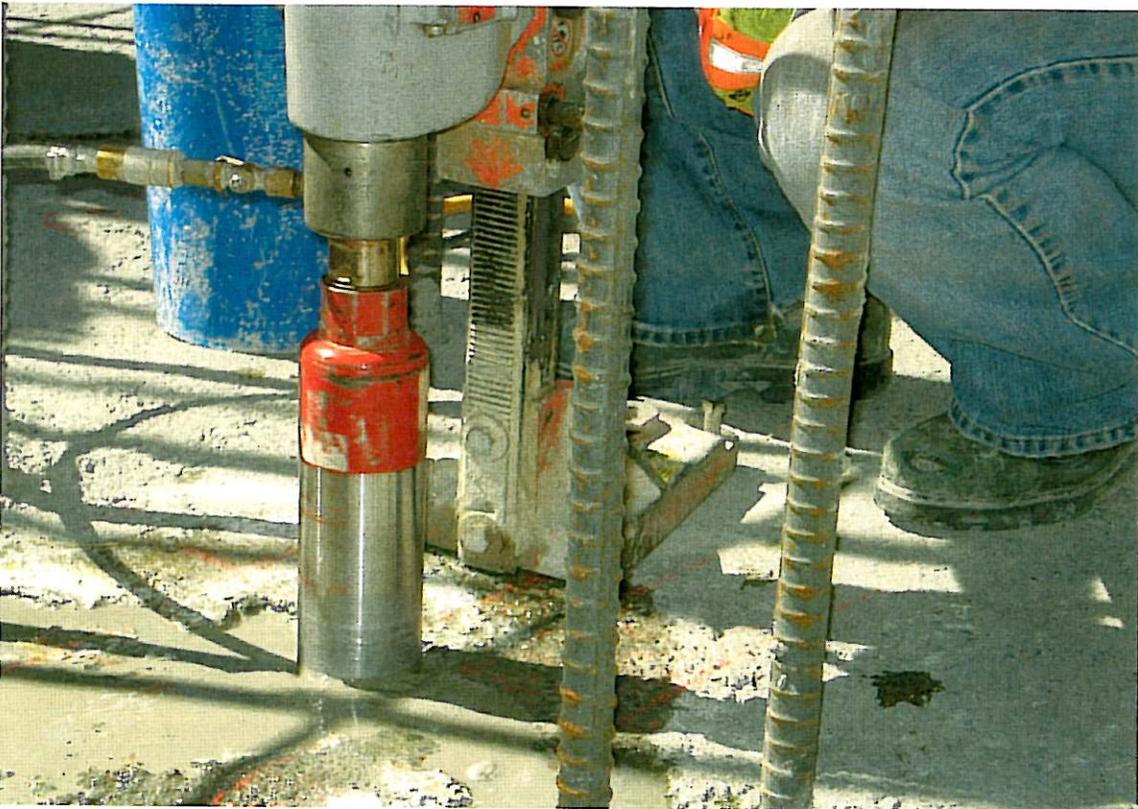
ABF Coring Operation – South column region

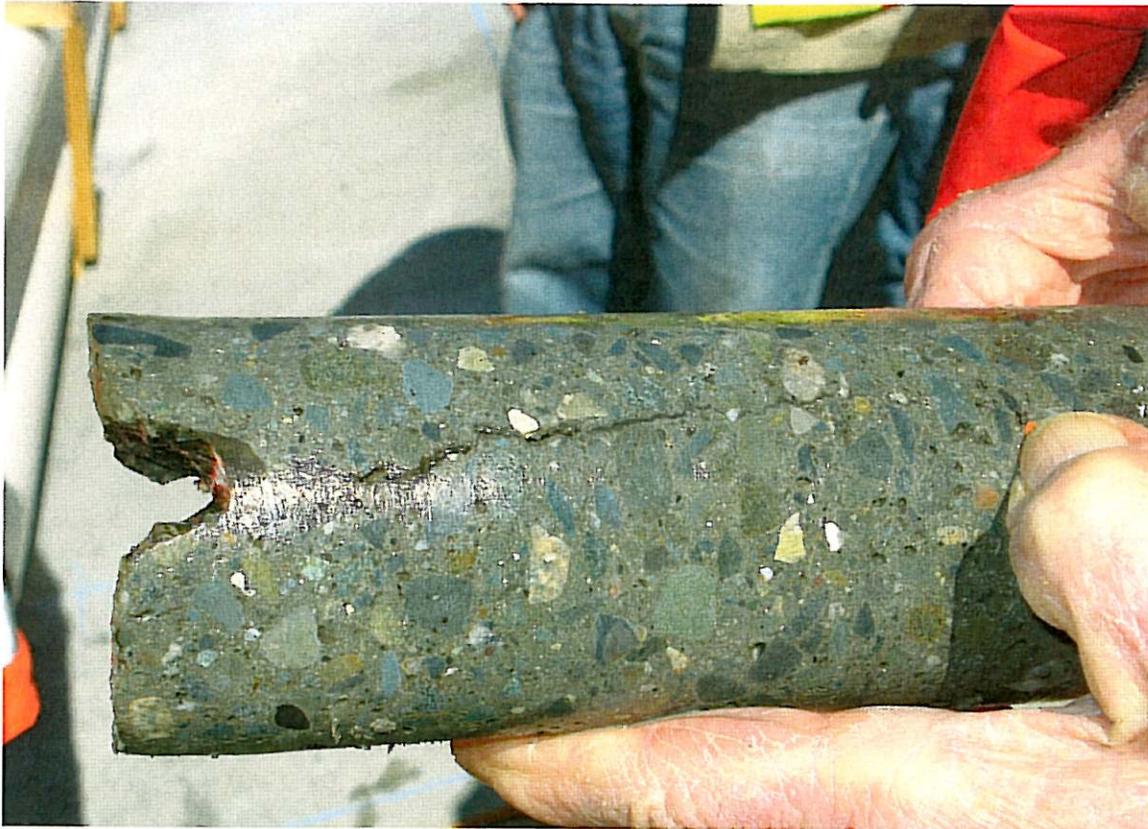
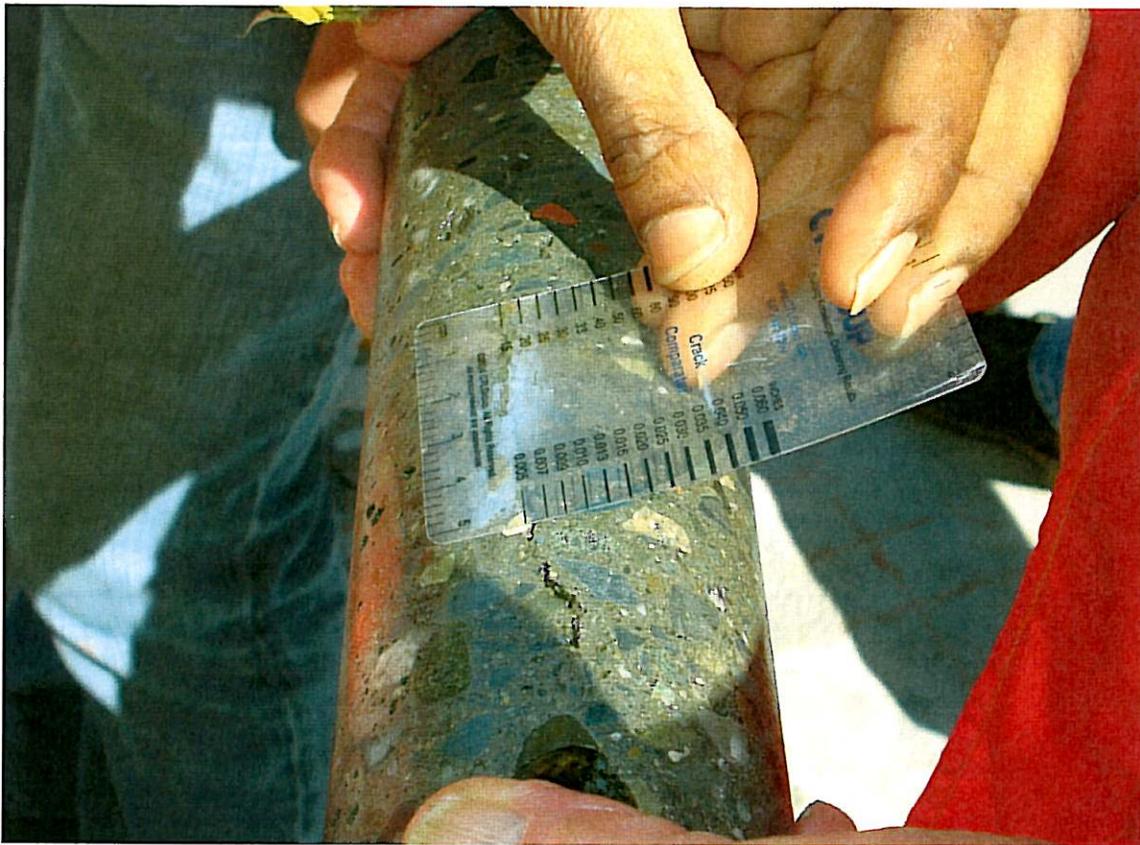
ABF Core sample #2 – Northeast slope location.

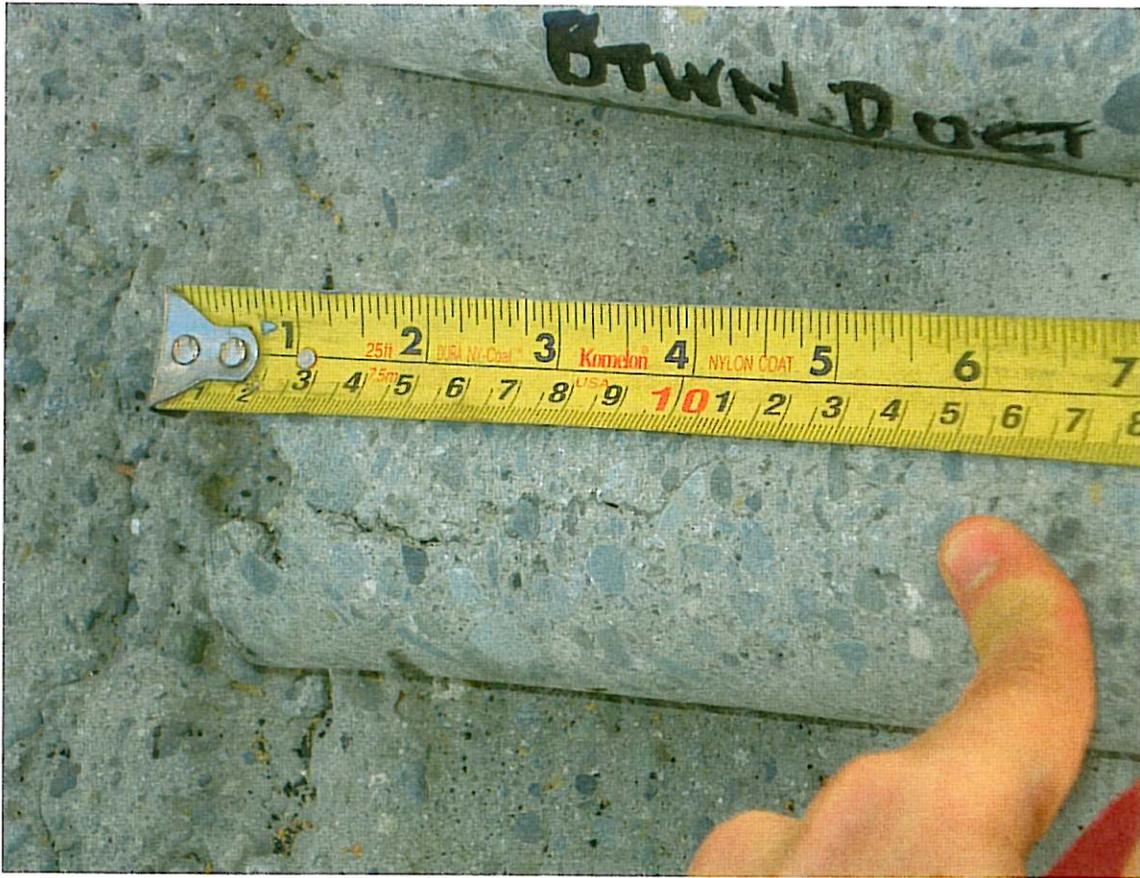
ABF Core sample #3 – North column location.
