Job Stamp:
04-SF-80-13.2/13.9 04-0120F4
SFOBB SAS
San Francisco Co. in San Francisco
Fm 0.6 km to 1.3 km East of Yerba Buena
Tunnel East Portal

Report No. **46.B**

ASSISTANT RESIDENT ENGINEER'S DAILY BRIDGE REPORT

Location: W2 Cap Beam	7-day const. cal.: 467	Weather: AM fog, clear PM
Remark: Coring by ISI	Project work day: 677	Hi 62F/Lo 48F

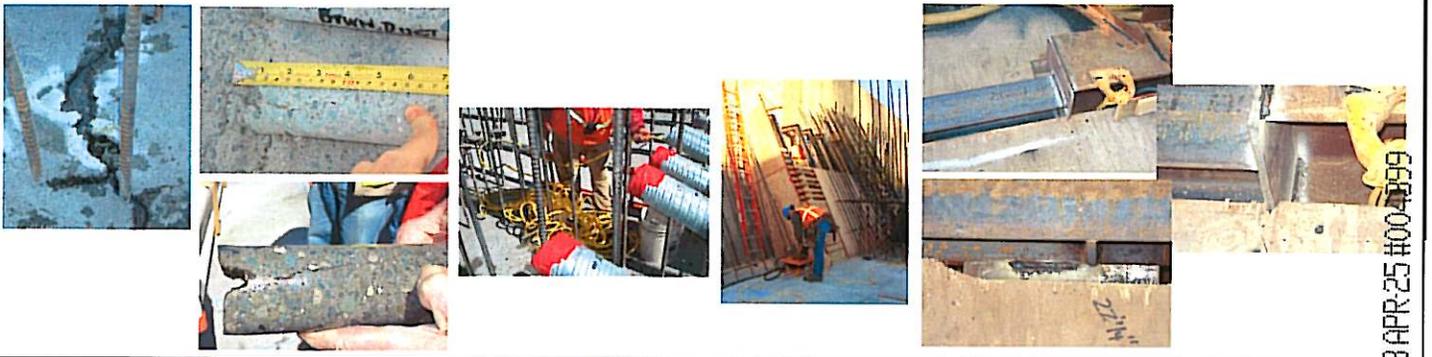
-Workers were running a rabbit through the transverse PT ducts. The rabbit was a solid white plastic bulb. See picture below. Judging by the ability of this white bulb going through the duct from one end of the duct to the other, the strands should have no problem being inserted into the ducts (for the part of ducts that are ALREADY cast in concrete. This would not necessarily apply to ductwork that has not yet been cast in concrete - concrete mortar however, could still leak through any joints during pour 4 and 5 to fill the duct). The rabbit and rope used to pull the rabbit through were wetted by a few of the ducts - water may have entered and may be stagnant inside the duct.
