Job Stamp:
04-SF-80-13.2/13.9 04-0120F4
SFOBB SAS
San Francisco Co. in San Francisco
Fm 0.6 km to 1.3 km East of Yerba Buena
Tunnel East Portal

Report No. **46.B**

ASSISTANT RESIDENT ENGINEER'S DAILY

Location: W2 Cap Beam	7-day const. cal.: 469	Weather: Clear/light & mod. Winds
Remark: diaphragm formwork	Project work day: 679	Hi 59F/Lo 49F

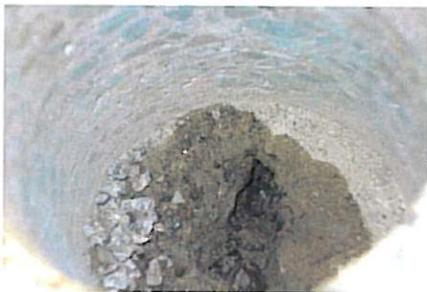
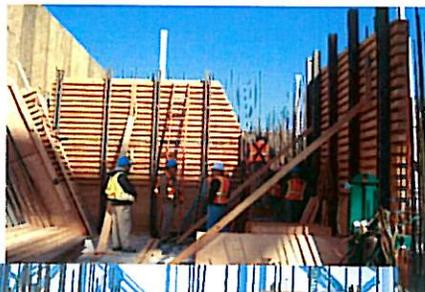
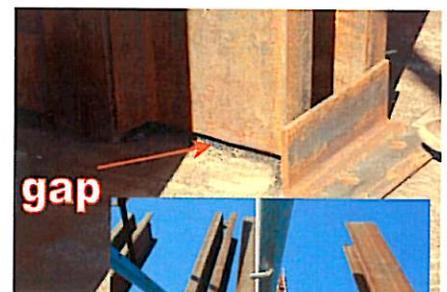
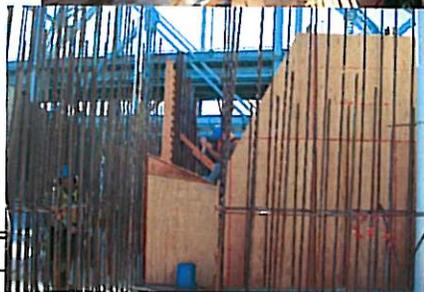
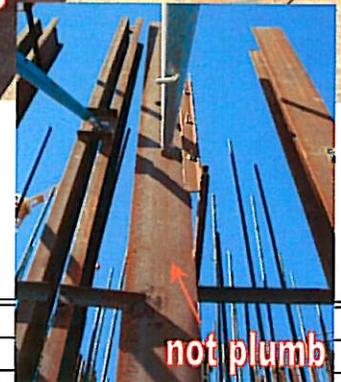
During the weekly meeting, Gil (CT) requested a survey control plan to be submitted by ABF per the Special Provisions - specifically for Pier E2. Pam (CT) mentioned a she was able to place a length of tie-wire into the cored hole #4 (shown below). This may have been due to the lack of re-vibration of the concrete after finishing as specified in the special provisions, as I explained in my diary on 2/20/08. The concrete settles and a pocket forms underneath the horizontal rebar. This is likely to be what Pam encountered. Gil determined that this was not a big issue. During a field visit, I've noticed that the crews have cut out the haunch in their forms, as I specified was missing yesterday. During a walkthrough of the formwork supports on the east side, Pam noticed that some of the formwork is not placed plumb (shown below). Also, some of these members are not flush with the platform, but rather resting on the bolt that is strawn through the flanges. The first issue is more important than the second; the tributary area of the adjacent members may be increased. The second issue of these members not flush with the platform is a moot point. The only weight it needs to carry is it's own. There is no vertical load on these members, only transverse. The PVC pipes mentioned in my diary yesterday are not for concrete placement. One of the crew told me that they are placeholders so the ironworkers do not place steel in its place. These will be removed once the ironwork is placed. These locations can still represent the concrete pump tube to be placed down with no obstruction.
