Job Stamp:
04-SF-80-13.2/13.9 04-0120F4
SFOBB SAS
San Francisco Co. in San Francisco
Fm 0.6 km to 1.3 km East of Yerba Buena
Tunnel East Portal

Report No. **46.B**
Date the Shift Began: **4/3/08**
 NIGHTWORK **THURSDAY**
Shift Hrs Start **7:00** Stop **15:30**
Engineer's Hrs Start **7:00** Stop **15:30**

ASSISTANT RESIDENT ENGINEER'S DAILY BRIDGE REPORT

Location: W2 Cap Beam	7-day const. cal.: 477	Weather: clear
Remark: ironwork for pour 2	Project work day: 687	Hi 62F/Lo 45F

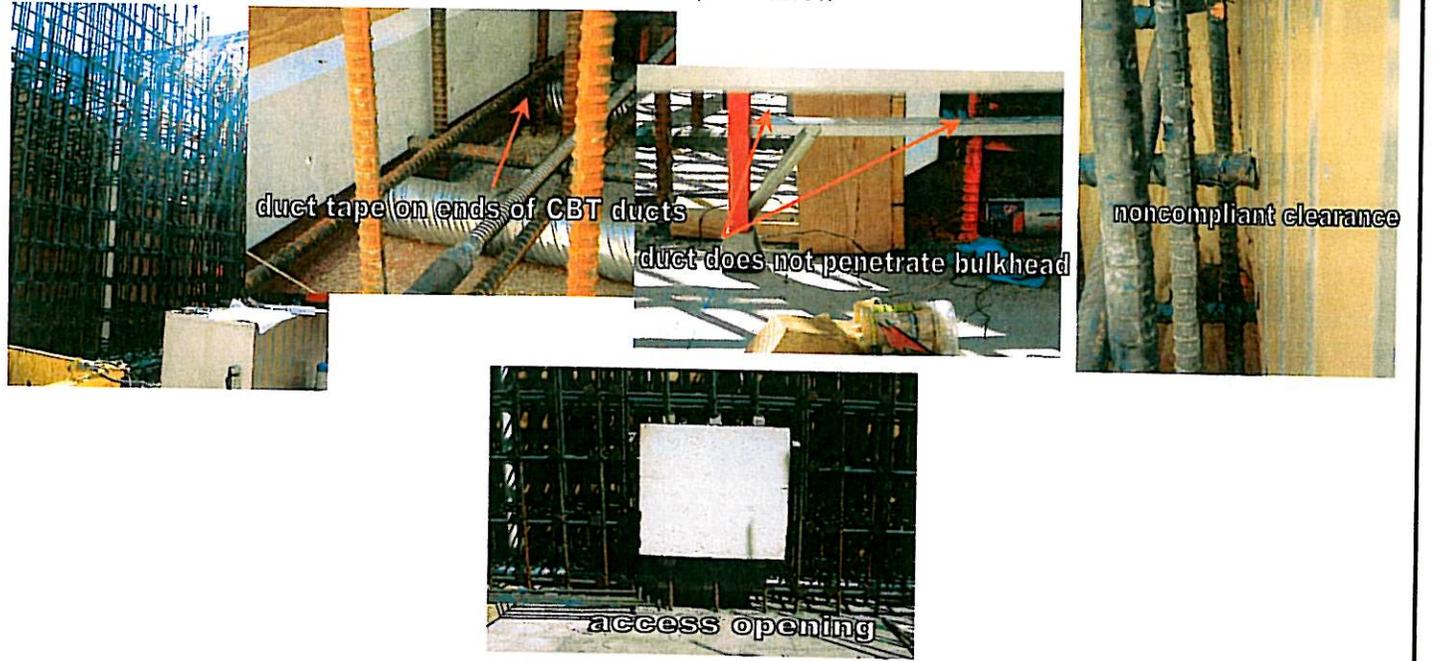
Weekly safety meeting: Lyme Disease
RPS completed placing vertical T-heads in the intermediate transverse diaphragm. They placed two manhole blockouts and placed the verticals in that region as well. Their detailer had 7 bars going across but there are only 3 according to the plans. In the other dimension, there are four bars. In this case --> (7-3) x 4 = 16. There are four manholes so there would be 64 extra of these T-headed bars on both ends. They placed two ducts and butted them against the bulkhead on the south side. We told them that they would need to put it through the formwork and they refused (in the pictures, the ends are duct taped and do not come out the other side of the forms). The ducts are still not set in their final position (laterally). I determined this by measuring their offset from the center line of W2 cap beam. I told the ironworkers that some rebar was butting against the access opening and therefore did not have the right cover. Also, on the same side of the opening on the opposite face of the wall that the picture was taken, the clearance was about 1/4" from a vertical bar. Two bars placed (not full length) in the east transverse wall: 1-36L10T91, 1-36L12T91.
