Job Stamp:
04-SF-80-13.2/13.9 04-0120F4
SFOBB SAS
San Francisco Co. in San Francisco
Fm 0.6 km to 1.3 km East of Yerba Buena
Tunnel East Portal

ASSISTANT RESIDENT ENGINEER'S DAILY

Location: W2 Cap Beam	7-day const. cal.: 481	Weather: party cloudy
Remark: ironwork/formwork for pour 2	Project work day: 691	Hi 60F/Lo 41F

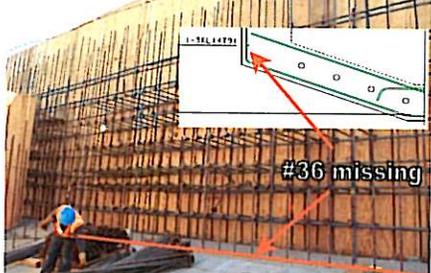
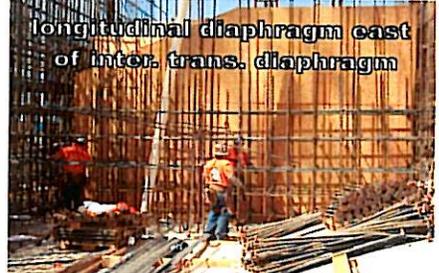
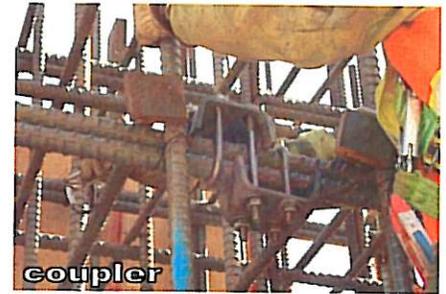
ABF's electrical conduit was stolen over the weekend. They could not supply any electricity from the generator. They supplied electricity by other means until an identical one (mobile) showed up. --> "MQ Power 220" - #549-96-6027
RPS started placing T-head ties in the east transverse diaphragm. Pam (CT) reminded them that they still need to place a #36 bar at the bottom 1-36L14T91. They fought this with Pam for a short time. They have not yet placed this bar. RPS also tried to place replacement bars for the long T-bars above the access opening. They again were fabricated too long.

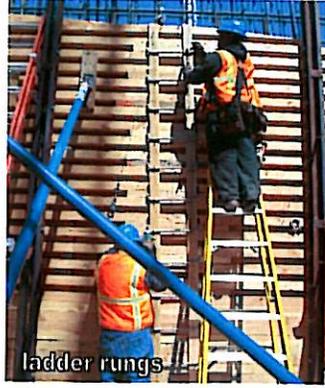
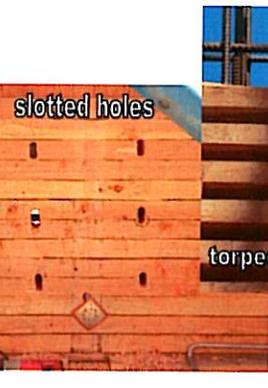
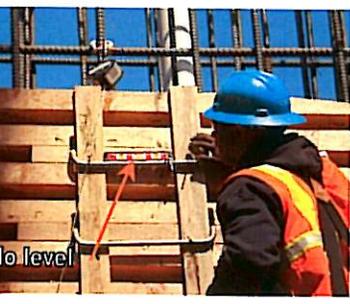
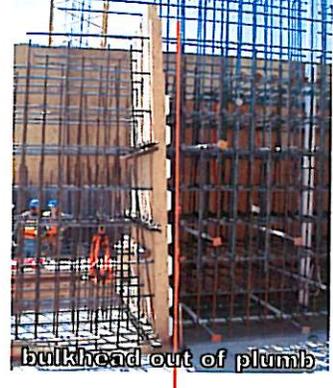
ABF has started placing couplers on the #36 bars in the intermediate diaphragm wall.
ABF has started and completed the installation of the ladder rungs for the south manhole. They are drilling slotted holes in their forms/support members in order to insert the ladder rungs. They are using a torpedo level to make sure the rungs are level. They have also started placing support members (double channel beams used as waters) for both bulkheads in the intermediate transverse diaphragm, but have not yet placed any kickers. After I repeatedly told them that they need to make sure the bulkhead is plumb, I again spoke to one of the carpenters and he said, "that's as plumb as you're going to get." As the south bulkhead exists, you do not need a level to tell that the bulkhead is out of plumb. They continue to place tieback rods with PVC.
