TOLL PROGRAM/DIST. 4 CONSTR.

Job Stamp:  
04-SF-80-13.2/13.9 04-0120F4  
SFOBB SAS  
San Francisco Co. in San Francisco  
Fm 0.6 km to 1.3 km East of Yerba Buena  
Tunnel East Portal

**ASSISTANT RESIDENT ENGINEER'S DAILY BRIDGE REPORT**

Location: <b>W2 Cap Beam</b>	7-day const. cal.: <b>484</b>	Weather: <b>Clear/warm</b>
Remark: <b>ironwork/formwork/cooling pipes for pour 2</b>	Project work day: <b>694</b>	<b>Hi 67F/Lo 45F</b>

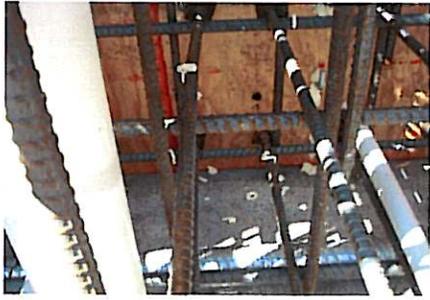
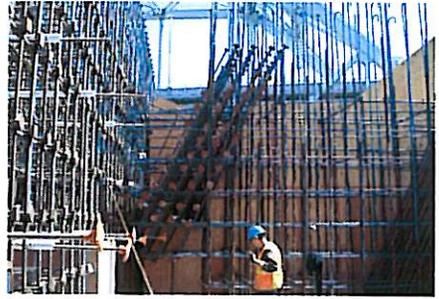
ABF continued to place tieback bolts in the east transverse diaphragm and longitudinal diaphragm. They also continued to place cooling pipes in the intermediate transverse diaphragm. They are getting ready to close the forms for the east transverse diaphragm. For the intermediate transverse diaphragm, there is styrofoam debris sticking to the rebar and formwork on the opposite side of the ladder rungs (left picture). RPS continued to place steel for the jacking saddle on the west side of the intermediate transverse diaphragm. ~1015 I told Lance (RPS foreman) that the ties in the longitudinal diaphragm on the east side of the intermediate diaphragm were placed wrong. According to the plans (sht 497S5), the ties alternate from being on top to being below the longitudinal steel in the longitudinal diaphragm. I told him this was also the case for the few ties they placed in the longitudinal diaphragm on the west side of the inter. trans. diaphragm. ~1030 Lance wanted to address the ties in the west trans. diaphragm. Shown on sht 495R2 (according to him), detail "headed tie alternate," the ties are staggered from being on top of the interior face single #36 to being below the exterior horizontal bundle #36s. I told him I was reading it that way as well. However, I noticed that was not how they were placing them. They were placing the ties all on top of the #36s. Lance asked if they could continue to place the bars that way. I asked Gil (CT) and he said it was okay.

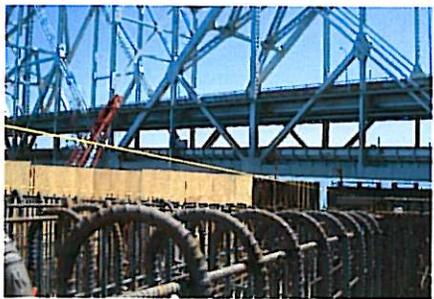
Two of RPS crew were dedicated to adjusting all the hooks/T-heads in the inter. trans. diaphragm (center picture). They measured each one to be 55mm below the neon stringline which was set by ABF surveyors. By the end of the day, RPS had one row of hooks/T-heads complete. Matt (CT) and I checked the grades for the stringline set by ABF and it was right/within tolerance.
